the play inspection company

Annual Inspection

Farthinghoe Parish Council

Farthinghoe Play Park

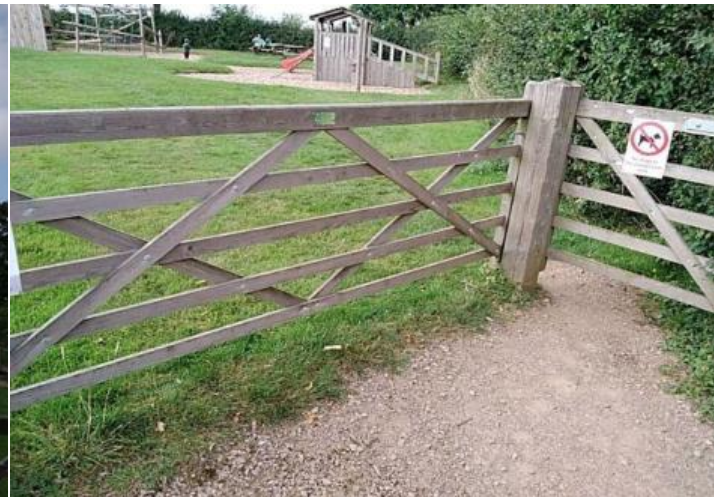
Finding: It is recommended that signage, with information including the site address, contact information for maintenance issues and emergency contact details are provided for the facility

Action: Provide in accordance with the recommendations

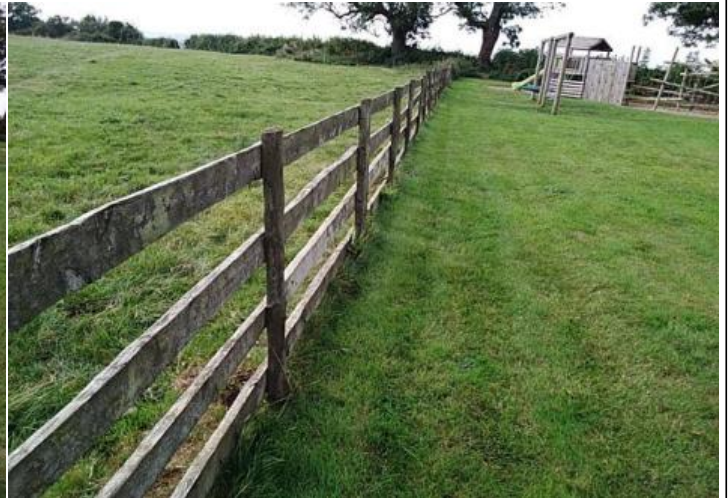
Finding: There are a number of loose posts around the fence

Action: Monitor for any further deterioration and reset as required

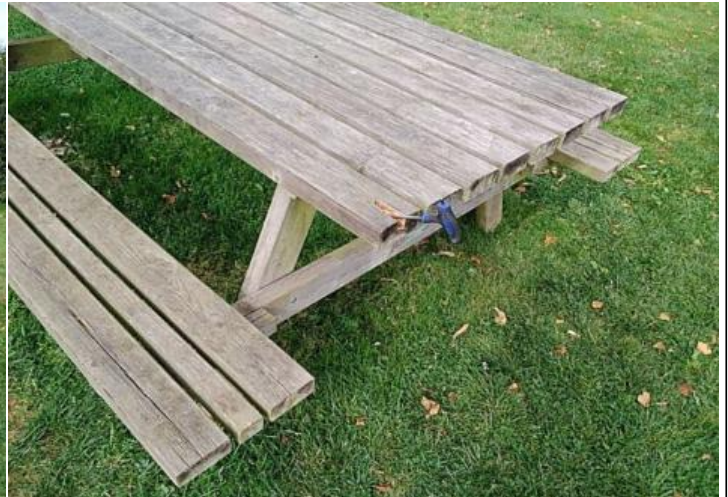
Finding: There is some evidence of rot in the timber

Action: Monitor for any further deterioration and replace as required

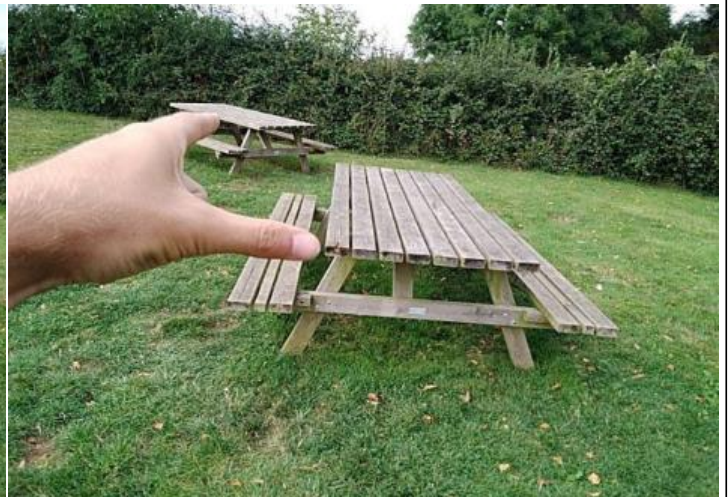
Finding: A number of fixing(s) have worked loose
Action: Secure all loose fixings

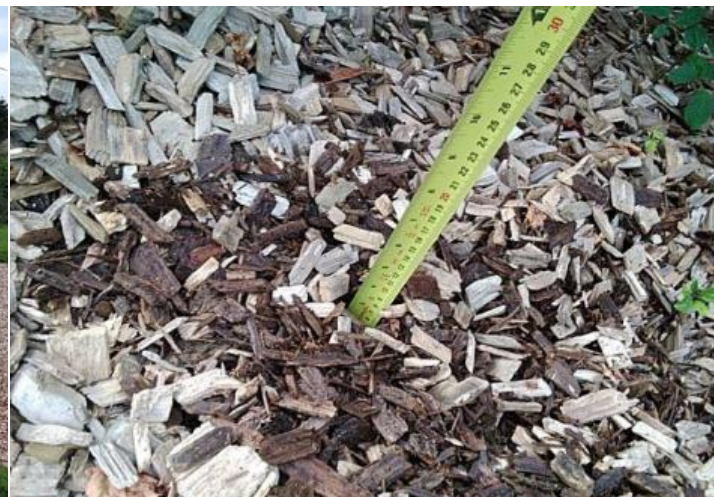
Finding: The depth of the loose fill surfacing is lower than the recommended depth specified in BS EN 1176; the free height of fall of the equipment is less than 2.0m and a minimum of 300mm depth should be provided (including an extra 100mm to allow for compaction and displacement as per BS EN 1176 Part 1 - Table 4)

Action: Top up loose fill surfacing to recommended levels

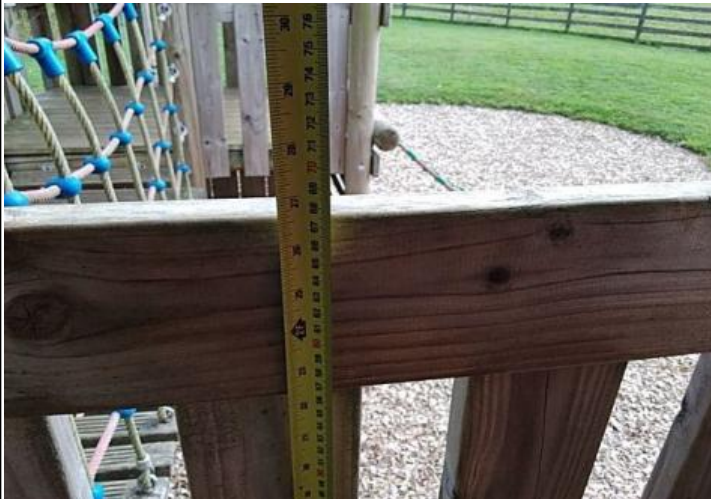
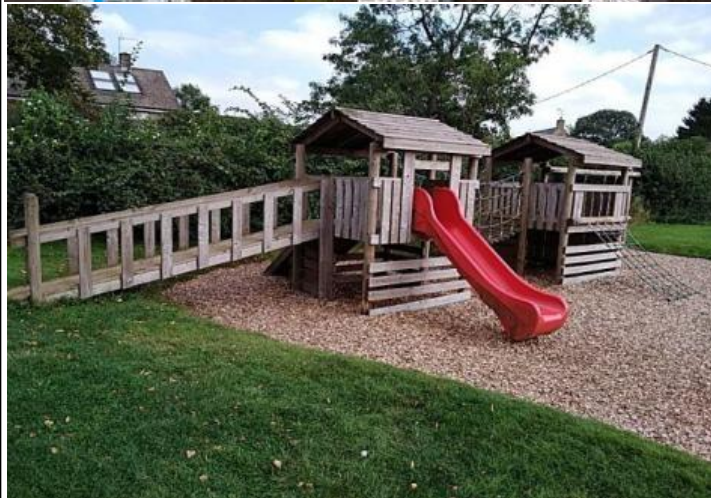
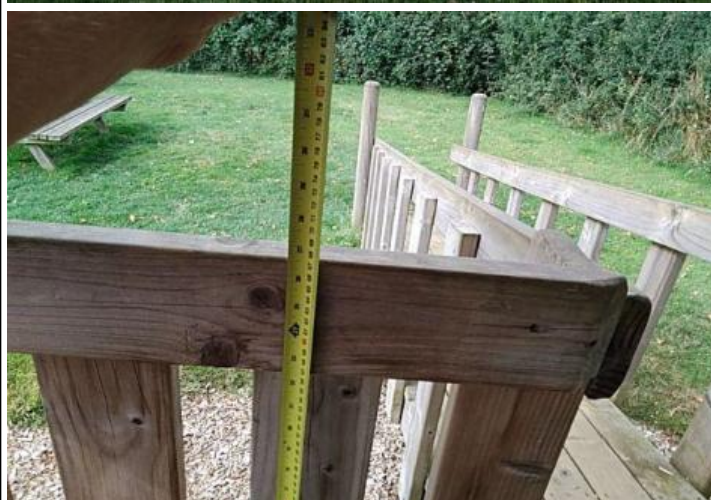
Finding: The height of the barrier(s) is insufficient and fails to meet the requirements of BS EN 1176 Part 1 **Action:** Monitor - No remedial work recommended

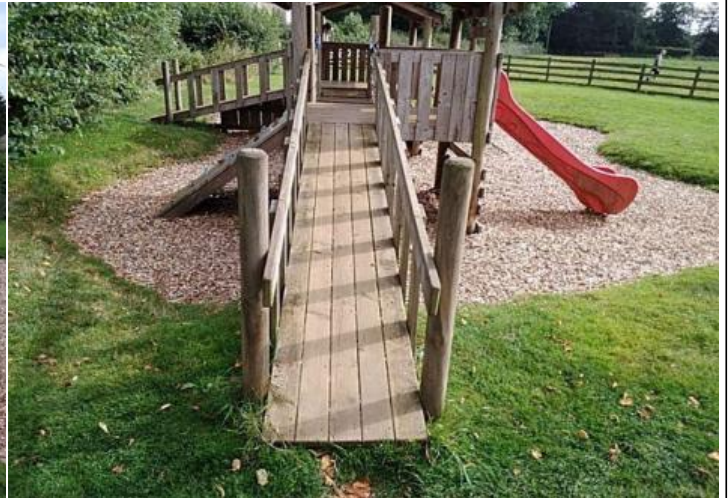
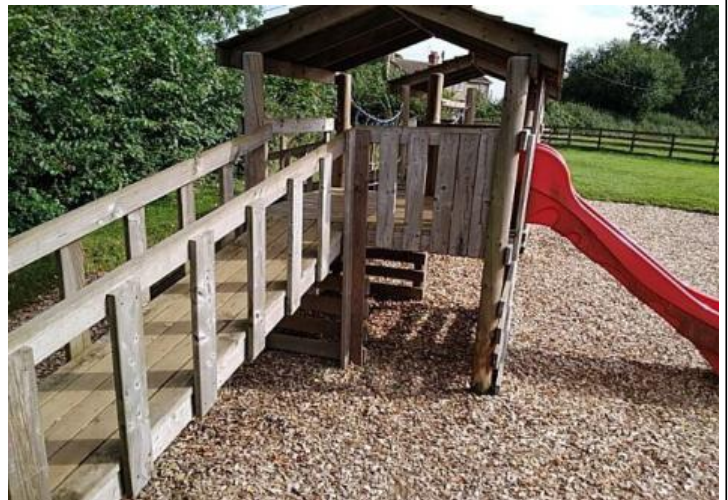
Finding: The unit is easily accessible and should have the appropriate barriers installed to meet the requirements of BS EN 1176 Part 1 as the height of the unit exceeds 600mm

Action: Monitor - No remedial work recommended

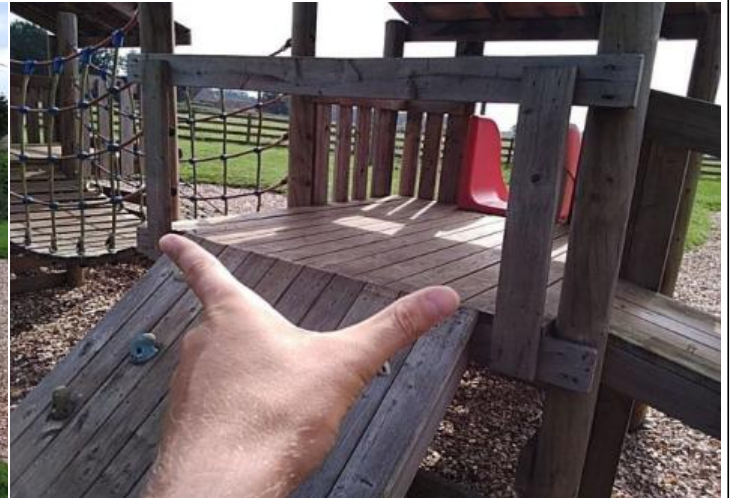
Finding: The platform provides access to a steep play element via a barrier with a width exceeding 1200mm and this fails to meet the requirements of BS EN1176 Part 1.

Action: Monitor - No remedial work recommended

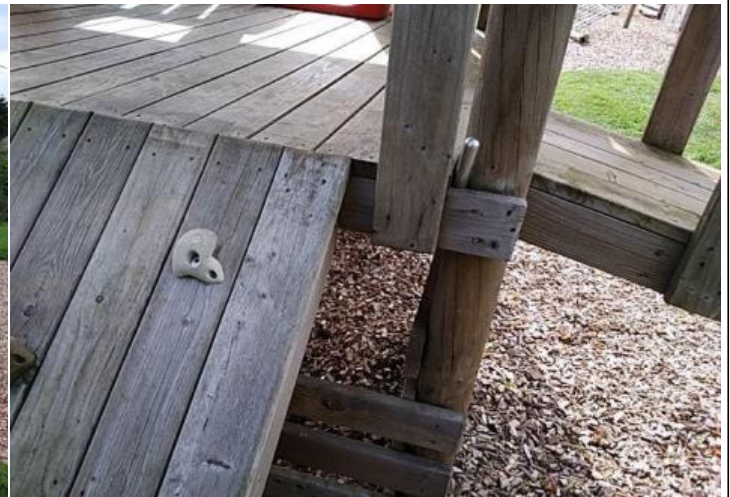
Finding: There is/are finger entrapment/s in the frame and the item fails to meet the requirements of BS EN 1176 Part 1 4.2.7.6 Entrapment of fingers

Action: Monitor - No remedial work recommended

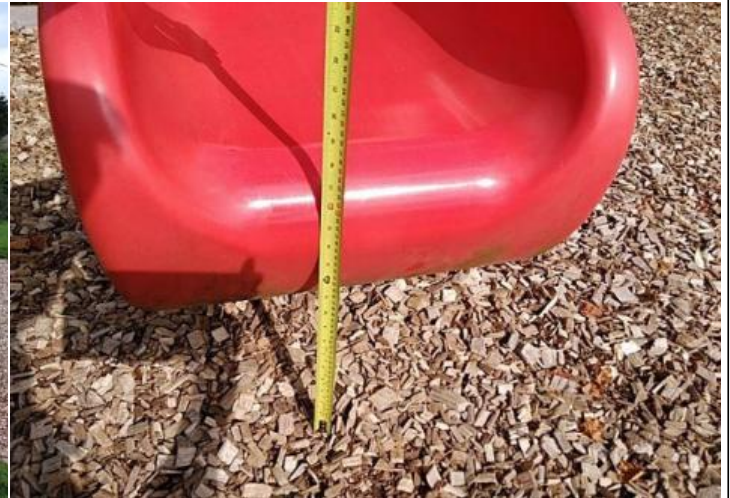
Finding: The height of the slide runout is in excess of 200mm and fails the requirements of BS EN 1176 Part 3

Action: Top up surfacing to comply

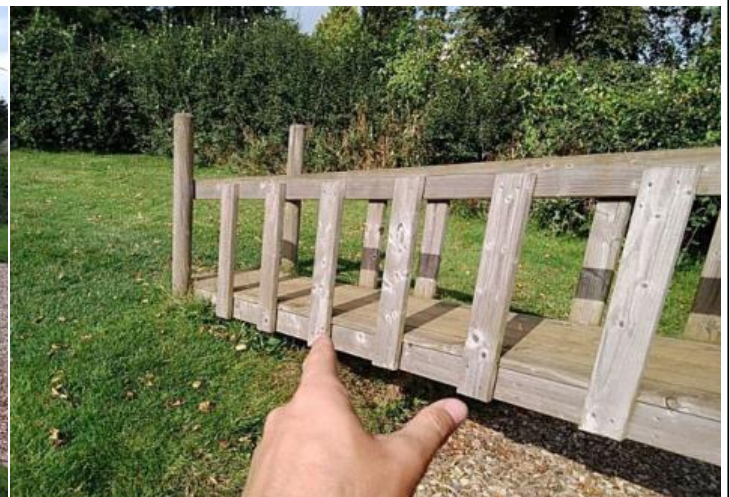
Finding: A number of fixing(s) have worked loose

Action: Secure all loose fixings

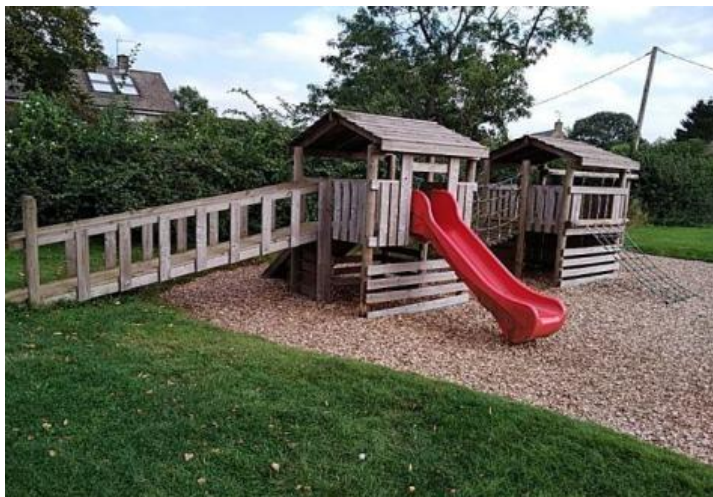
Finding: There is or are fixings missing on the item

Action: Replace all missing fixings

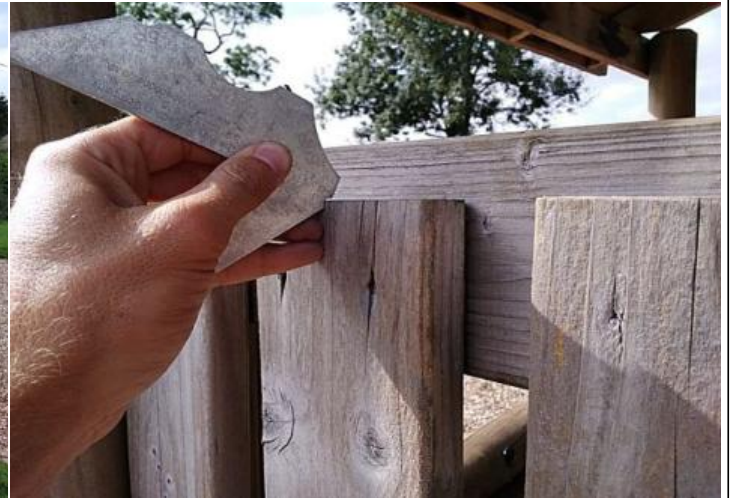
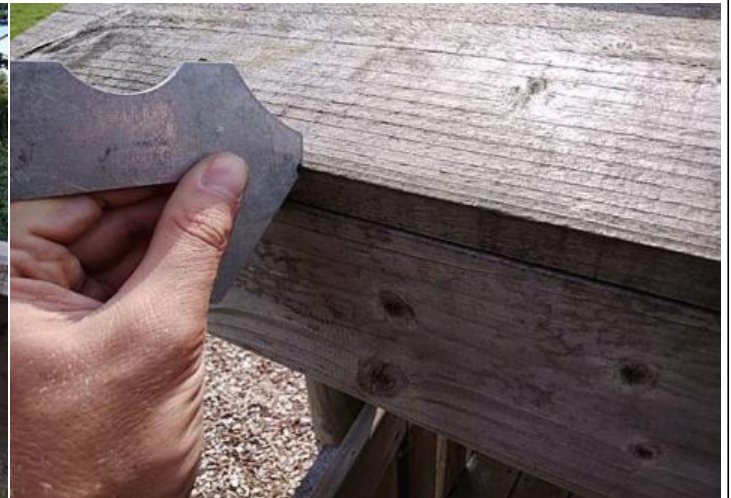
Finding: The item has exposed edges and corners with a radius of less than 3mm and fails the requirements of BS EN 1176
Action: Provide a 3mm radius to all exposed edges and corners

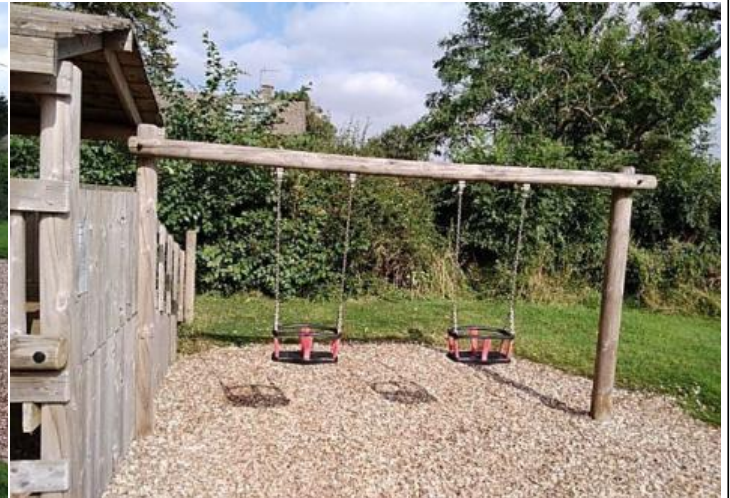
Finding: Swing bays and/or their beams should only be attached to other equipment where specific measures are undertaken to segregate them from other activities such as enclosures, swing barriers or a 1500mm area

Action: Monitor - No remedial work recommended

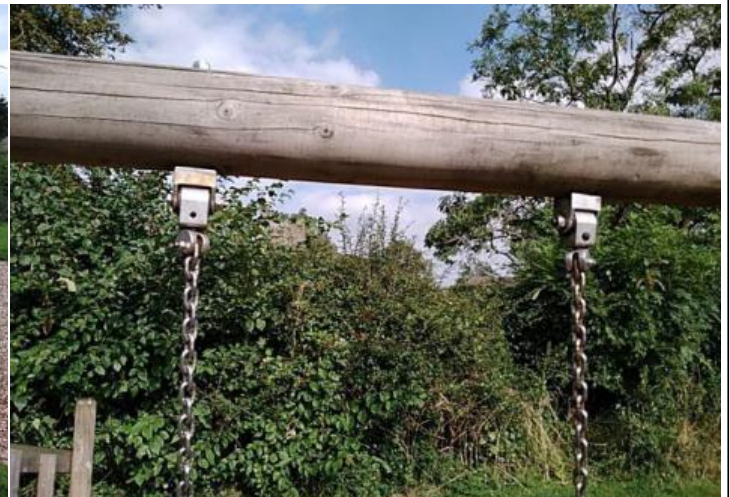
Finding: This design of swing joint has been known to fail on the weld connecting the joint to the threaded stud

Action: We would recommend that the joint be dismantled and checked on a regular basis or a Secondary Safety Device be fitted

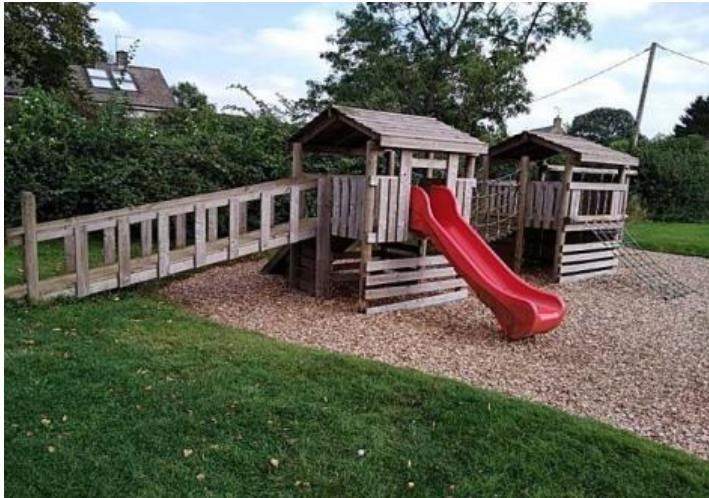
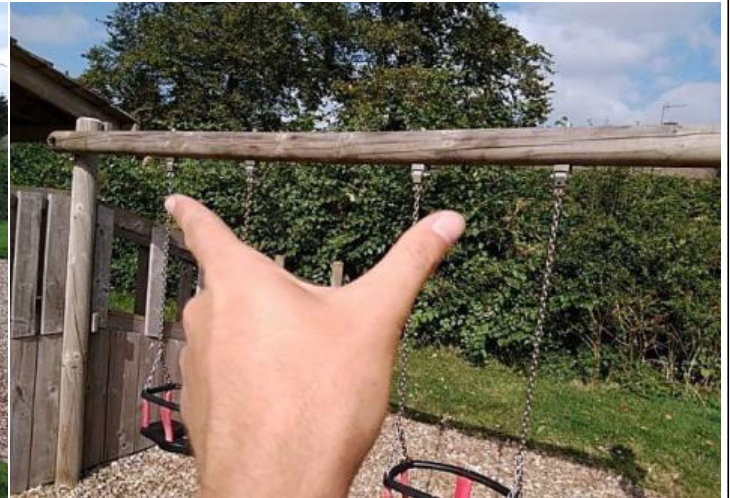
Finding: A number of fixing(s) have worked loose

Action: Secure all loose fixings

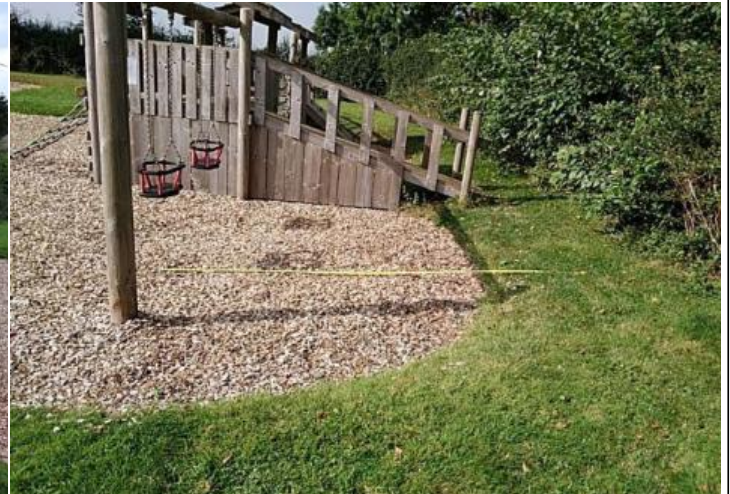
Finding: The surfacing dimensions are short and do not meet with the requirements of the current applicable standard

Action: Monitor - no remedial action recommended

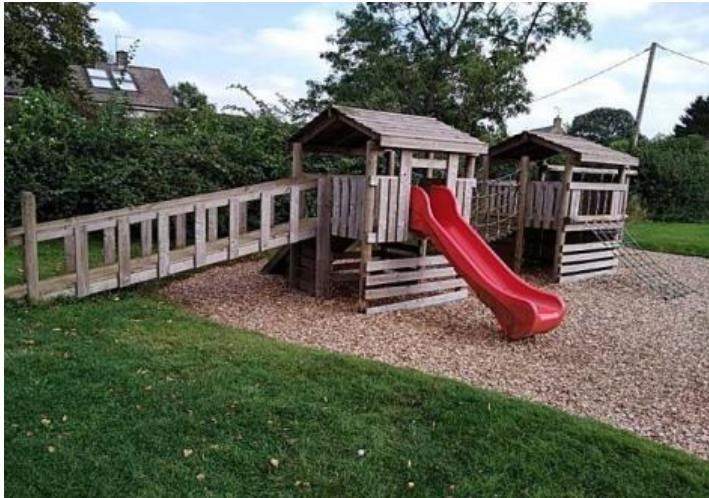
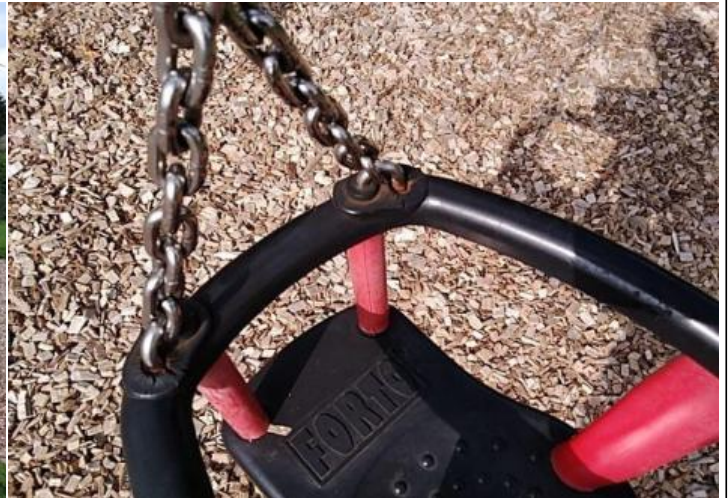
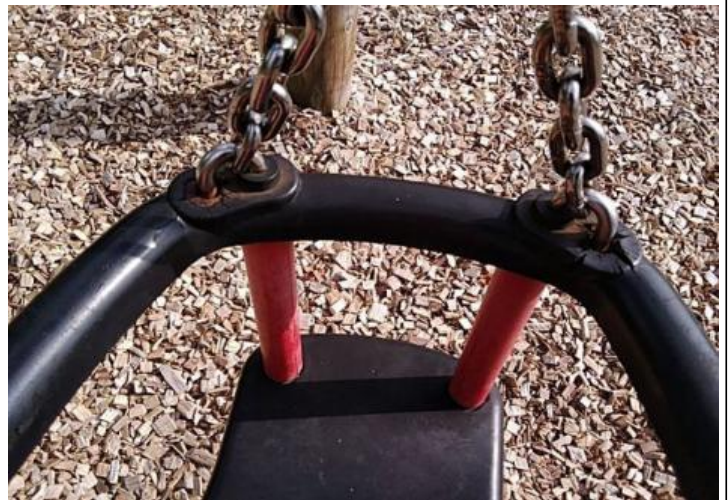
Finding: There is surface corrosion present on the fixings

Action: Replace the corroded fixings

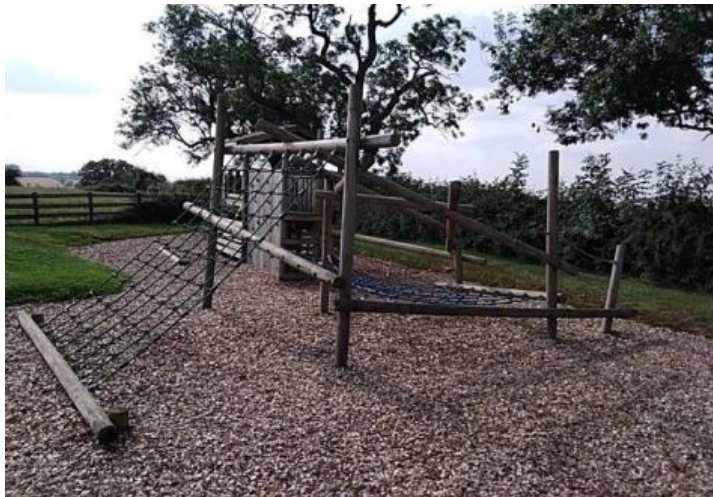
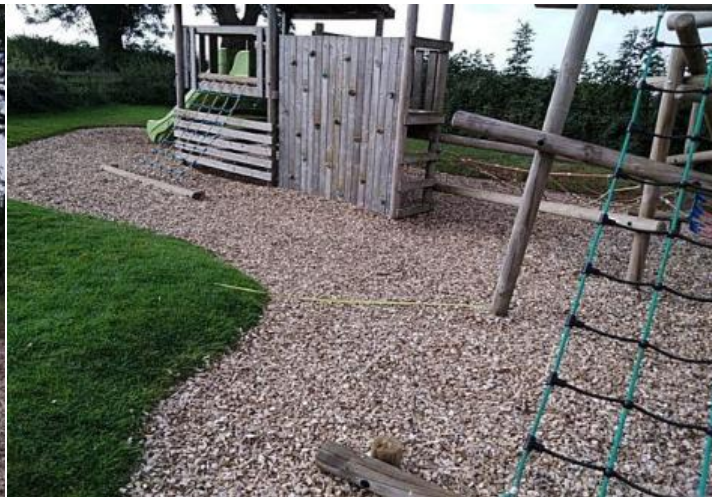
Finding: The surfacing dimensions are short and do not meet with the requirements of the current applicable standard

Action: Monitor - no remedial action recommended

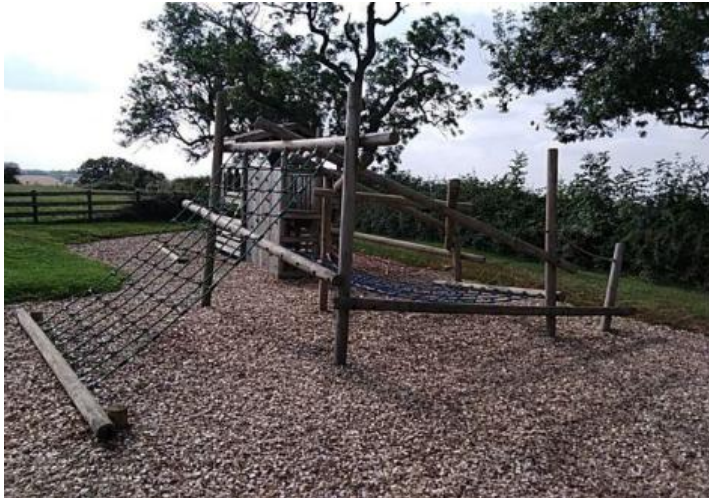
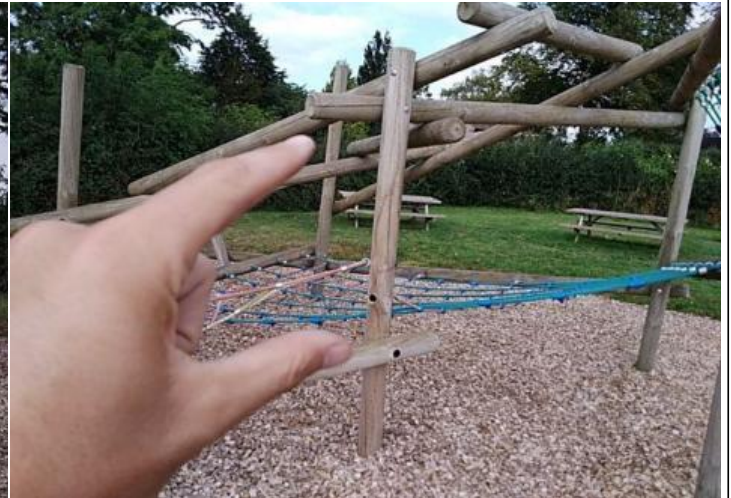
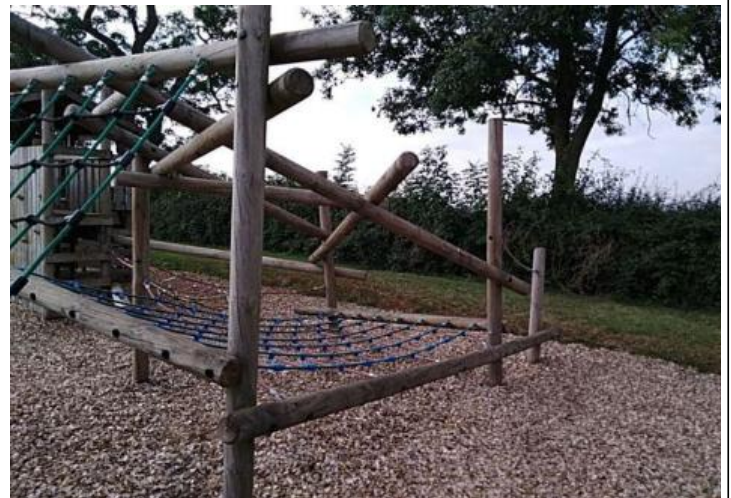
Finding: There are falls in excess of 600mm between adjacent components on the structure, in contravention of the recommendations set out in BS EN 1176 Part 1; 4.2.8.4

Action: Monitor - No remedial work recommended

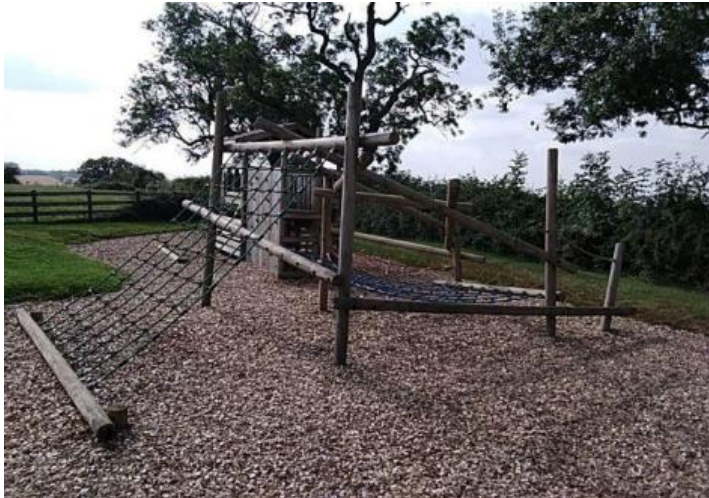
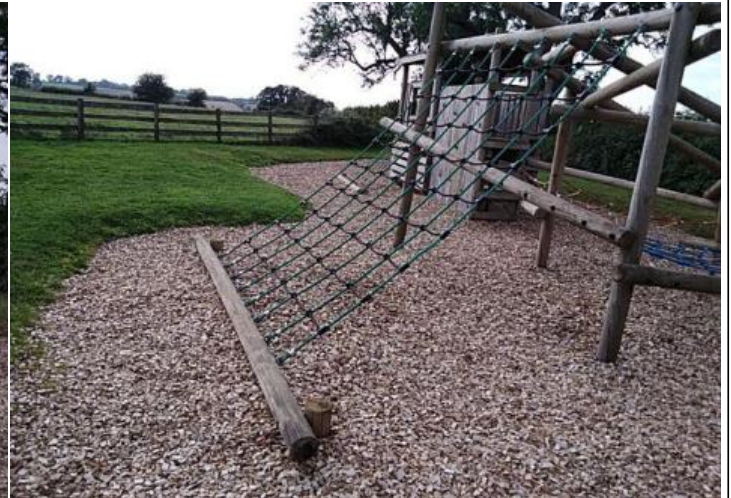
Finding: The net anchor forms a hard object within the impact area of the equipment in contravention of the requirements of BS EN 1176 Part 1

Action: Monitor - No remedial work recommended

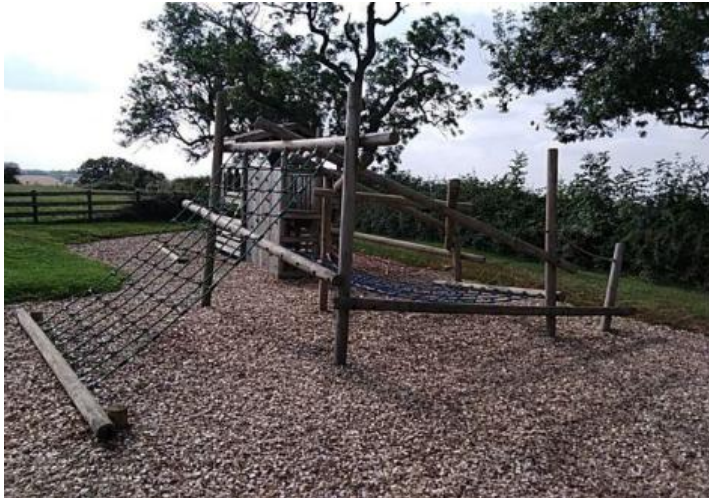
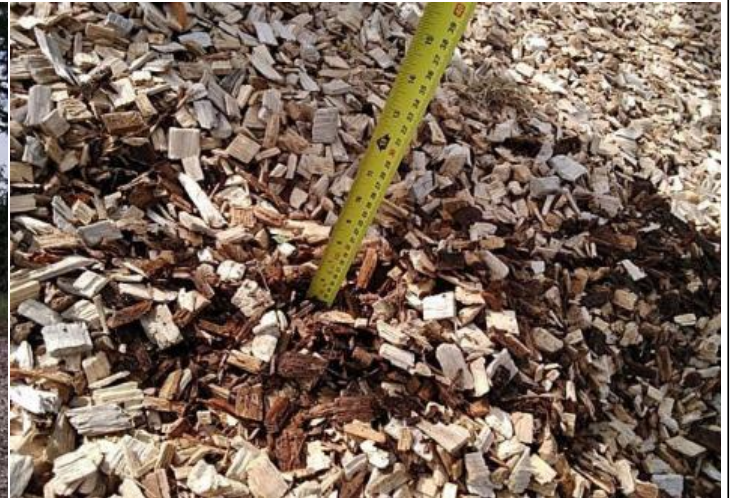
Finding: The depth of the loose fill surfacing is lower than the recommended depth specified in BS EN 1176 for a fall height over 2.0m. A minimum depth of 400mm is recommended (including an extra 100mm to allow for compaction and displacement as per BS EN 1176 Part 1 - Table 4)

Action: Top up loosefill to recommended levels

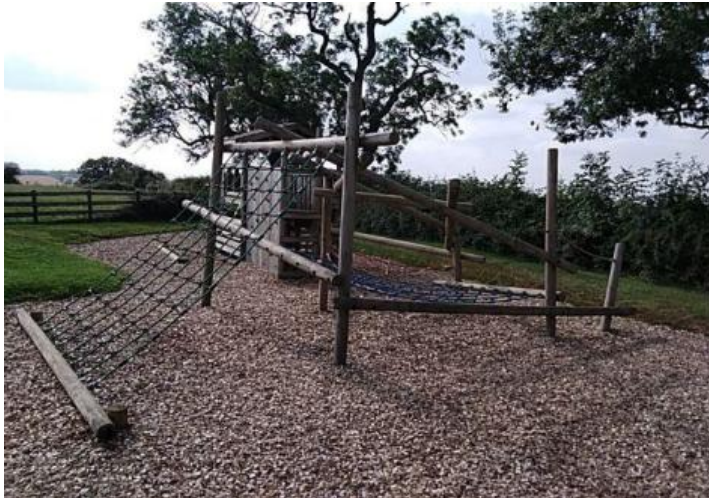
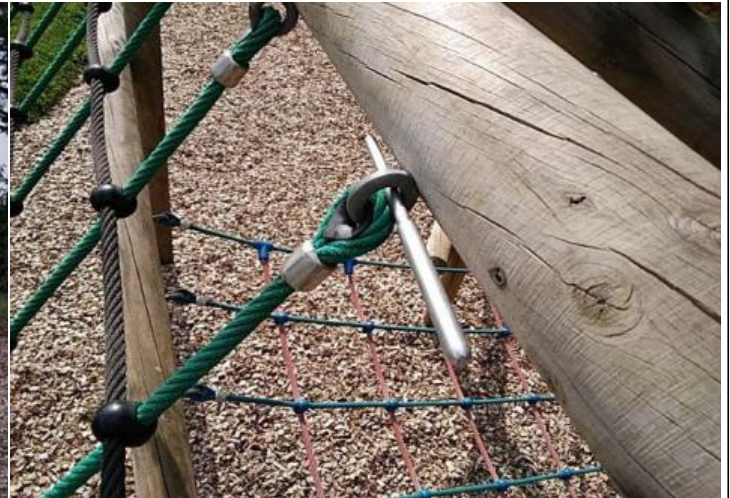
Finding: The connecting links are in excess of 8.6mm and less than 12mm and fail the requirements of BS EN 1176 Part 1; clause 4.2.13, Chains

Action: Monitor use and replace with compliant links at the next maintenance cycle

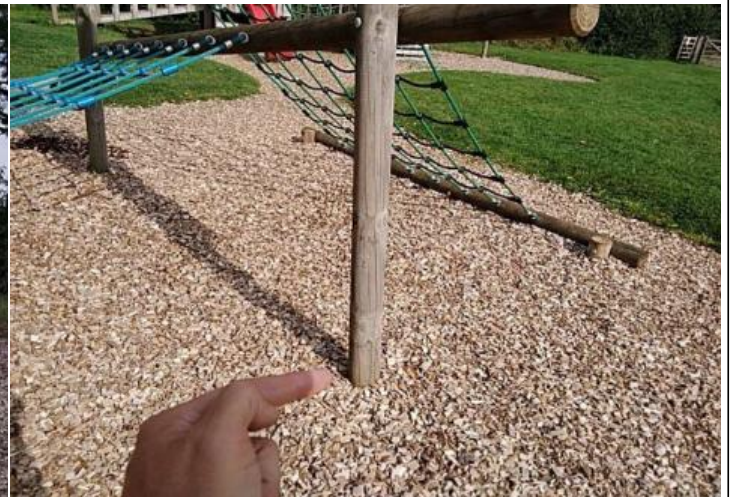
Finding: The item is slightly loose in its foundations

Action: Monitor for any further deterioration and repair as required

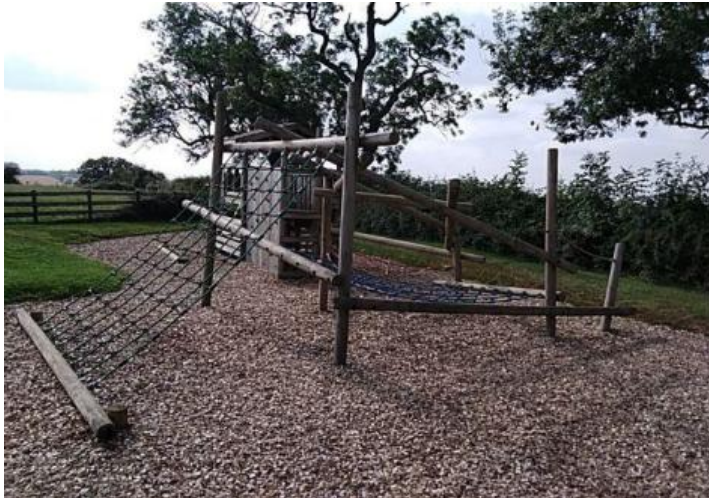
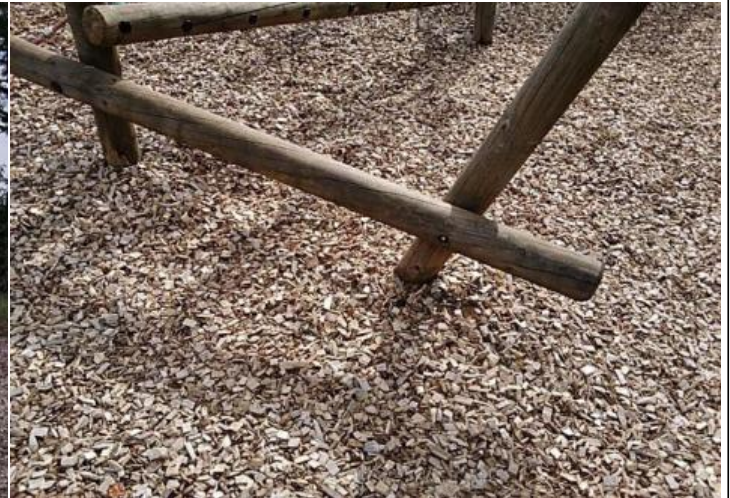
Finding: There is/are bolt cap covers missing or damaged on the item

Action: Replace missing or damaged bolt cap covers

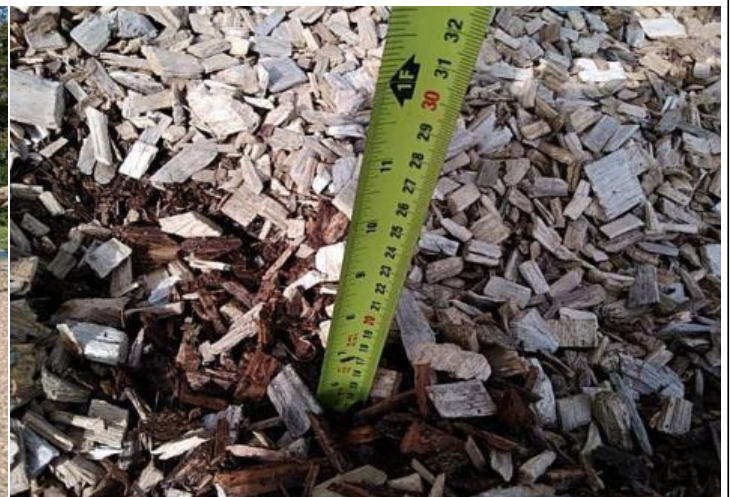
Finding: The depth of the loose fill surfacing is lower than the recommended depth specified in BS EN 1176; the free height of fall of the equipment is less than 2.0m and a minimum of 300mm depth should be provided (including an extra 100mm to allow for compaction and displacement as per BS EN 1176 Part 1 - Table 4)

Action: Top up loose fill surfacing to recommended levels

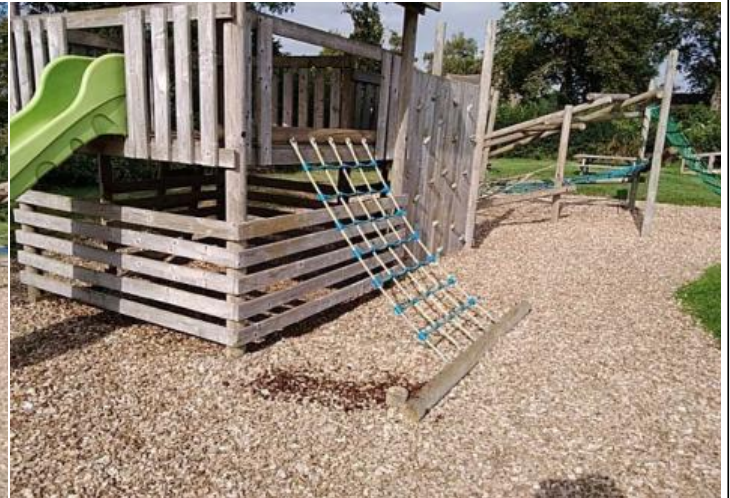
Finding: The net anchor forms a hard object within the impact area of the equipment in contravention of the requirements of BS EN 1176 Part 1

Action: Monitor - No remedial work recommended

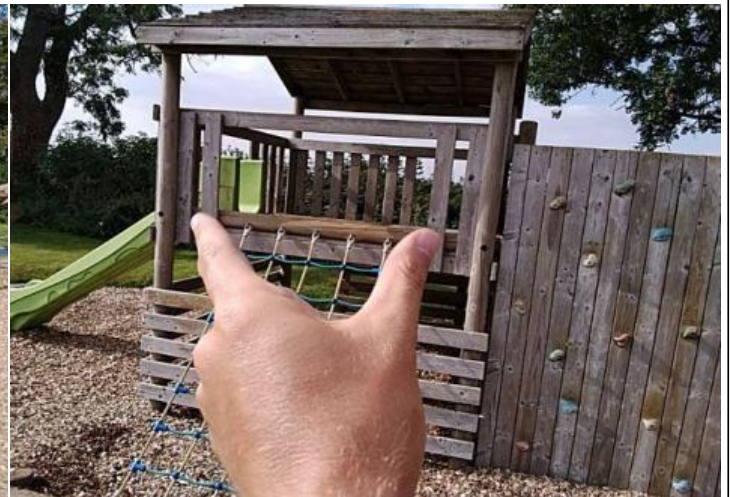
Finding: The platform provides access to a steep play element via a barrier with a width exceeding 1200mm and this fails to meet the requirements of BS EN1176 Part 1.

Action: Monitor - No remedial work recommended

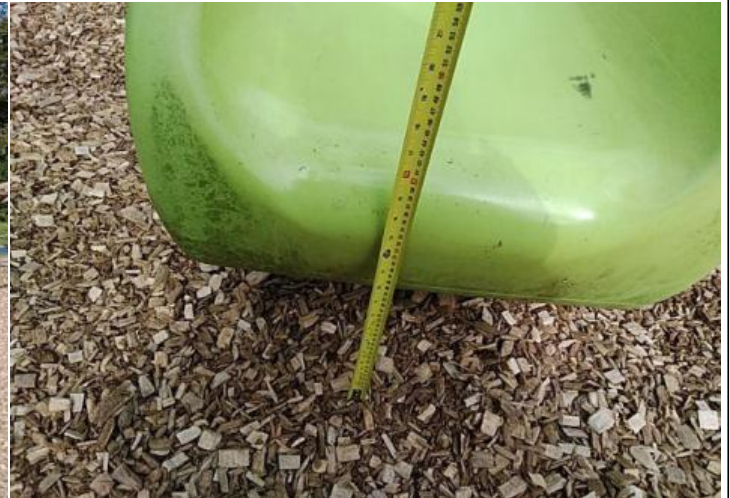
Finding: The height of the slide runout is in excess of 350mm and fails the requirements of BS EN 1176: Part 3

Action: Top up surfacing to comply

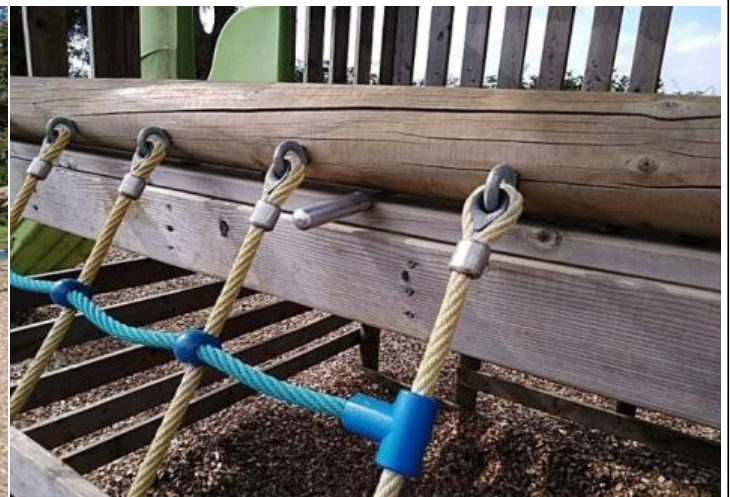
Finding: There is/are finger entrapment/s in the platform and the item fails to meet the requirements of BS EN 1176 Part 1 4.2.7.6 Entrapment of fingers

Action: Monitor - No remedial work recommended

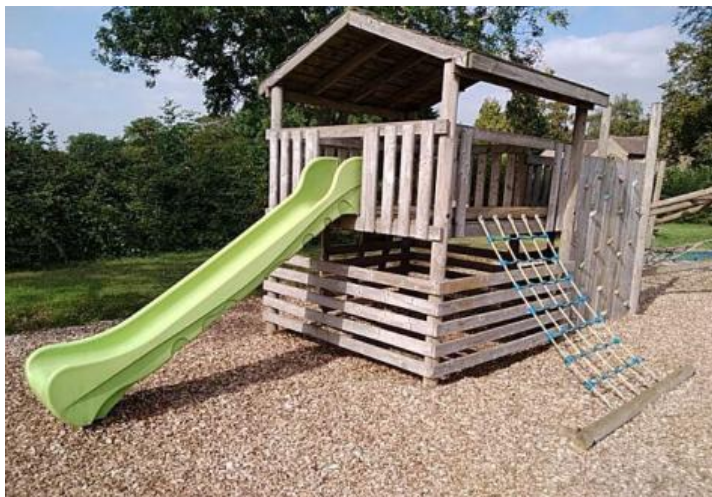
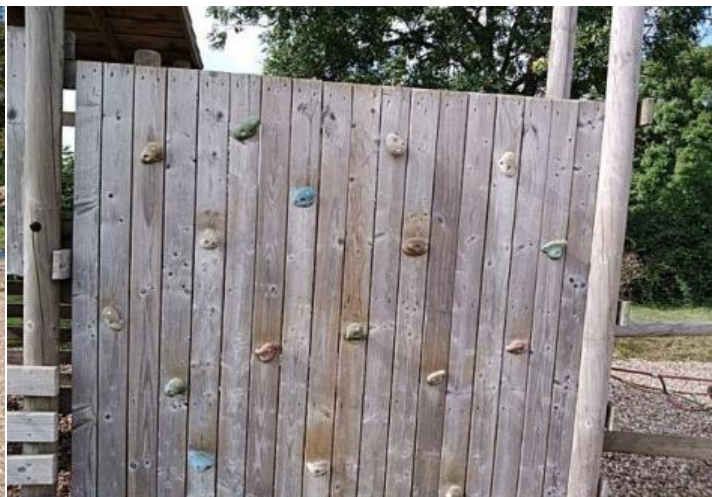
Finding: A number of fixing(s) have worked loose

Action: Secure all loose fixings

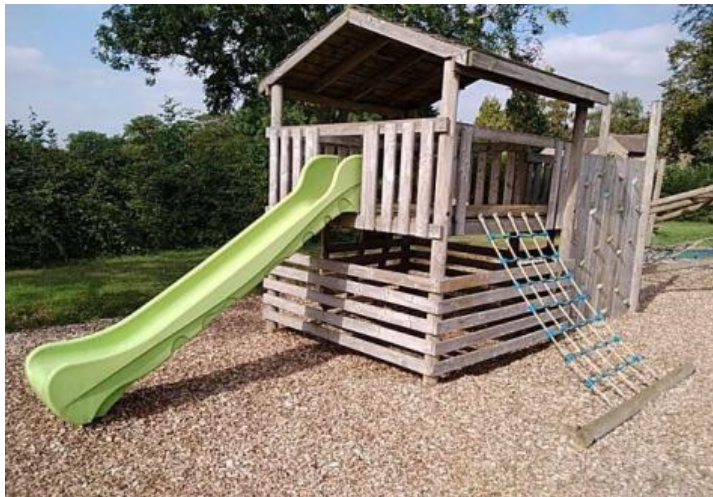
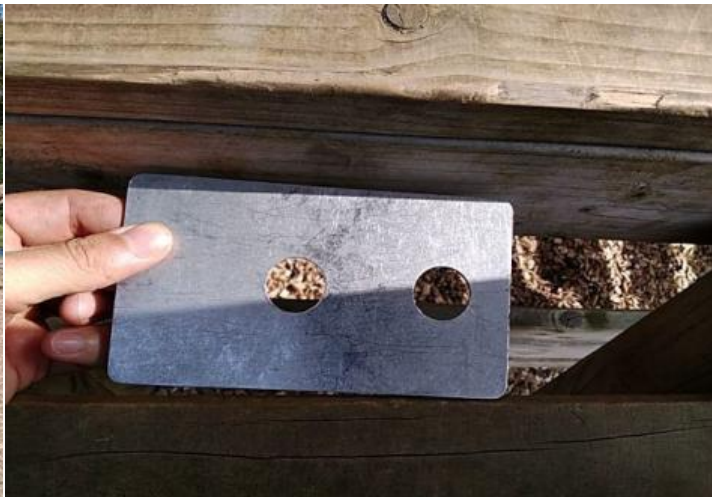
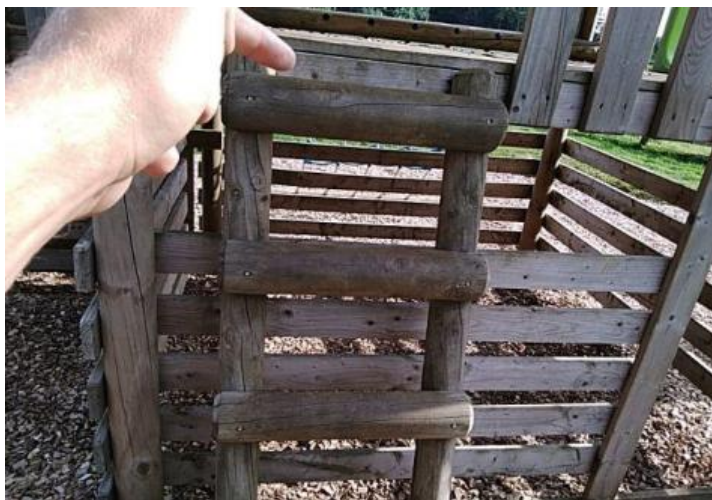
Finding: The item fails to meet the requirements of BS EN 1176 Part 1 4.2.7.2 head and neck entrapment in the barriers and/or steps

Action: Monitor - No remedial work recommended

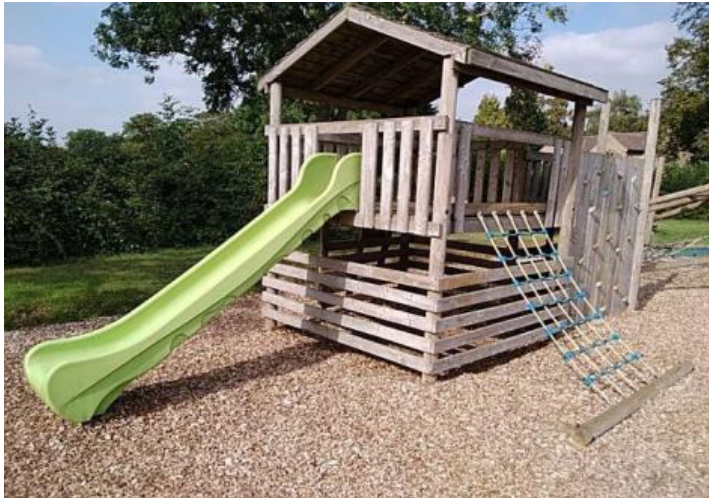
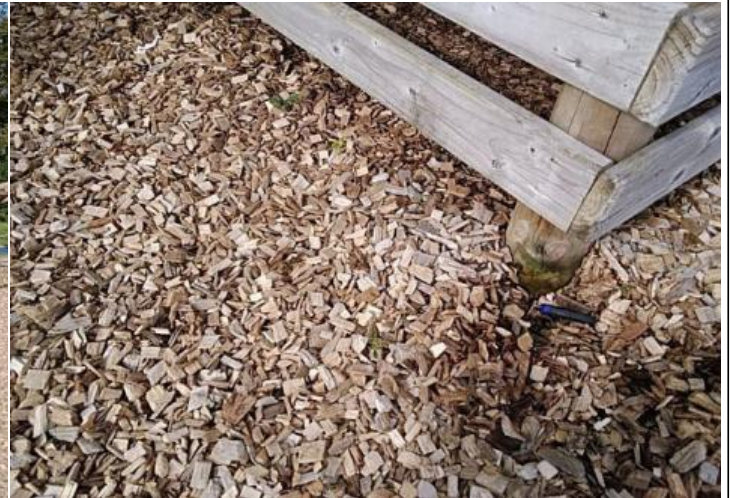
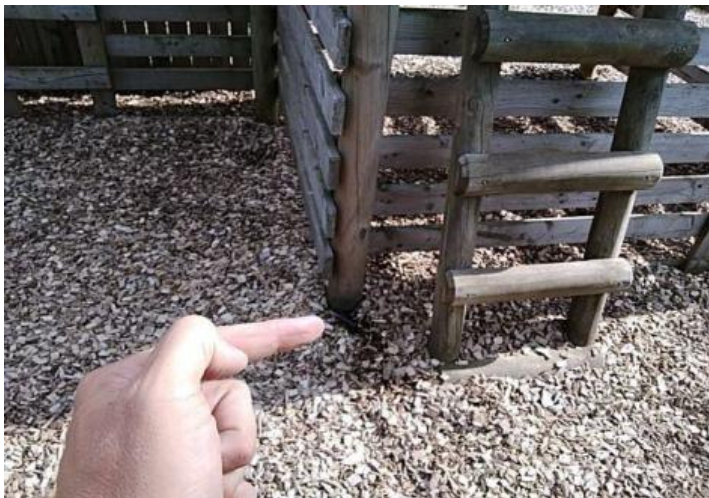
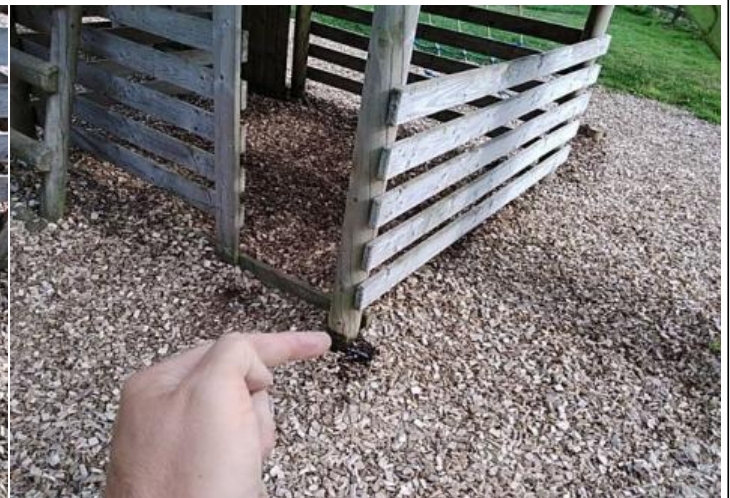
Finding: There is some evidence of rot in the timber

Action: Monitor for any further deterioration and replace as required

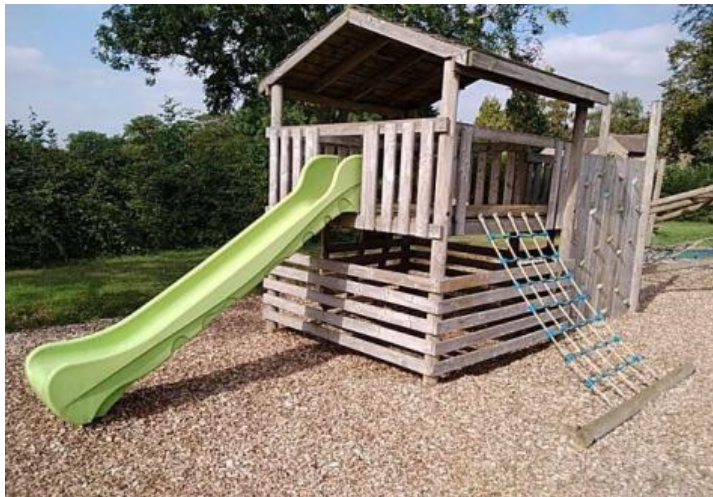
Finding: There is/are bolt cap covers missing or damaged on the item

Action: Replace missing or damaged bolt cap covers

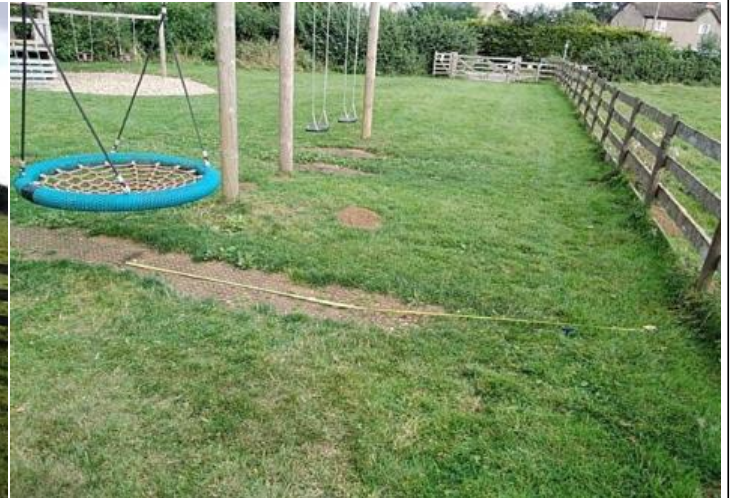
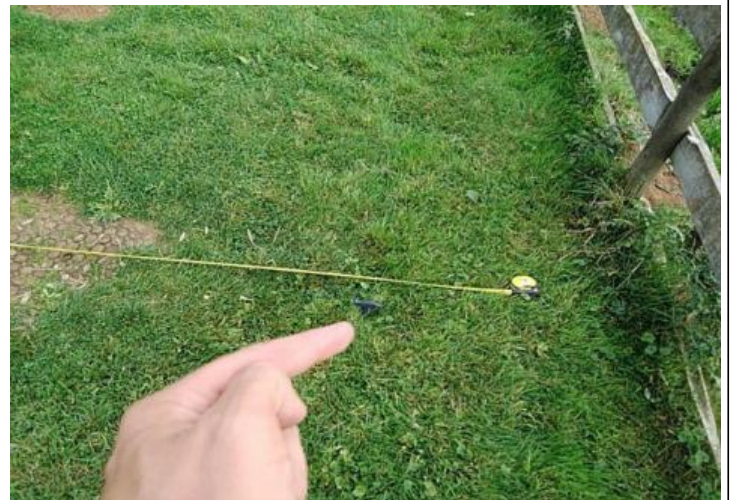
Finding: The surfacing dimensions are short and do not meet with the requirements of the current applicable standard

Action: Monitor - no remedial action recommended

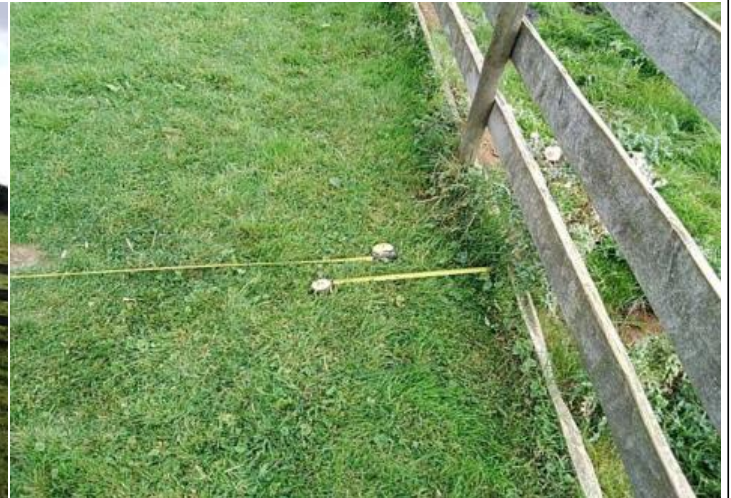
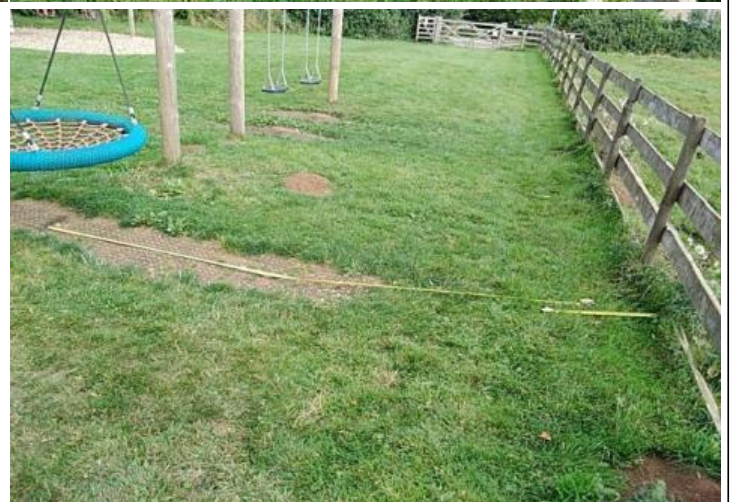
Finding: BS EN 1176 requires an additional 0.5m of unobstructed space at each end of the swing surfacing area. This is a relatively low risk finding and no remedial action is recommended at this point.

Action: Monitor - No remedial work recommended

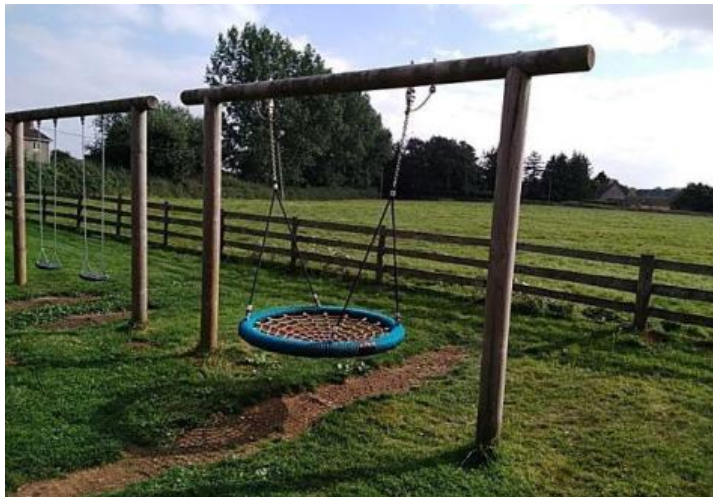
Finding: The edges of the grass mat surface have not been installed in accordance with the API Code of Practice
Action: Tuck in edges of grass mat to remove trip hazards
