the play inspection company

Annual Inspection

Farthinghoe Parish Council

Farthinghoe Play Park

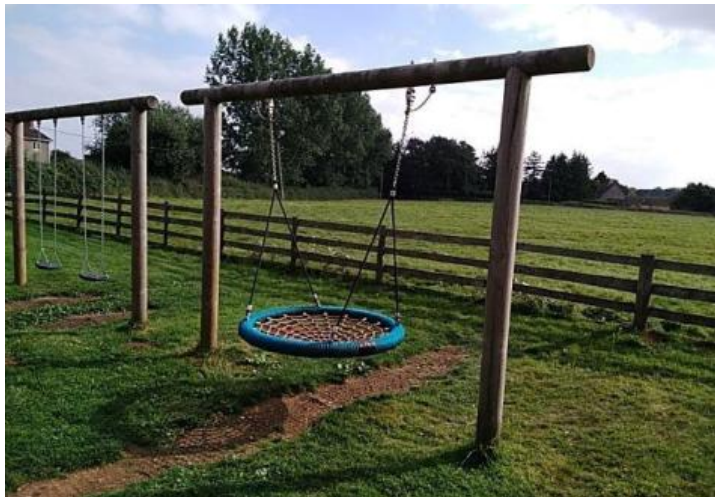
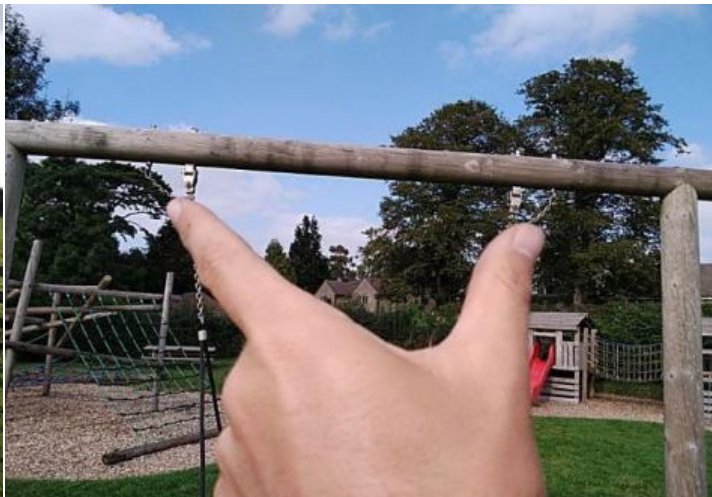
Finding: All fixings have worked loose

Action: Secure all loose fixings

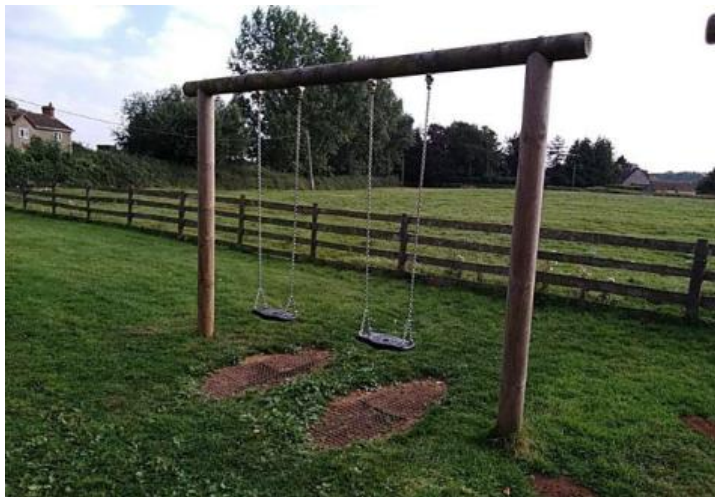
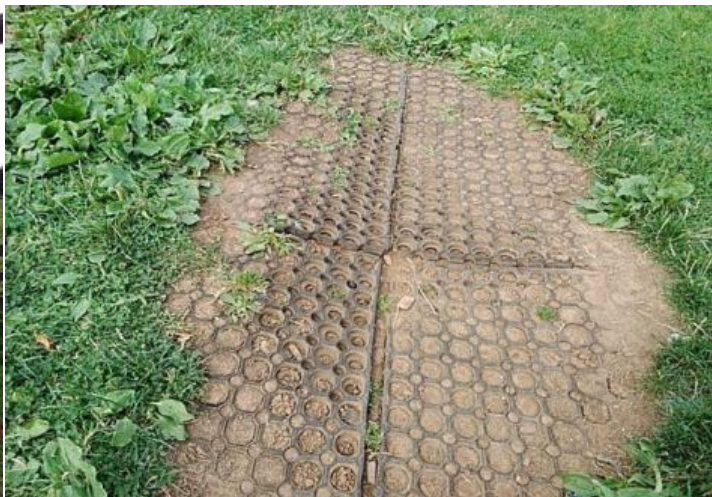
Finding: The edges of the grass mat surface have not been installed in accordance with the API Code of Practice

Action: Tuck in edges of grass mat to remove trip hazards

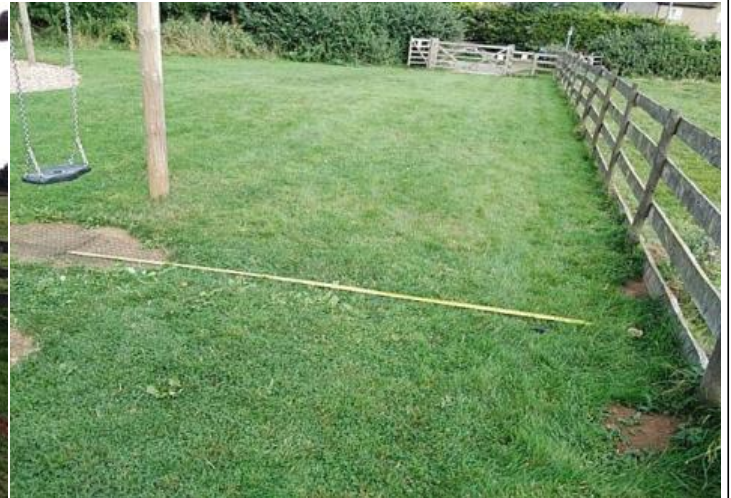
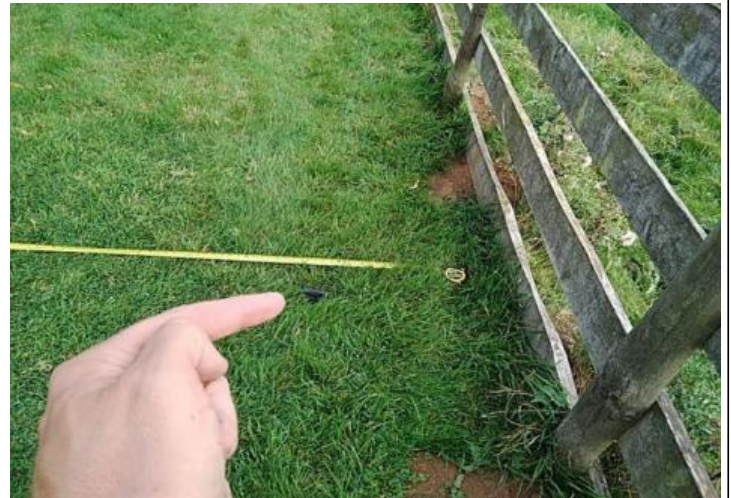
Finding: The surfacing dimensions are short and do not meet with the requirements of the current applicable standard

Action: Monitor - no remedial action recommended

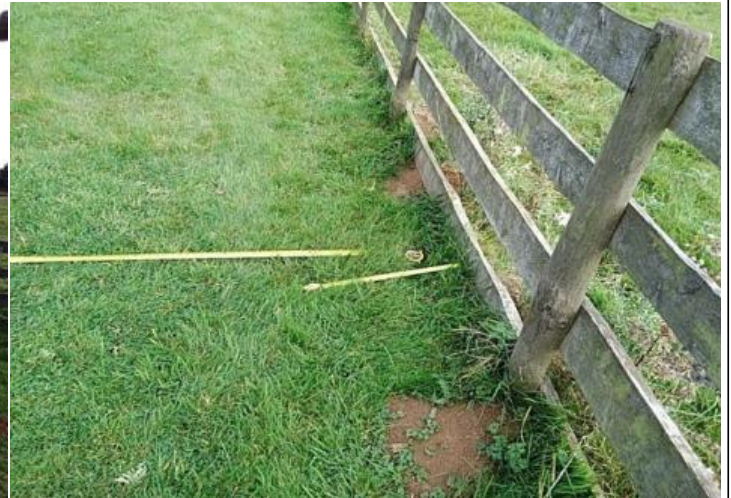
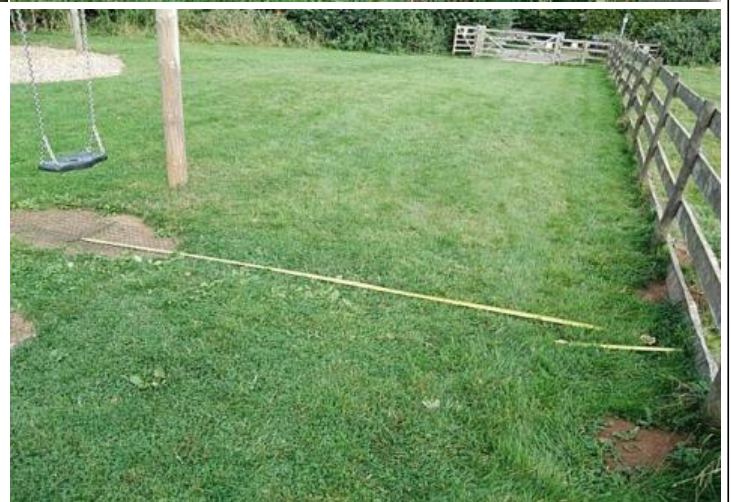
Finding: BS EN 1176 requires an additional 0.5m of unobstructed space at each end of the swing surfacing area. This is a relatively low risk finding and no remedial action is recommended at this point.

Action: Monitor - No remedial work recommended

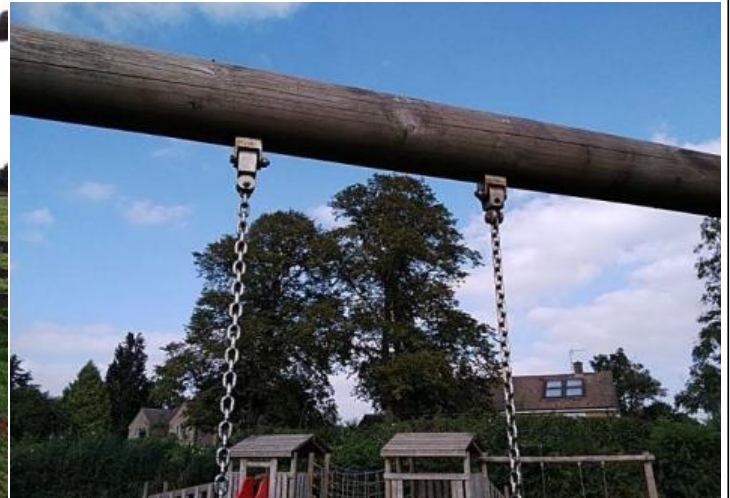
Finding: This design of swing joint has been known to fail on the weld connecting the joint to the threaded stud

Action: We would recommend that the joint be dismantled and checked on a regular basis or a Secondary Safety Device be fitted

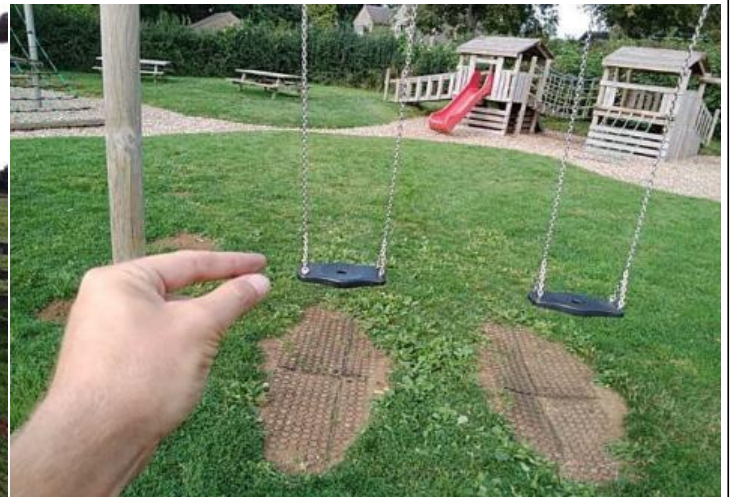
Finding: The swing seat connectors are loose

Action: Tighten to secure

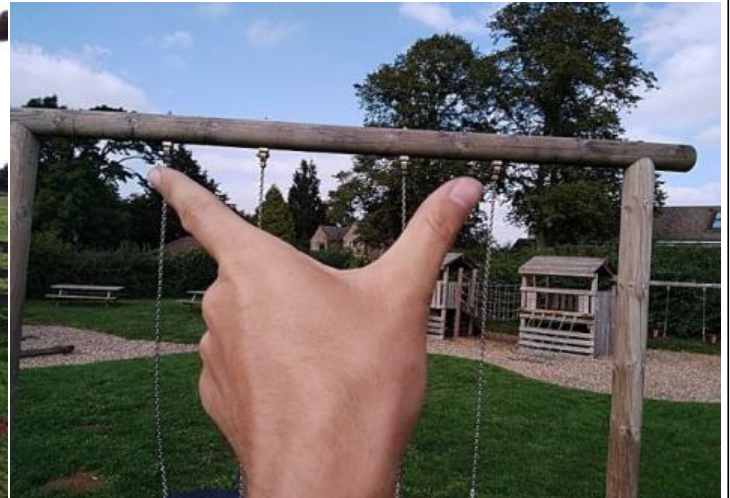
Finding: All fixings are loose

Action: Secure all loose fixings
