# the **play inspection** company

## Annual Inspection

Farthinghoe Parish Council

Farthinghoe Play Park

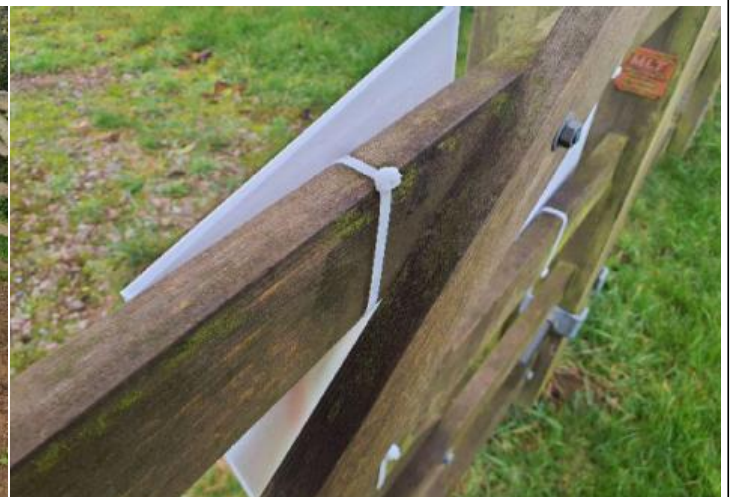
**Finding:** Cable ties have been used on the item and there are sharp projecting ends

**Action:** Remove if not required or replace with a more appropriate alternative fixing method if used as a fixing

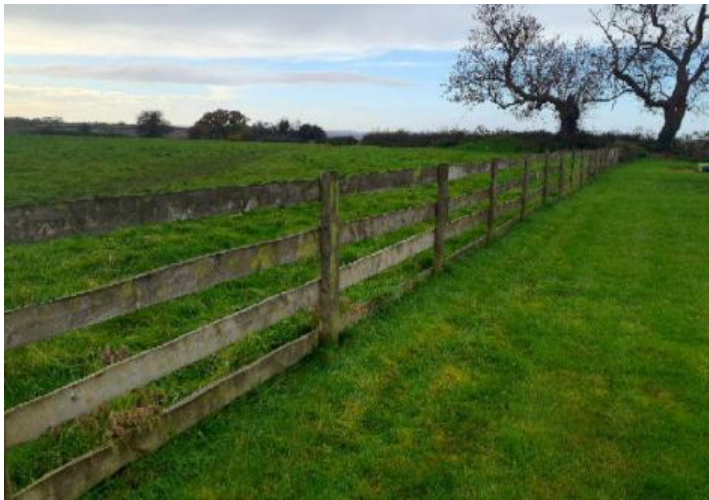
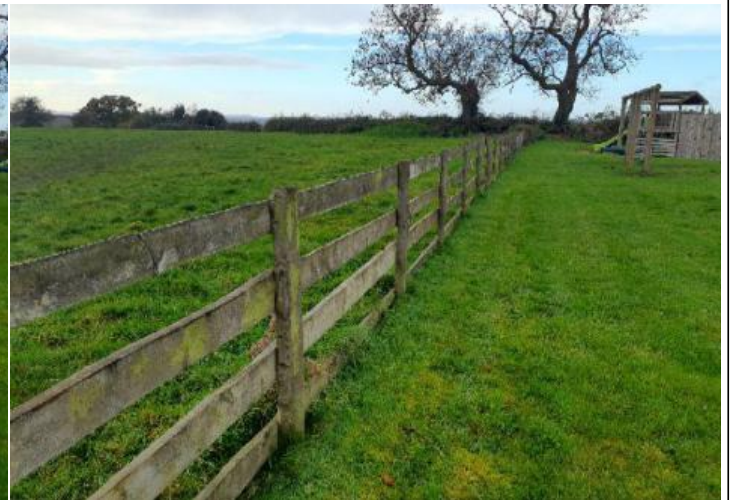
**Finding:** There are a number of loose posts around the fence

**Action:** Monitor for any further deterioration and reset as required

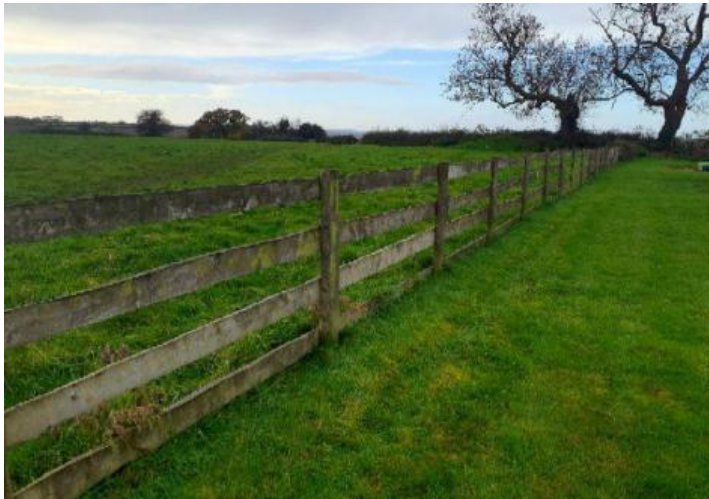
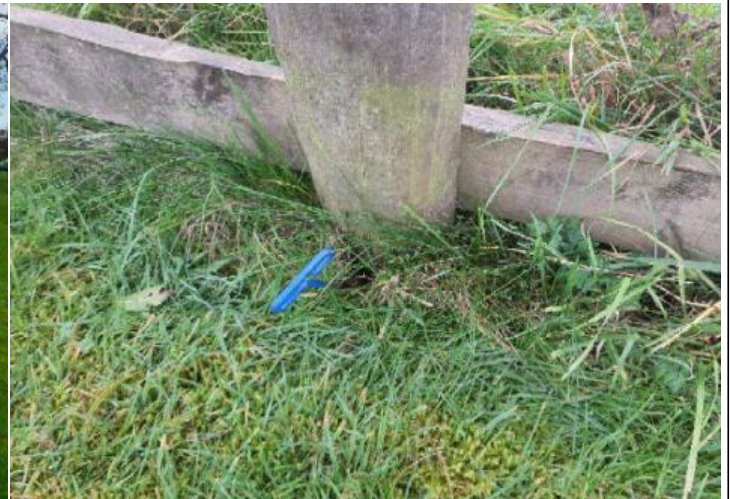
**Finding:** There is some evidence of rot in the timber

**Action:** Monitor for any further deterioration and replace as required

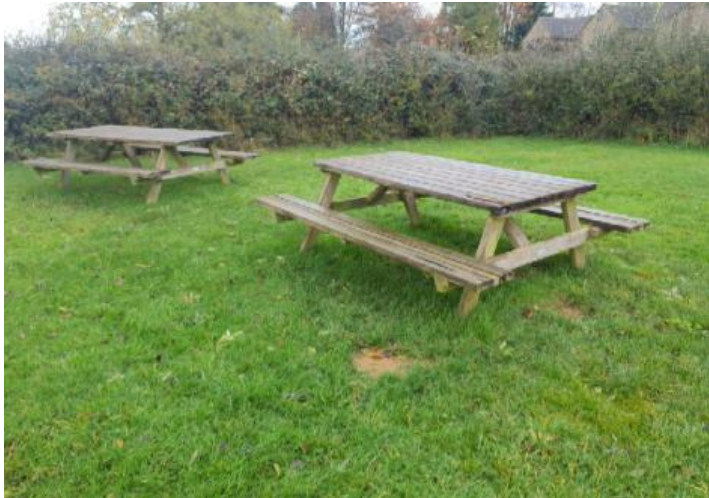
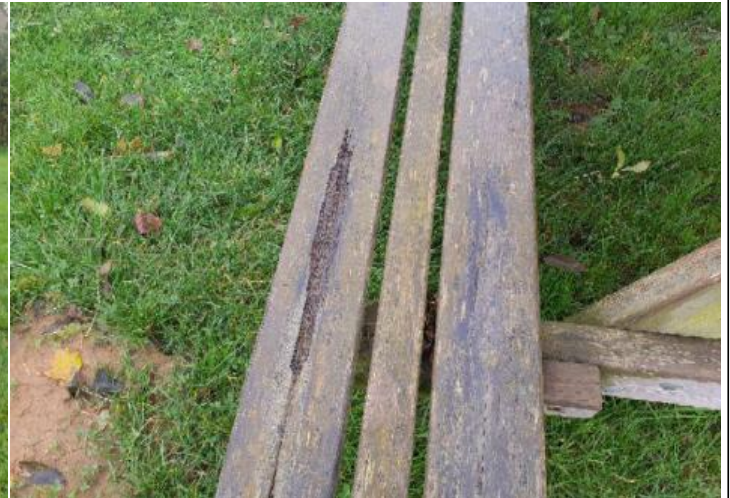
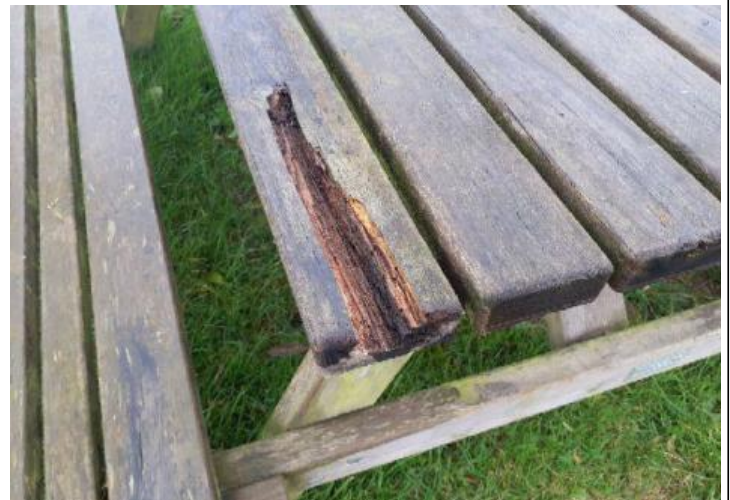
**Finding:** There are areas or parts of the timber on the structure that have rotted

**Action:** Replace all affected timbers

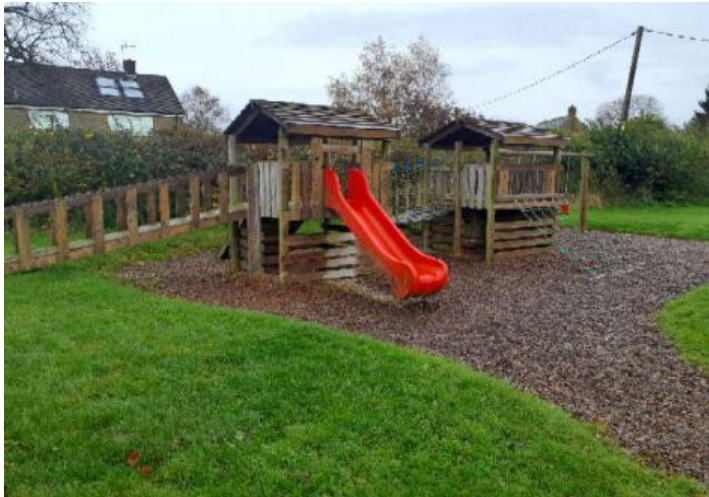
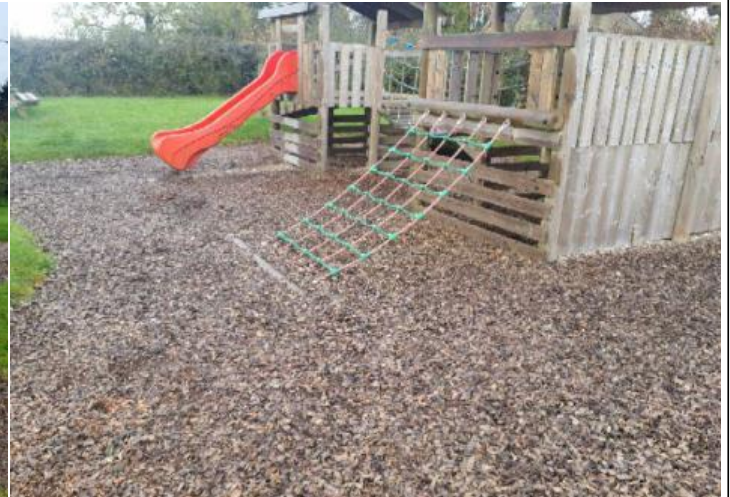
**Finding:** The depth of the loose fill surfacing is lower than the recommended depth specified in BS EN 1176; the free height of fall of the equipment is less than 2.0m and a minimum of 300mm depth should be provided (including an extra 100mm to allow for compaction and displacement as per BS EN 1176 Part 1 - Table 4)  
**Action:** Top up loose fill surfacing to recommended levels

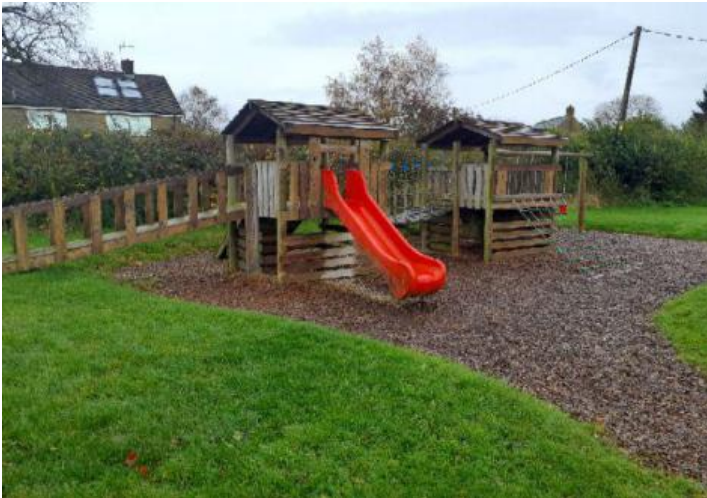
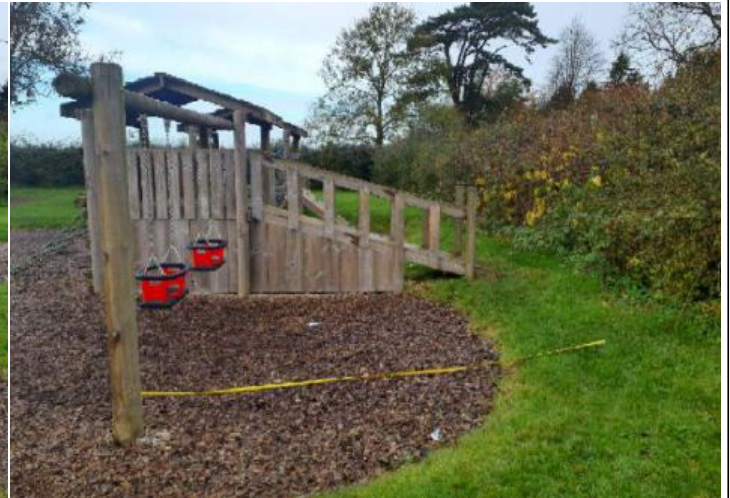
**Finding:** The surfacing dimensions are short and do not meet with the requirements of the current applicable standard

**Action:** Monitor - no remedial action recommended

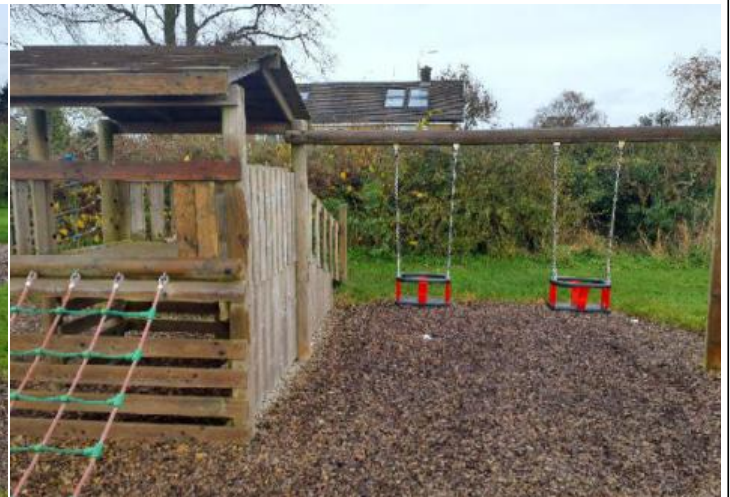
**Finding:** Swing frames or their top bar should only be attached to other equipment where specific measures are undertaken to segregate them from other activities, eg. additional 1.50m circulation area, barrier, or enclosures - BS EN 1176 Part 2 - 4.9

**Action:** Monitor - No remedial work recommended

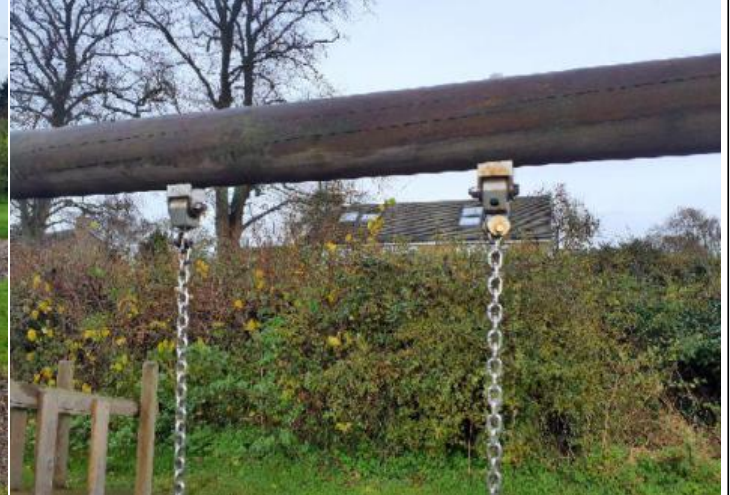
**Finding:** This design of swing joint has been known to fail on the weld connecting the joint to the threaded stud

**Action:** We would recommend that the joint be dismantled and checked on a regular basis or consulting with manufacturer on whether a Secondary Safety Device can be fitted

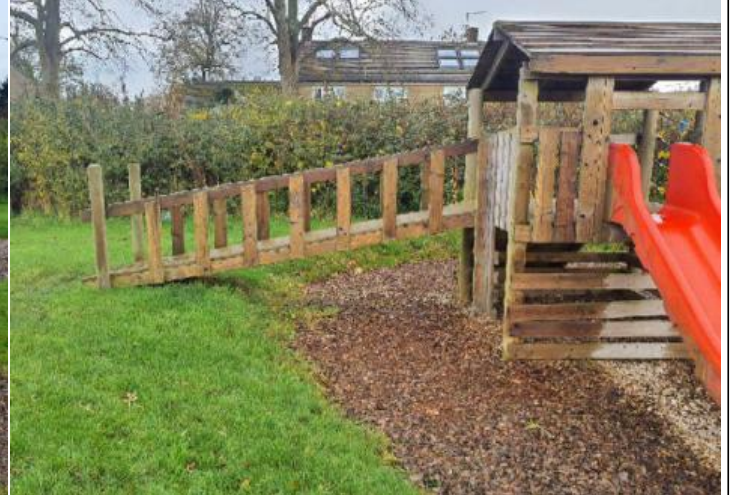
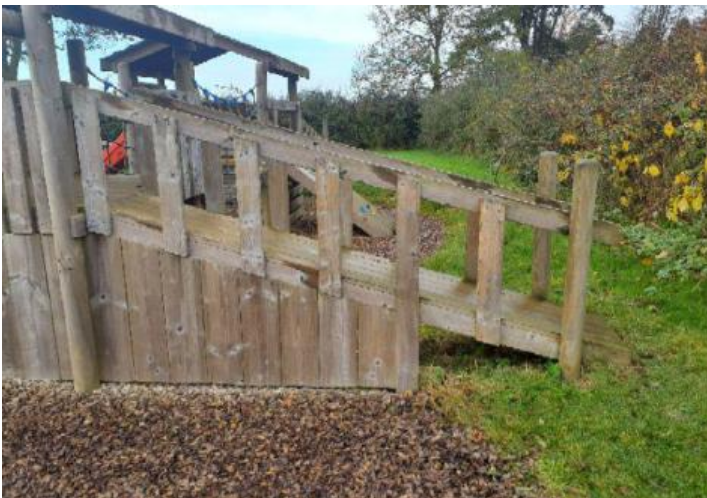
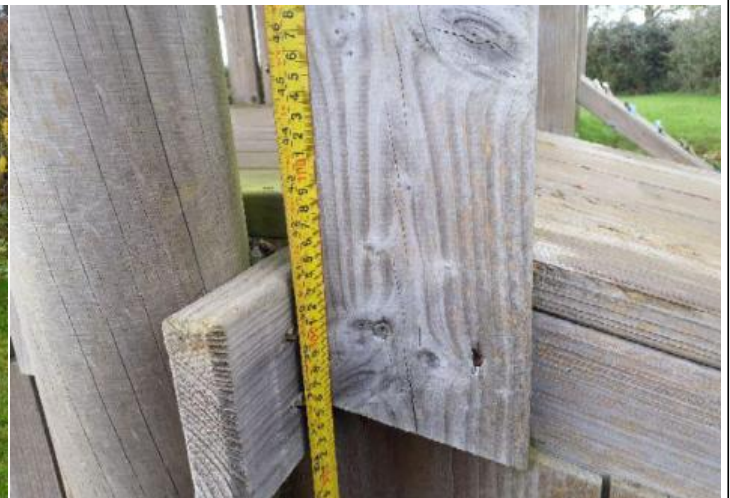
**Finding:** The unit is easily accessible and should have the appropriate barriers installed to meet the requirements of BS EN 1176 Part 1 as the height of the unit exceeds 600mm

**Action:** Monitor - No remedial work recommended

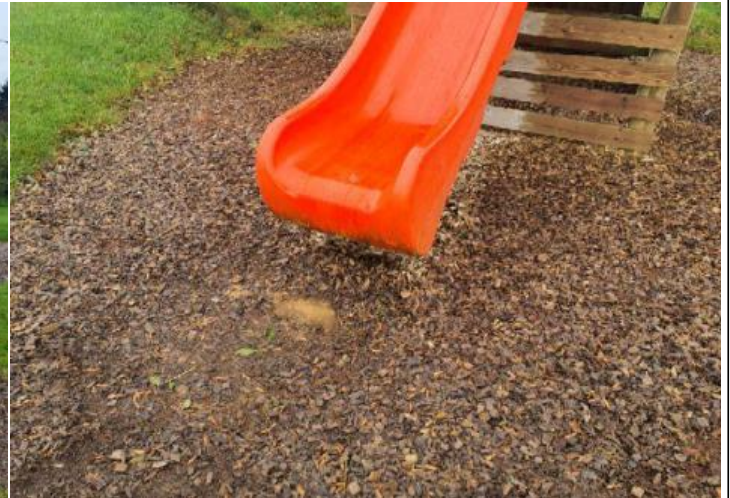
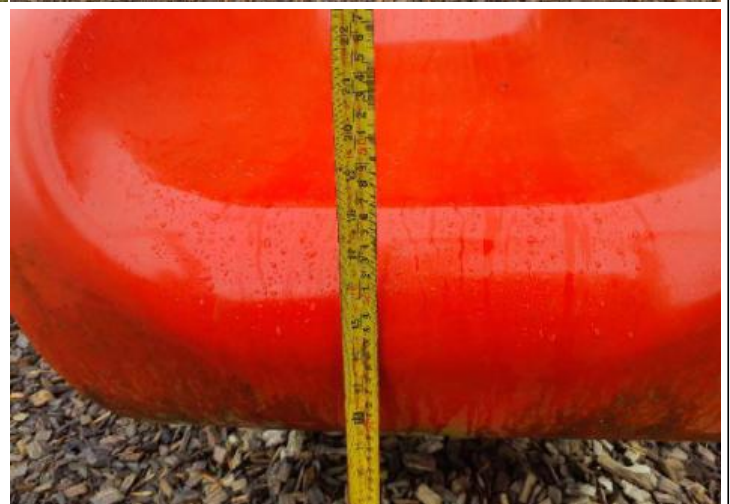
**Finding:** The height of the slide runout is in excess of 200mm and does not meet the requirements of BS EN 1176 Part 3

**Action:** Top up loose fill surfacing to recommended levels

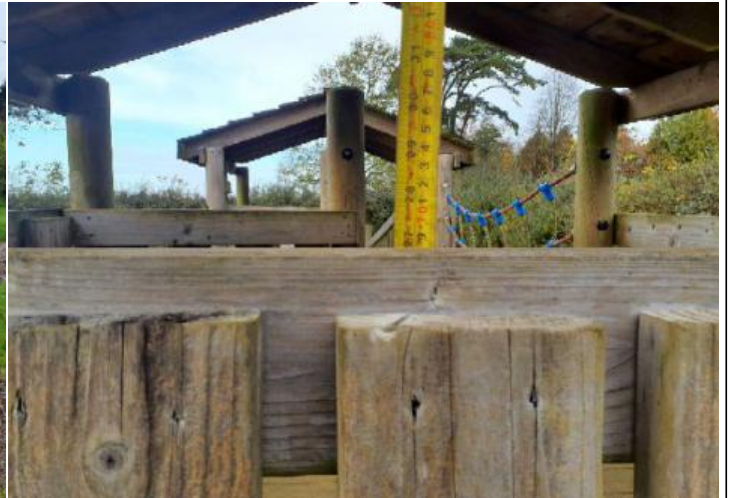
**Finding:** The height of the barrier(s) is insufficient and fails to meet the requirements of BS EN 1176 Part 1  
**Action:** Monitor - No remedial work recommended

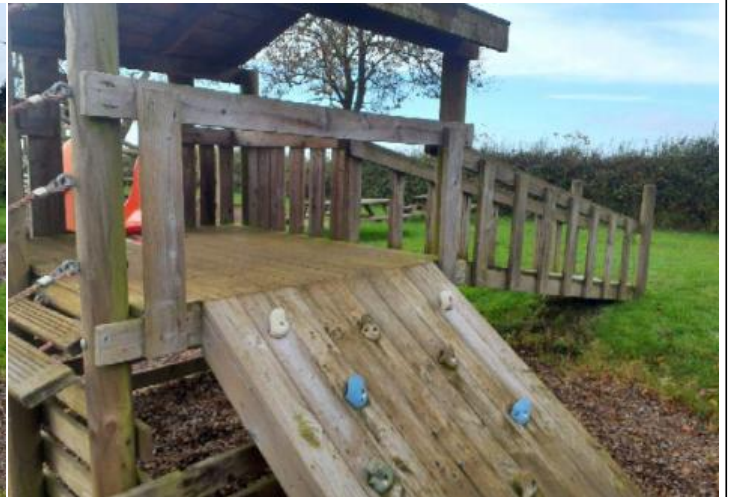
**Finding:** The unit is easily accessible and has an opening in the barrier to steep play elements in excess of 500mm in contravention of BS EN 1176 Part 1  
**Action:** Monitor - No remedial work recommended

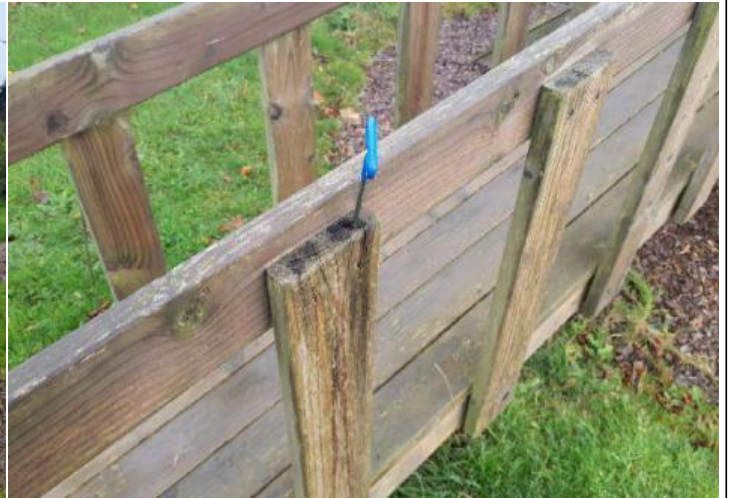
**Finding:** There are areas or parts of the timber barriers on the structure that have rotted

**Action:** Replace all affected timbers

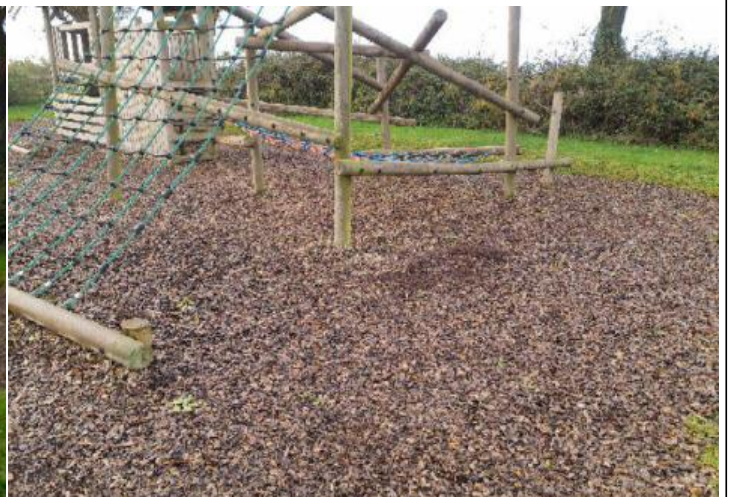
**Finding:** The depth of the loose fill surfacing is lower than the recommended depth specified in BS EN 1176 for a fall height over 2.0m. A minimum depth of 400mm is recommended (including an extra 100mm to allow for compaction and displacement as per BS EN 1176 Part 1 - Table 4)

**Action:** Top up loosefill to recommended levels

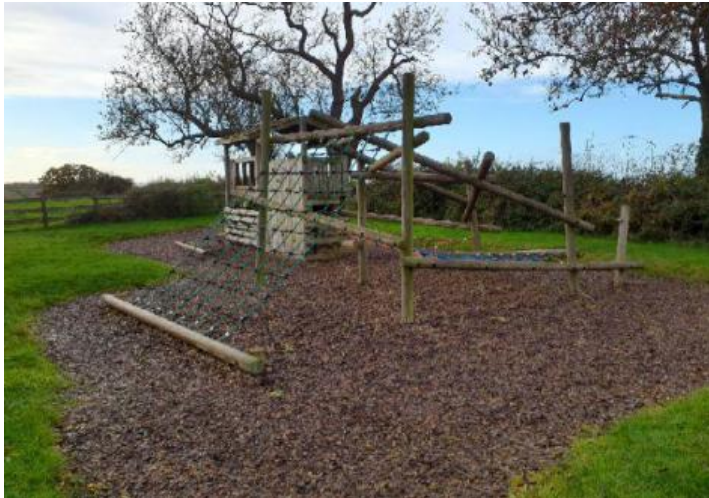
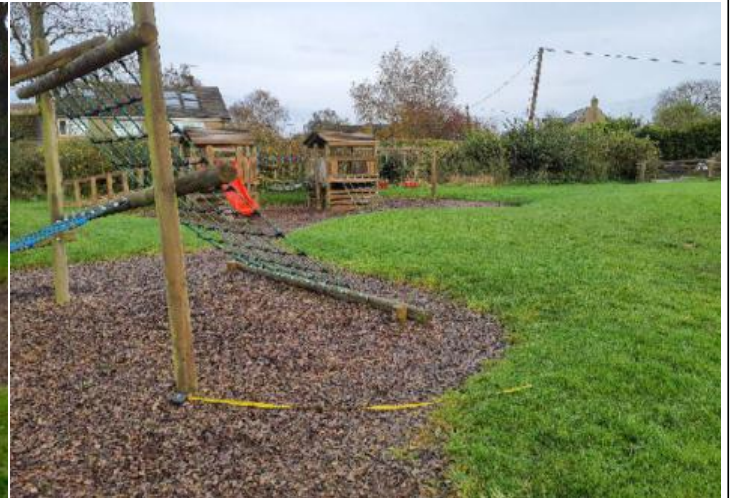
**Finding:** The surfacing dimensions are short and do not meet with the requirements of the current applicable standard

**Action:** Monitor - no remedial action recommended

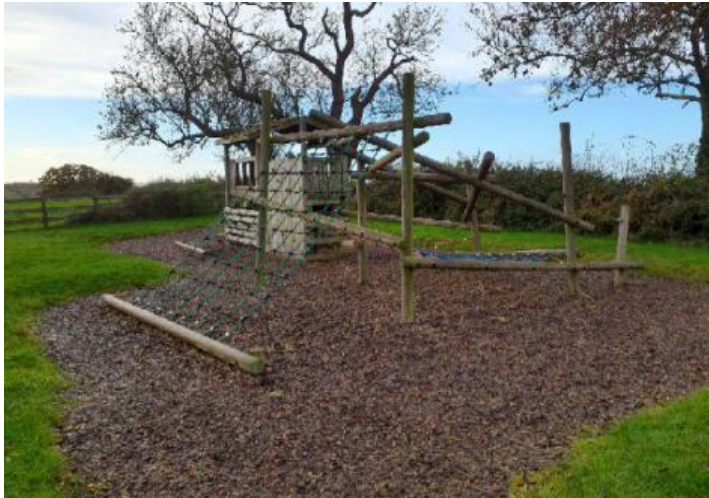
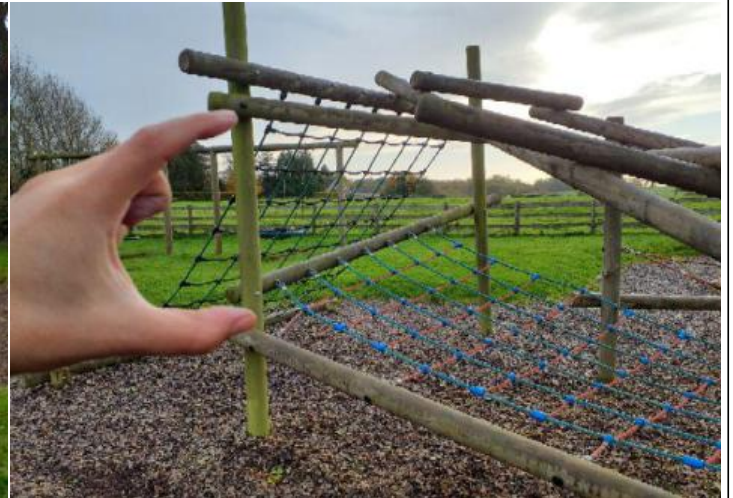
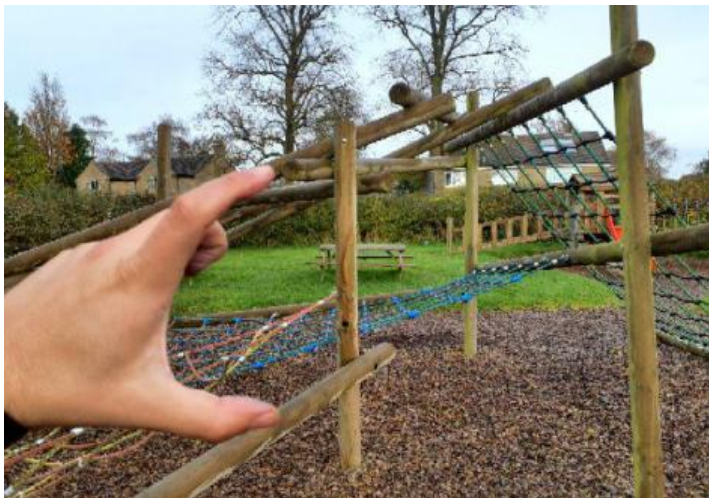
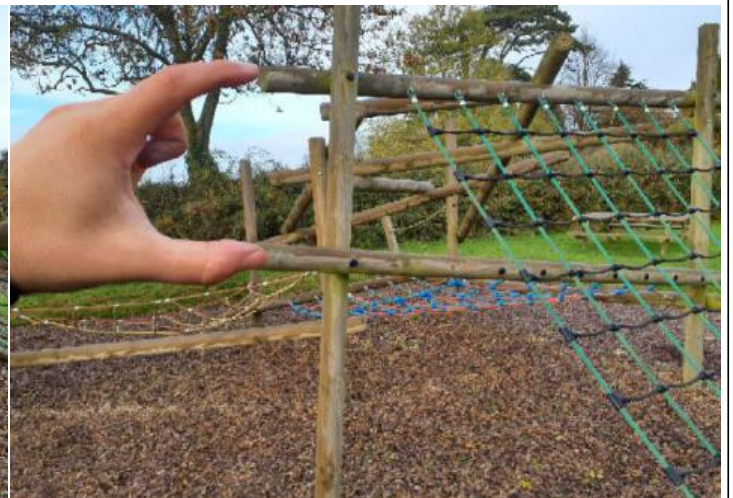
**Finding:** There are falls in excess of 600mm between adjacent components on the structure, in contravention of the recommendations set out in BS EN 1176 Part 1; 4.2.8.4

**Action:** Monitor use and review risk assessment regularly

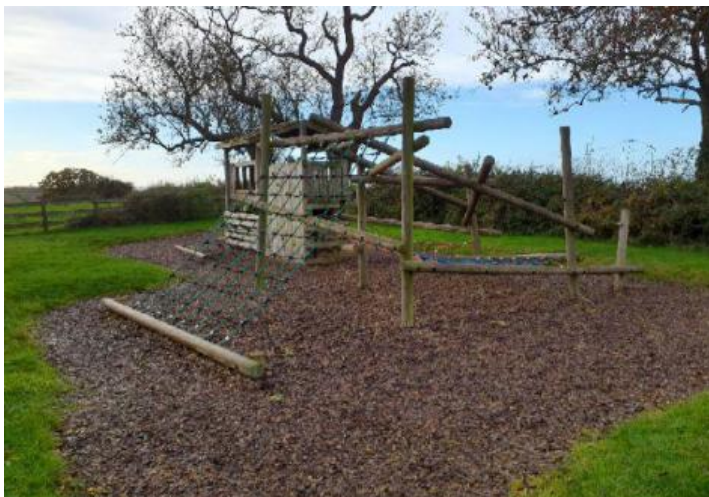
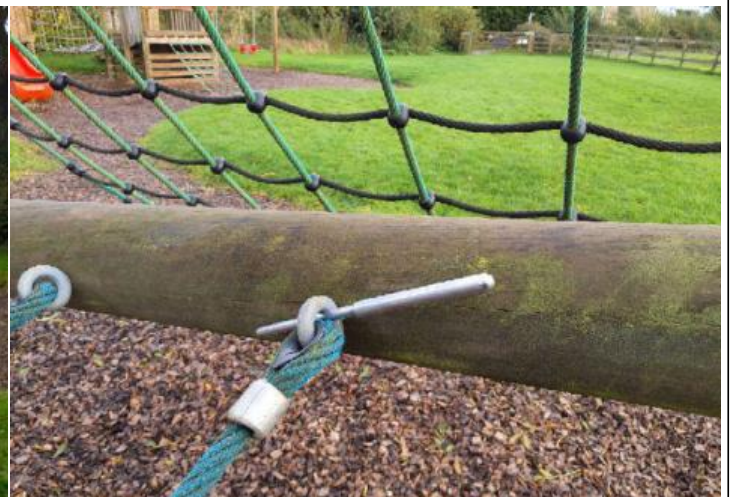
**Finding:** The connecting links are in excess of 8.6mm and less than 12mm and fail the requirements of BS EN 1176 Part 1; clause 4.2.13, Chains

**Action:** Monitor - No remedial work recommended

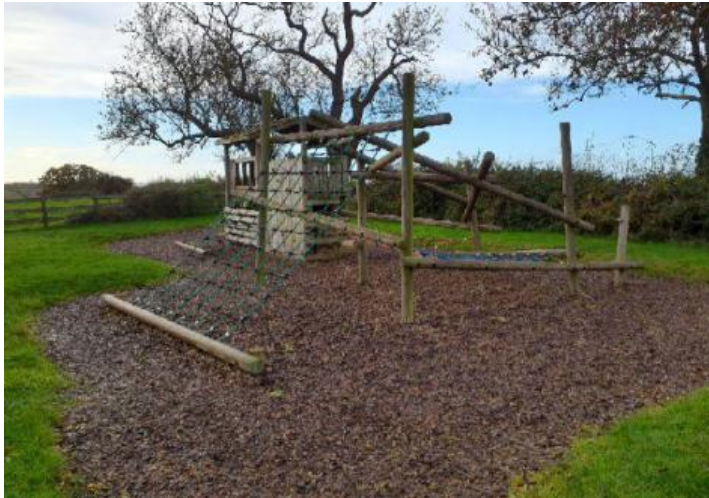
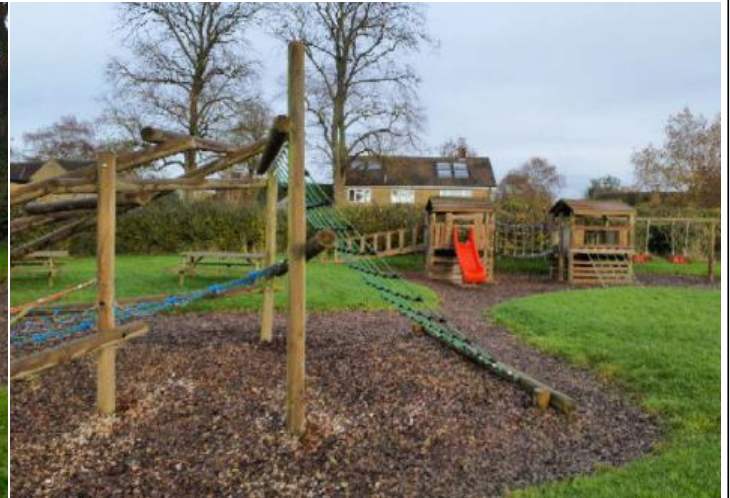
**Finding:** The item is slightly loose in its foundations

**Action:** Monitor for any further deterioration and repair as required

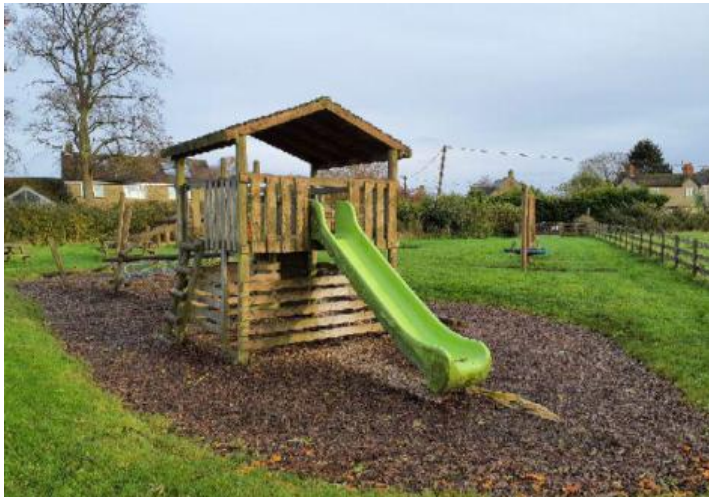
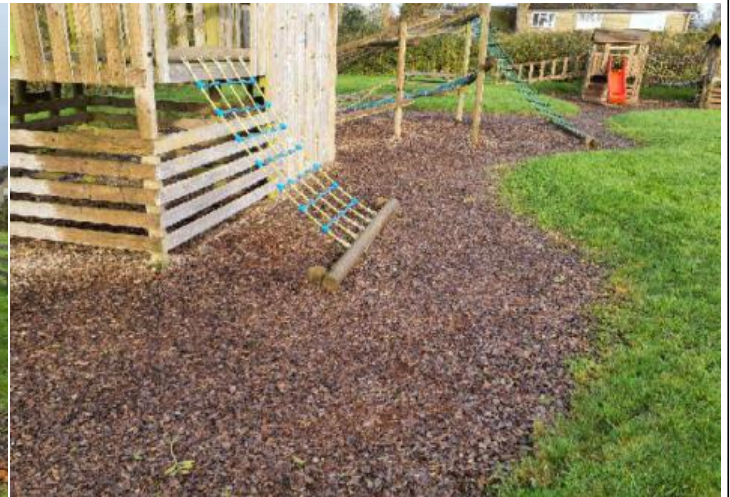
**Finding:** The depth of the loose fill surfacing is lower than the recommended depth specified in BS EN 1176 for a fall height over 2.0m. A minimum depth of 400mm is recommended (including an extra 100mm to allow for compaction and displacement as per BS EN 1176 Part 1 - Table 4)

**Action:** Top up loosefill to recommended levels

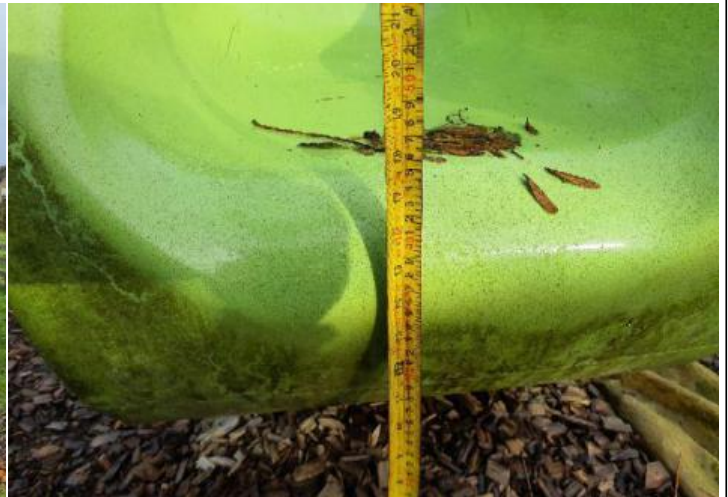
**Finding:** The height of the slide runout is in excess of 350mm and does not meet the requirements of BS EN 1176: 350mm Part 3

**Action:** Top up loose fill surfacing to reduce height below 350mm

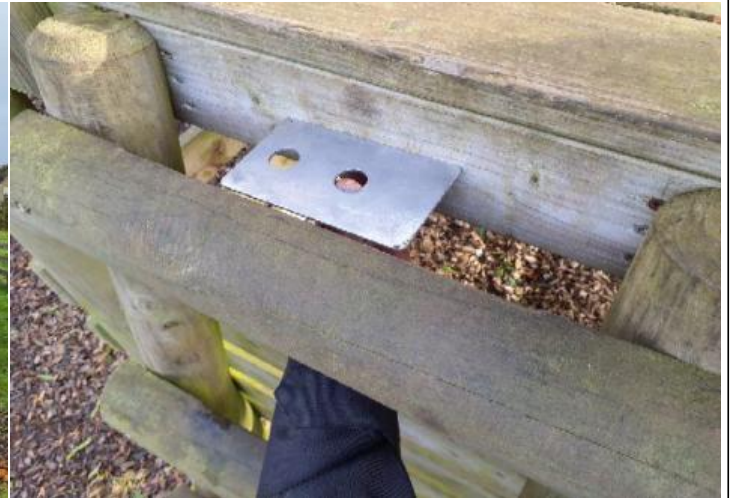
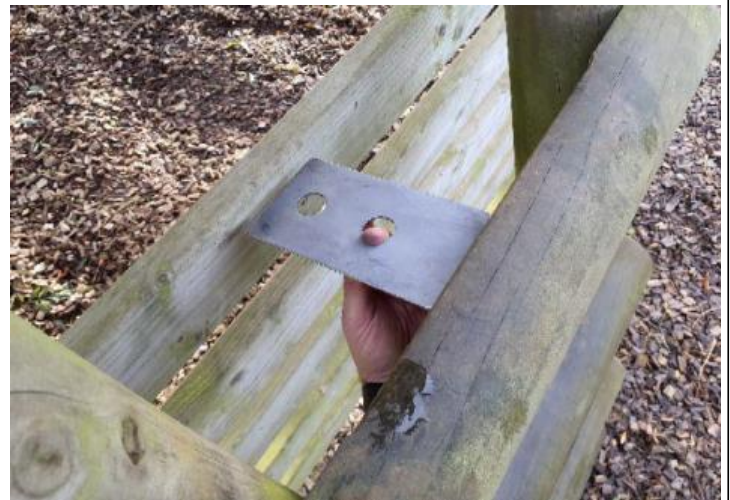
**Finding:** The item fails to meet the requirements of BS EN 1176 Part 1 4.2.7.2 for head and neck entrapment in the framework

**Action:** Monitor - No remedial work recommended

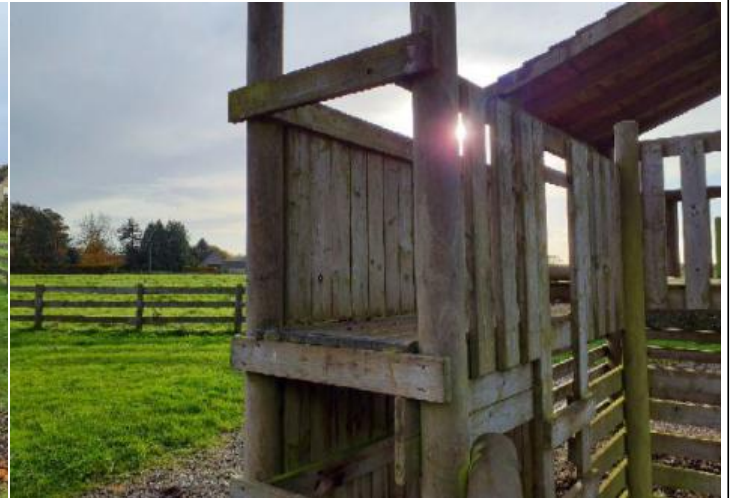
**Finding:** There are openings leading from platforms in excess of 1.0m in height to steep play elements and no hand supports complying with grip or grasp are provided, in contravention of BS EN 1176 Part 1: 4.2.9.4

**Action:** Monitor - No remedial work recommended

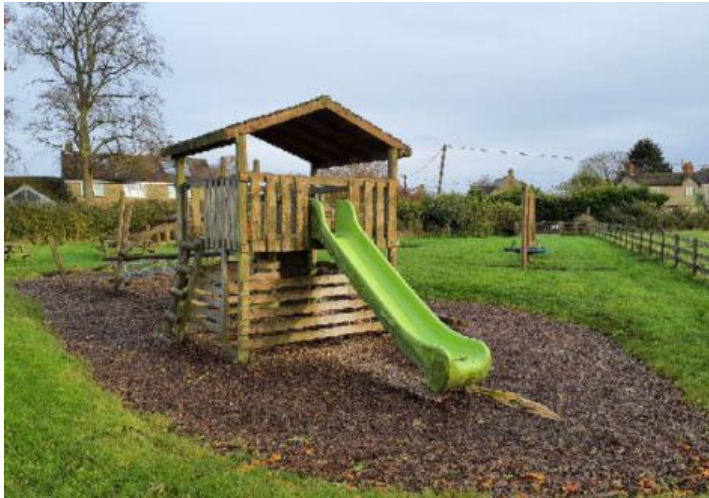
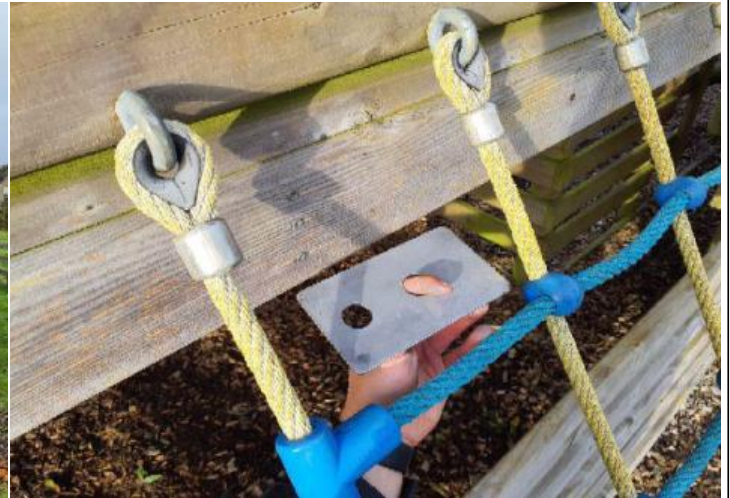
**Finding:** The item fails to meet the requirements of BS EN 1176 Part 1 4.2.7.2 for head and neck entrapment in between the rope net and framework

**Action:** Monitor - No remedial work recommended

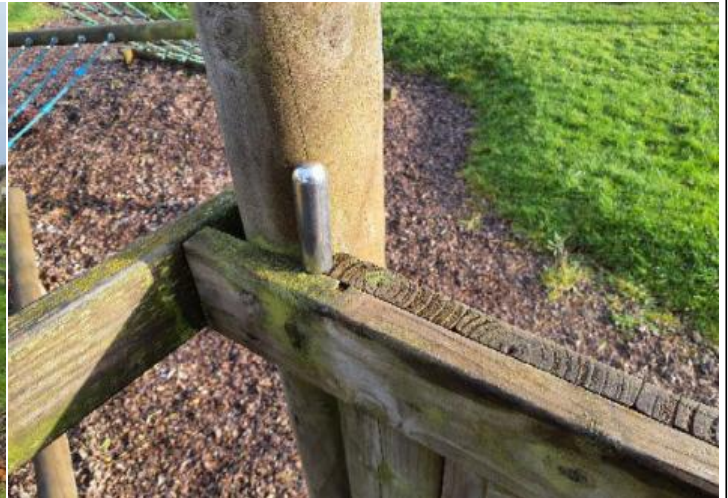
**Finding:** There is/are finger entrapment/s in the barriers and the item fails to meet the requirements of BS EN 1176 Part 1 4.2.7.6 Entrapment of fingers  
**Action:** Monitor - No remedial work recommended

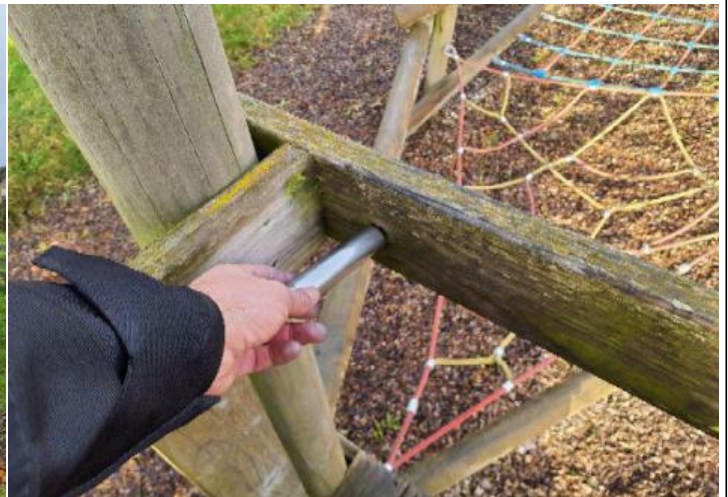
**Finding:** There is/are finger entrapment/s in the guardrail and the item fails to meet the requirements of BS EN 1176 Part 1 4.2.7.6 Entrapment of fingers  
**Action:** Remove entrapments

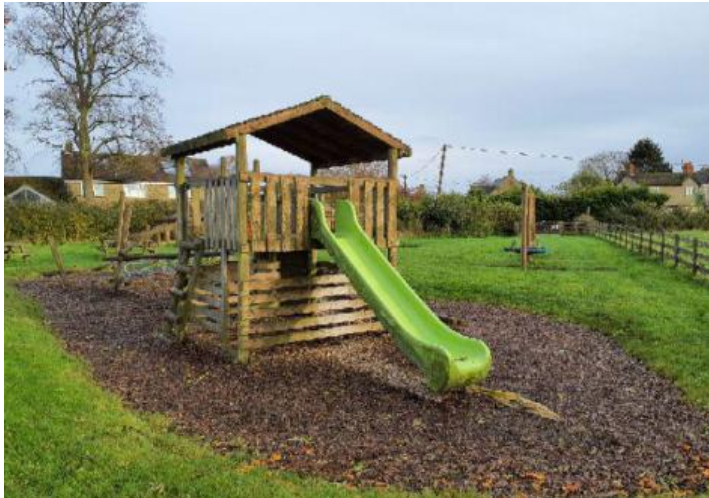
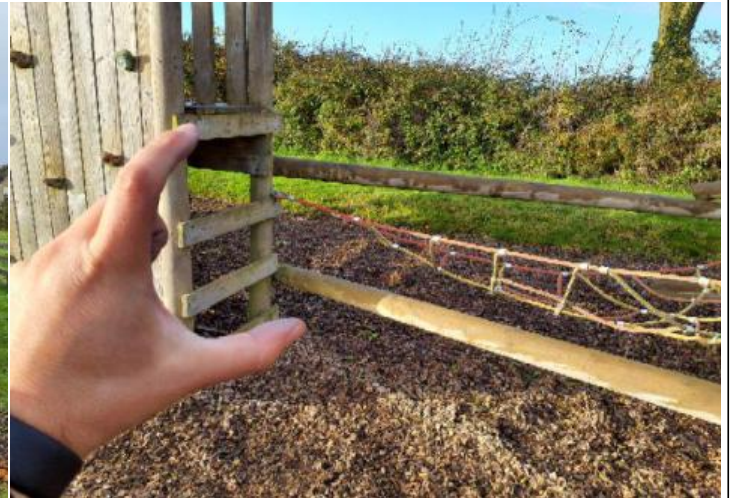
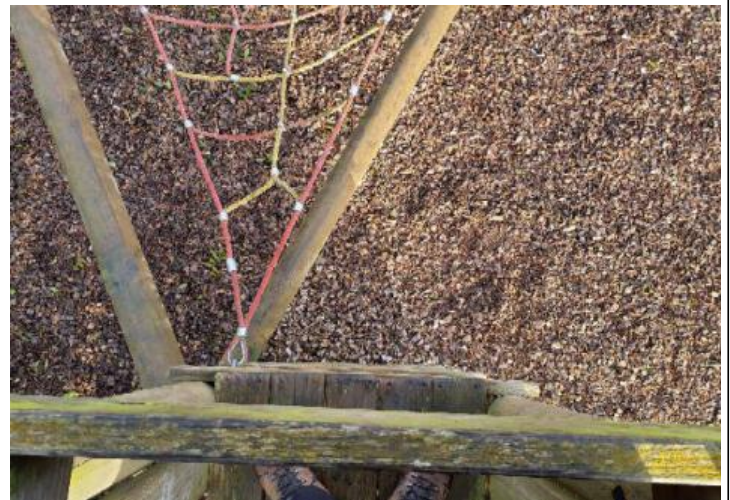
**Finding:** There are falls in excess of 600mm between adjacent components on the structure, in contravention of the recommendations set out in BS EN 1176 Part 1; 4.2.8.4

**Action:** Monitor - No remedial work recommended

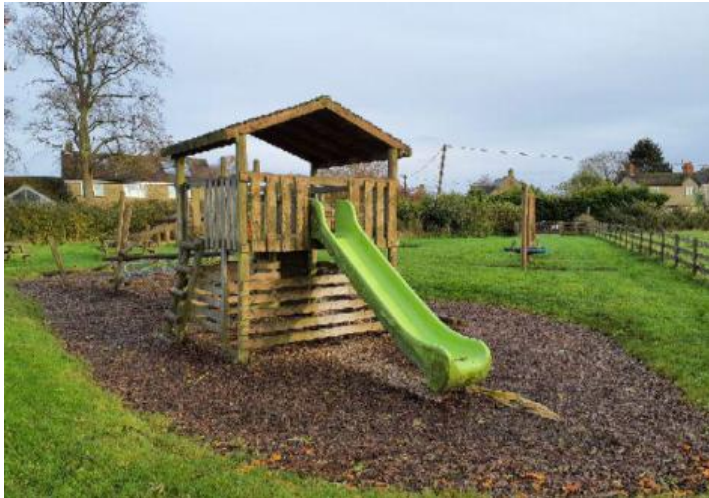
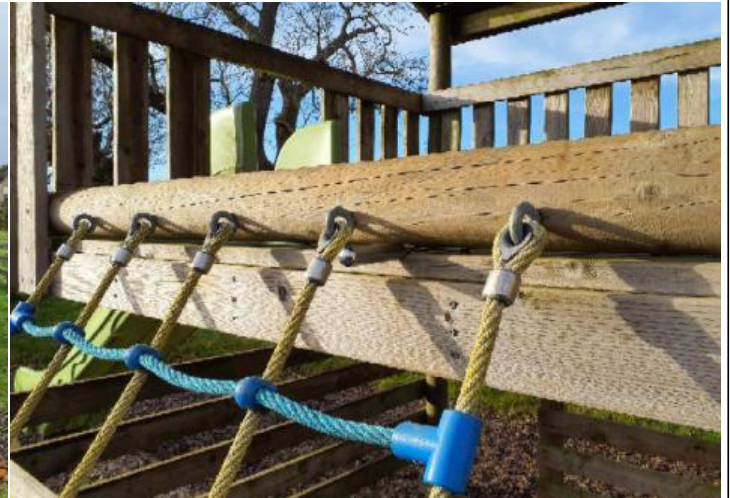
**Finding:** There is/are finger entrapment/s in the rope net framework and the item fails to meet the requirements of BS EN 1176 Part 1 4.2.7.6 Entrapment of fingers

**Action:** Monitor - No remedial work recommended

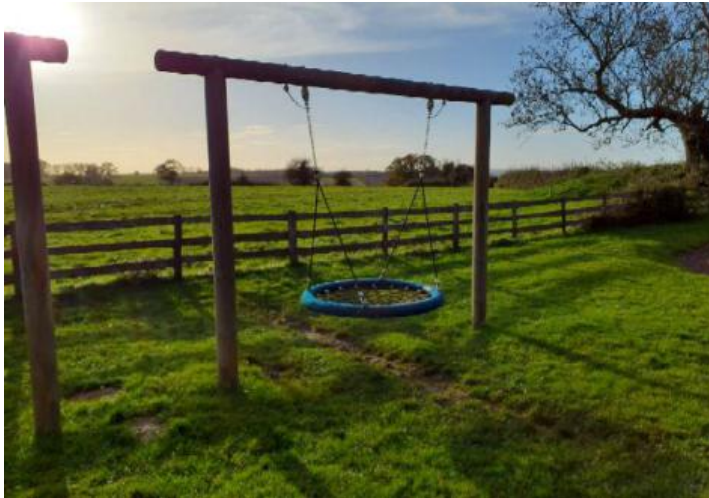
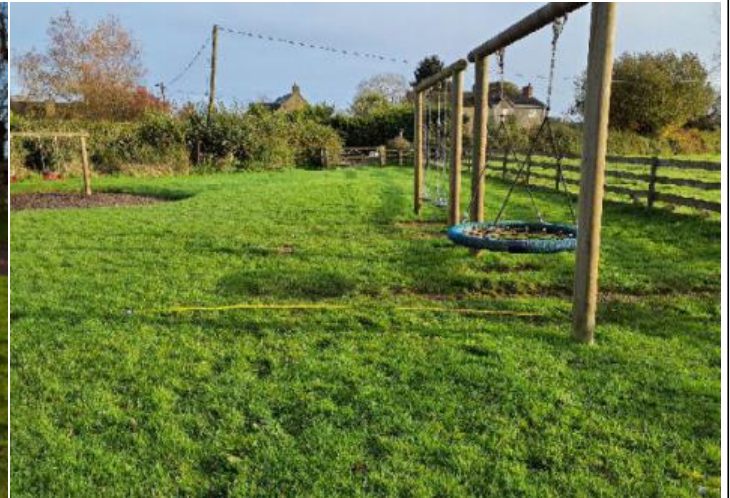
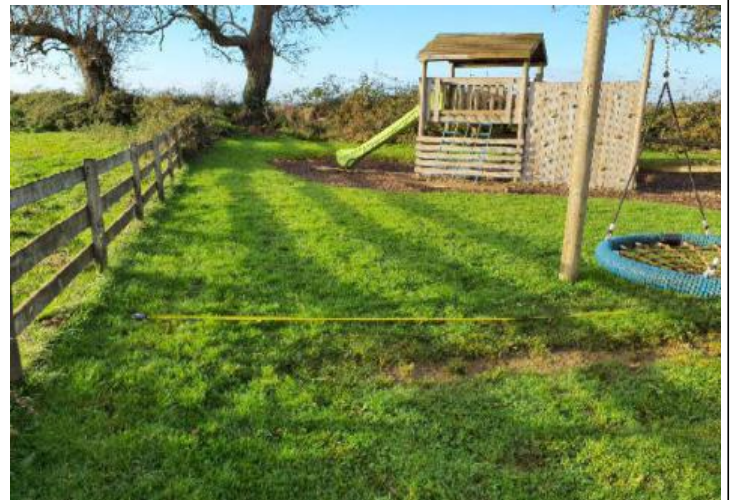
**Finding:** The surfacing dimensions are short and do not meet with the requirements of the current applicable standard

**Action:** Monitor - no remedial action recommended

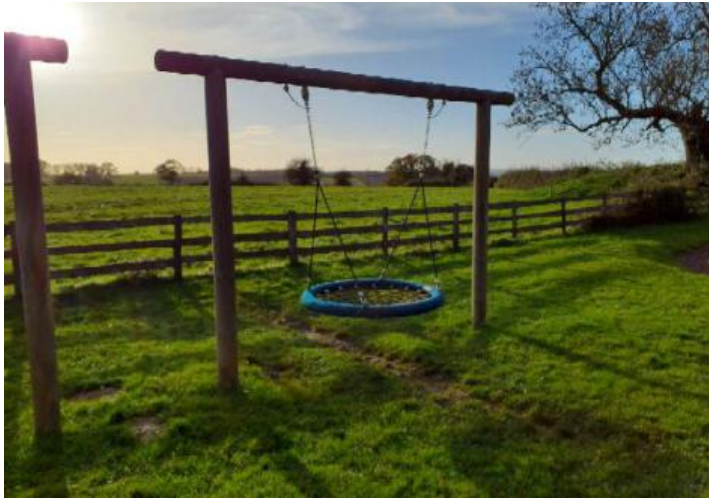
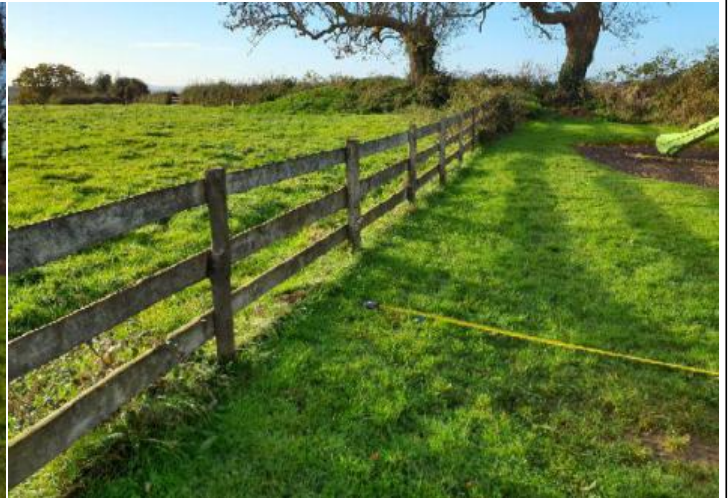
**Finding:** BS EN 1176 requires an additional 0.5m of unobstructed space at each end of the swing surfacing area. This is a relatively low risk finding and no remedial action is recommended at this point.

**Action:** Monitor - No remedial work recommended

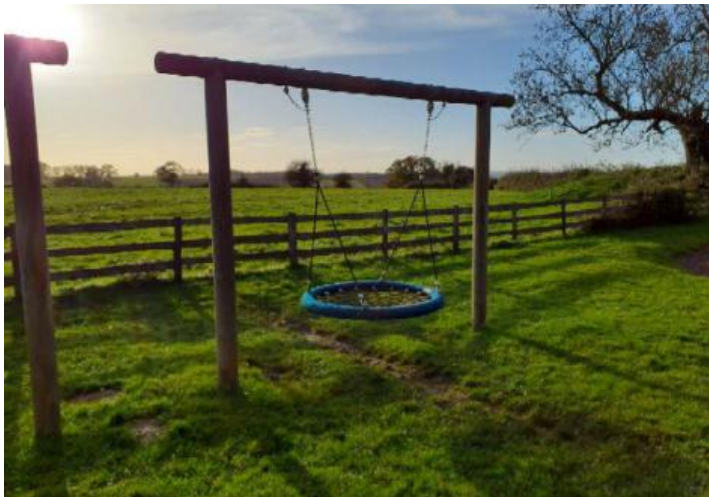
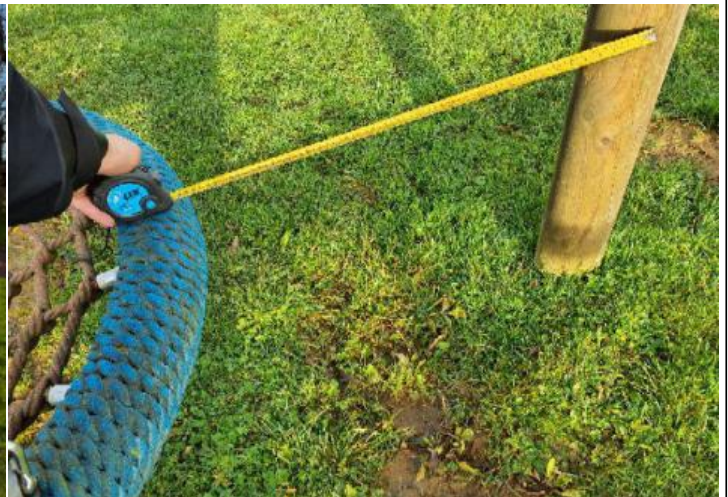
**Finding:** The seats are too close to the frame as defined in BS EN 1176 Part 2; this is a low risk failure and no remedial action is required

**Action:** Monitor - No remedial work recommended

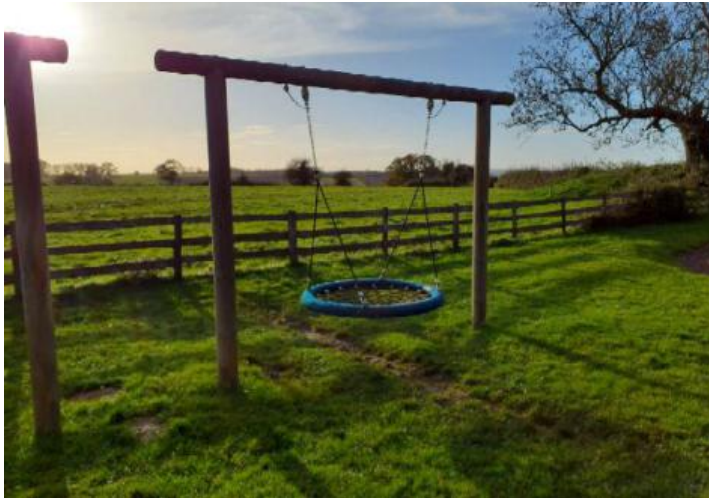
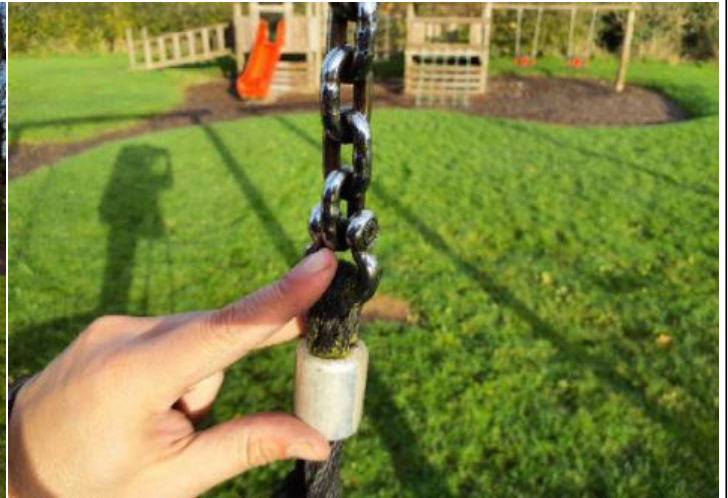
**Finding:** There is some notable evidence of chain wear

**Action:** Monitor for any further deterioration and replace when 40% worn
