# the **play inspection** company

## Annual Inspection

Farthinghoe Parish Council

Farthinghoe Play Park

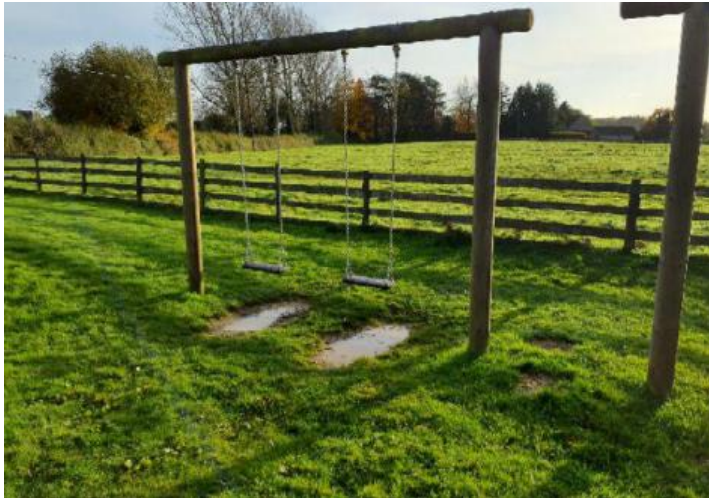
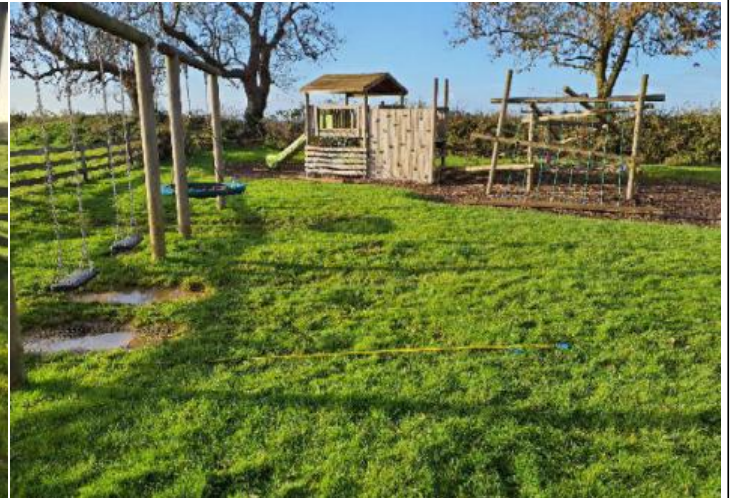
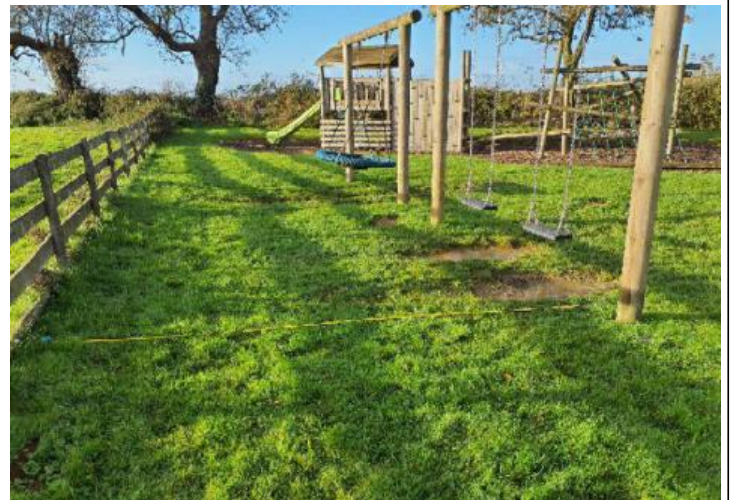
**Finding:** The surfacing dimensions are short and do not meet with the requirements of the current applicable standard

**Action:** Monitor - no remedial action recommended

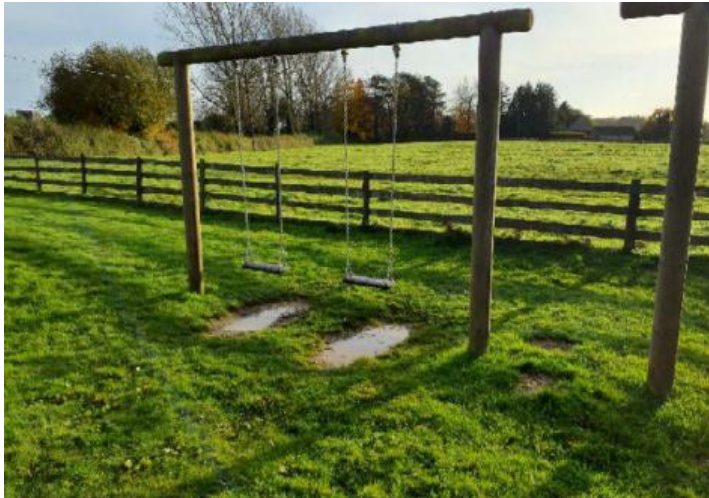
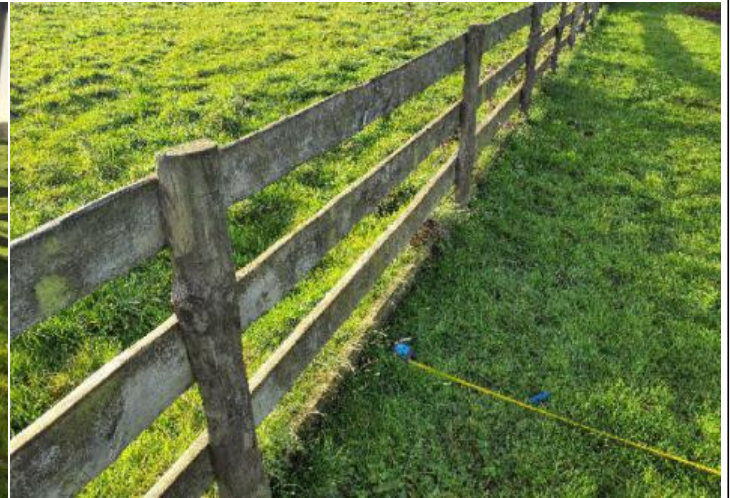
**Finding:** BS EN 1176 requires an additional 0.5m of unobstructed space at each end of the swing surfacing area. This is a relatively low risk finding and no remedial action is recommended at this point.

**Action:** Monitor - No remedial work recommended

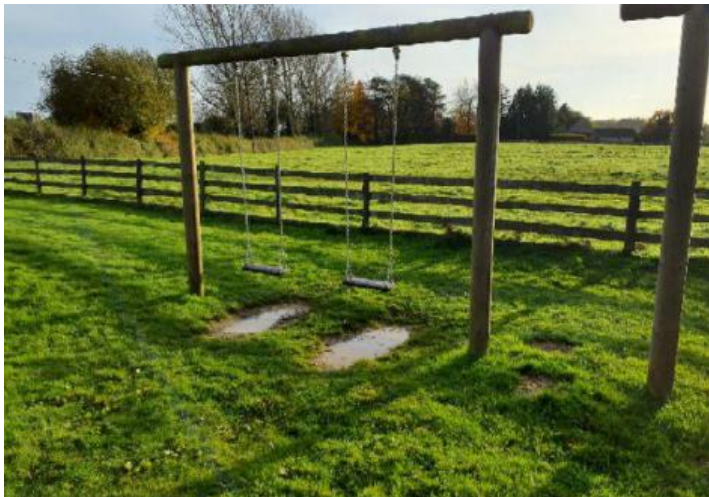
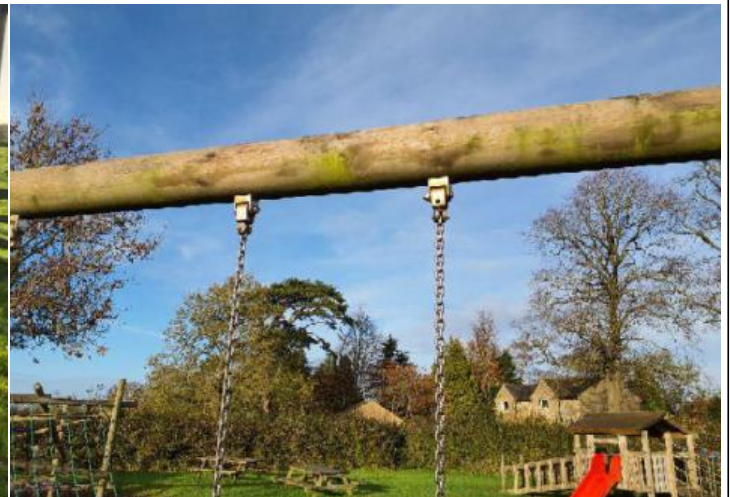
**Finding:** This design of swing joint has been known to fail on the weld connecting the joint to the threaded stud

**Action:** We would recommend that the joint be dismantled and checked on a regular basis or consulting with manufacturer on whether a Secondary Safety Device can be fitted

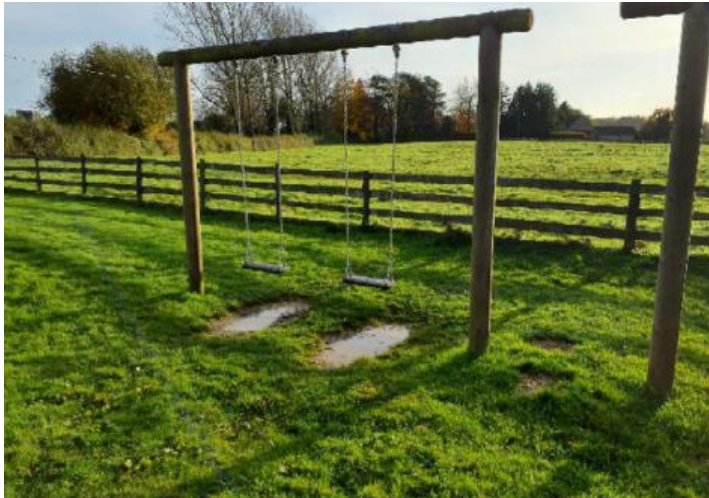
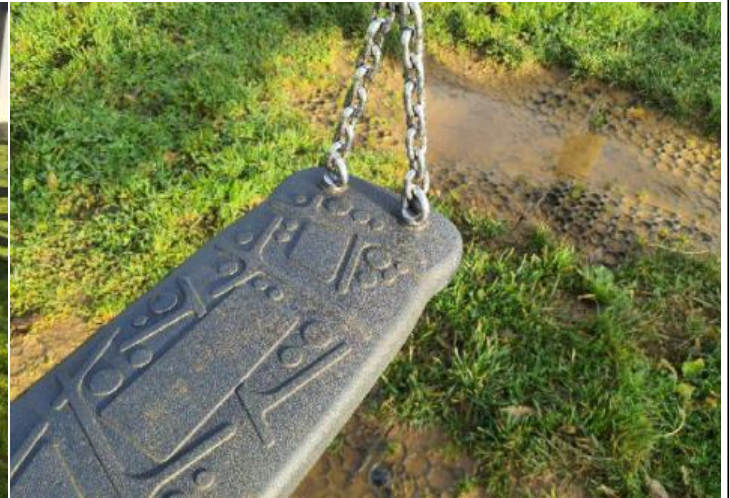
**Finding:** The swing seat connectors are loose

**Action:** Tighten to secure

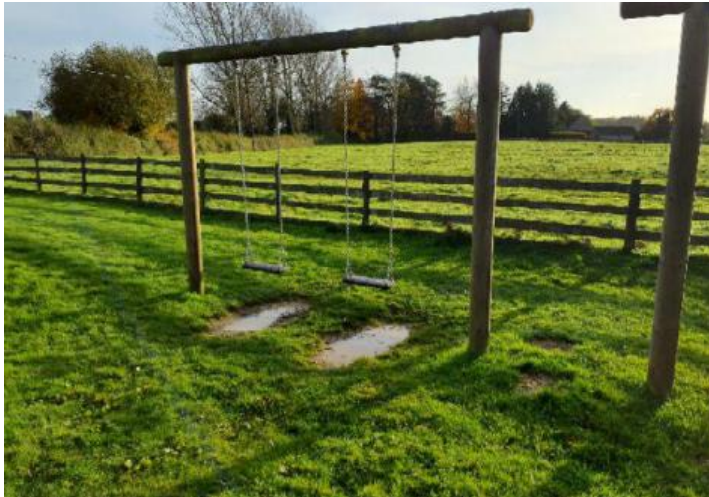
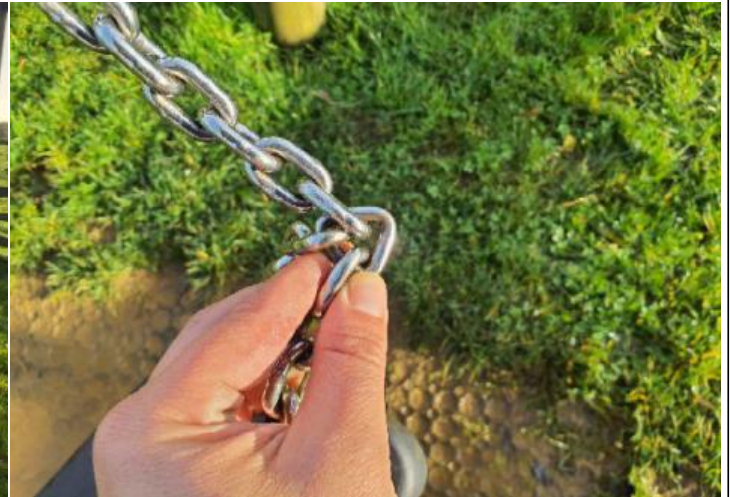
**Finding:** There is some notable evidence of chain wear

**Action:** Monitor for any further deterioration and replace when 40% worn

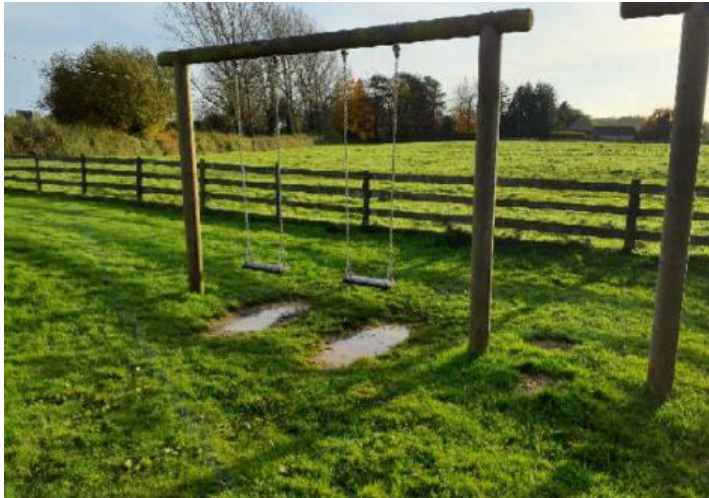
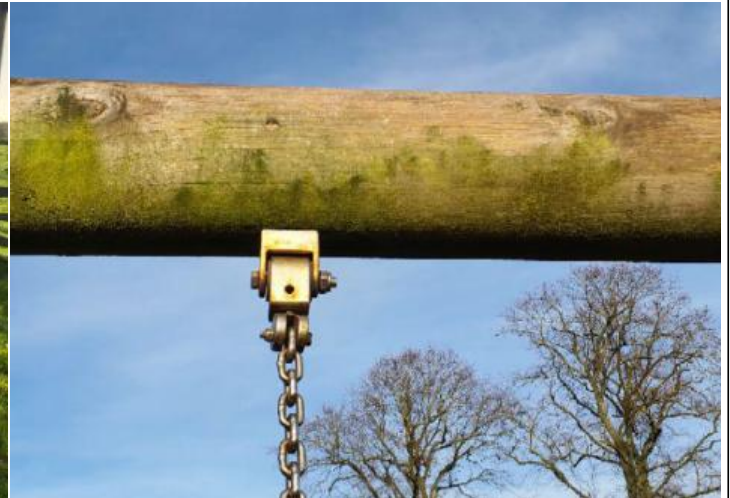
**Finding:** There is/are inserts missing

**Action:** Replace missing inserts
