the play inspection company

Annual Inspection

Farthinghoe Parish Council

Farthinghoe Play Park

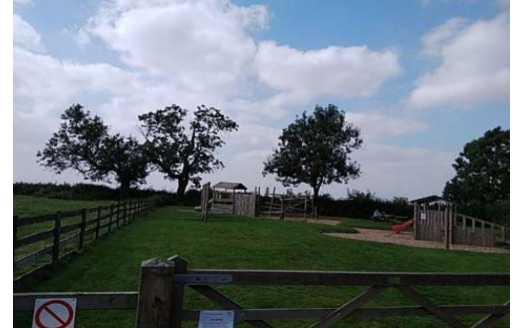
It is recommended that signage, with information including the site address, contact information for maintenance issues and emergency contact details are provided for the facility - Provide in accordance with the recommendations

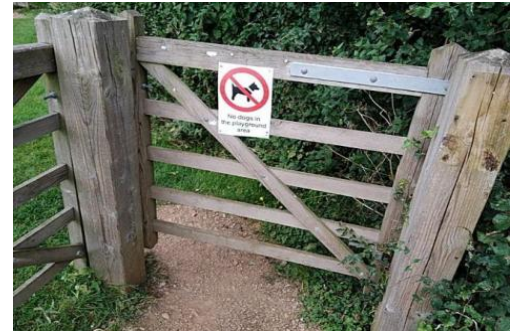
There are openings that are less than 12mm that could trap or crush fingers - Where possible a 12mm gap should be maintained on both sides or between the gate leaves

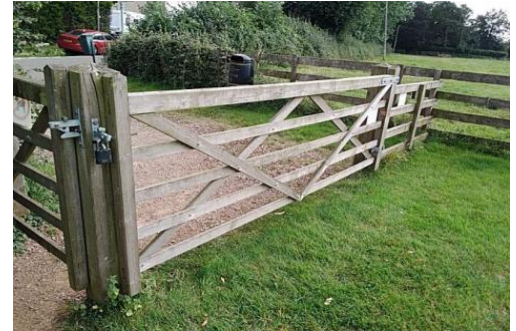
There are projecting bolt thread(s) present - Remove excess thread length and deburr or provide cap

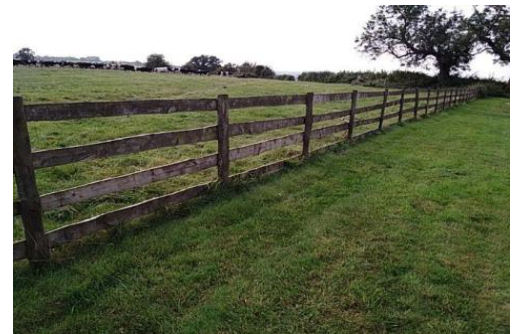
There are a number of loose posts around the fence - Monitor for any further deterioration and reset as required

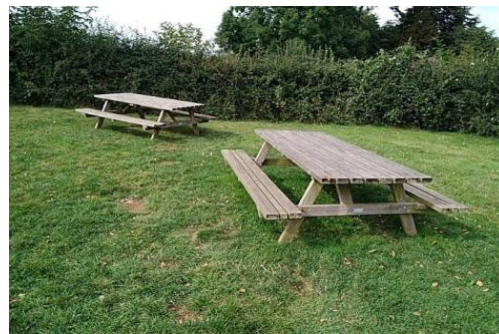
There is some evidence of rot in the timber - Monitor for any further deterioration and replace as required

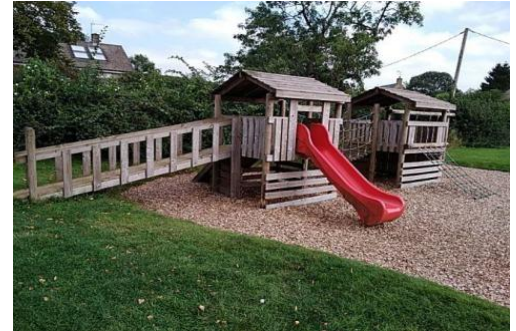
The depth of the loose fill surfacing is lower than the recommended depth specified in BS EN 1176; the free height of fall of the equipment is less than 2.0m and a minimum of 300mm depth should be provided (including an extra 100mm to allow for compaction and displacement as per BS EN 1176 Part 1 - Table 4) - Top up loose fill surfacing to recommended levels

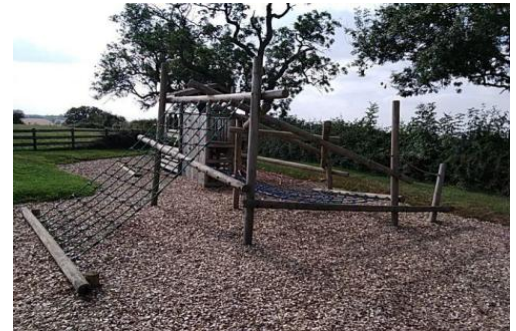
The surfacing dimensions are short and do not meet with the requirements of the current applicable standard - Monitor - no remedial action recommended

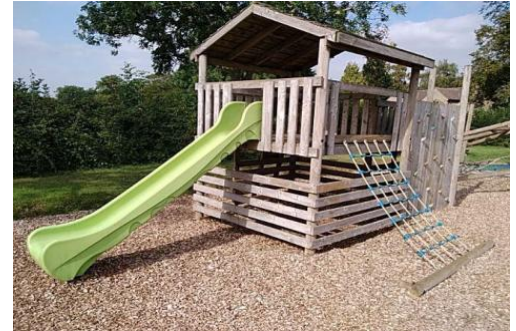
The depth of the loose fill surfacing is lower than the recommended depth specified in BS EN 1176; the free height of fall of the equipment is less than 2.0m and a minimum of 300mm depth should be provided (including an extra 100mm to allow for compaction and displacement as per BS EN 1176 Part 1 - Table 4) - Top up loose fill surfacing to recommended levels

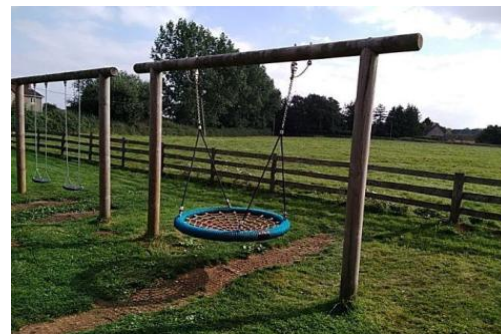
The surfacing dimensions are short and do not meet with the requirements of the current applicable standard - Monitor - no remedial action recommended

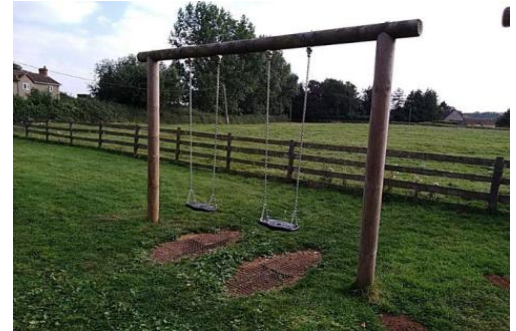
The edges of the grass mat surface have not been installed in accordance with the API Code of Practice - Tuck in edges of grass mat to remove trip hazards

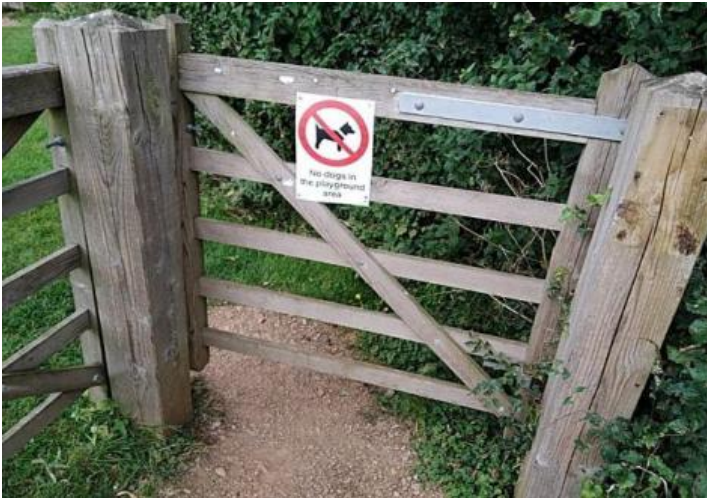
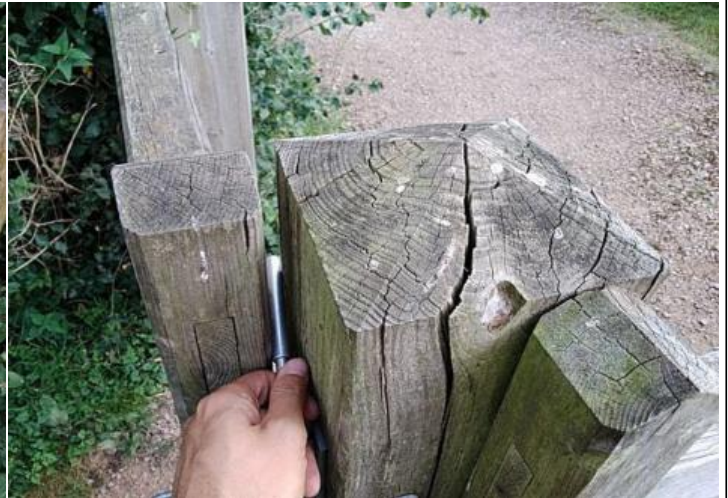
Finding: There are openings that are less than 12mm that could trap or crush fingers

Action: Where possible a 12mm gap should be maintained on both sides or between the gate leafs

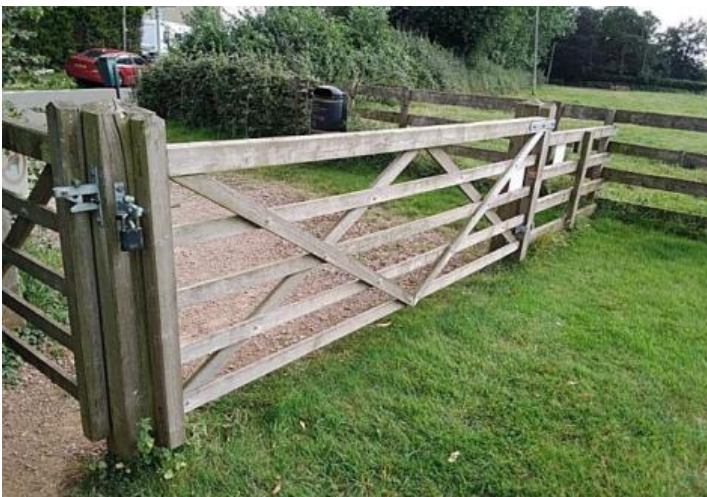
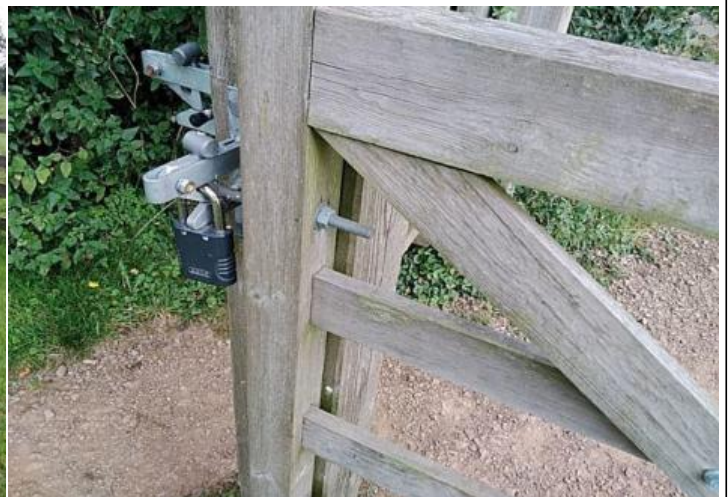
Finding: There are projecting bolt thread(s) present

Action: Remove excess thread length and deburr or provide cap

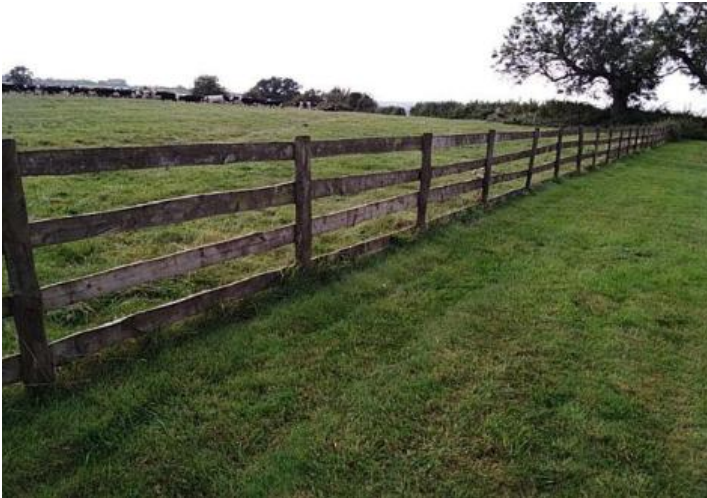
Finding: There are a number of loose posts around the fence

Action: Monitor for any further deterioration and reset as required

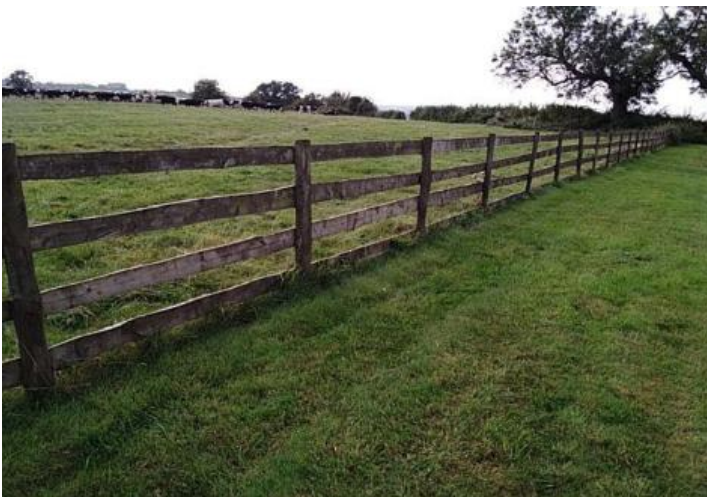
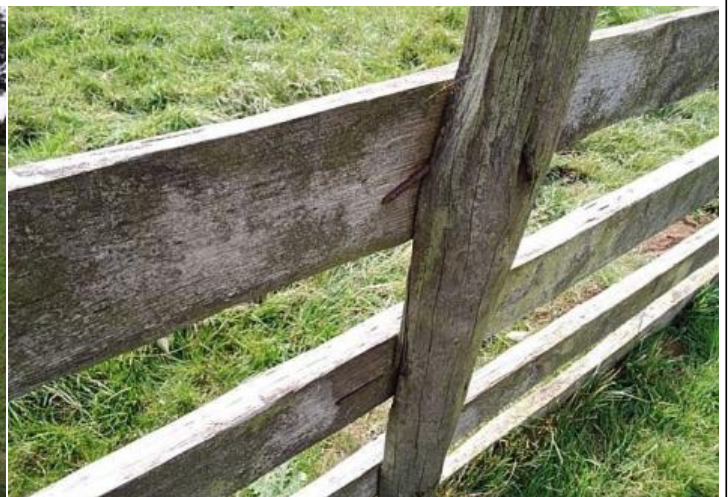
Finding: There are projecting nail ends present

Action: Remove and provide more appropriate fixings if required

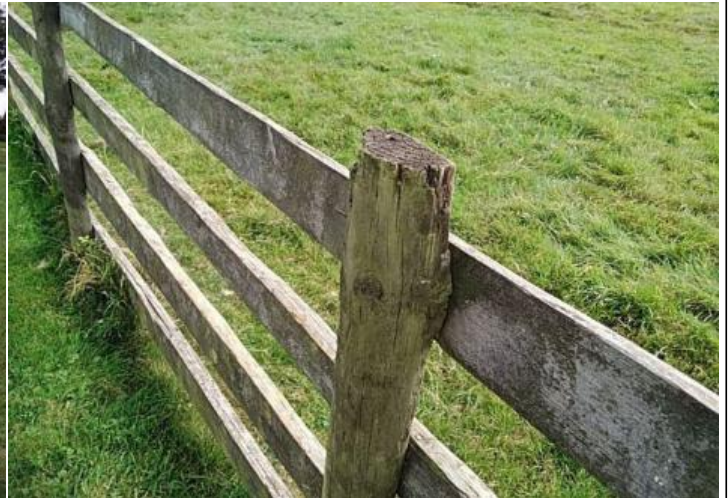
Finding: Parts of the timber are rough or splintered

Action: Remove all rough or sharp edges

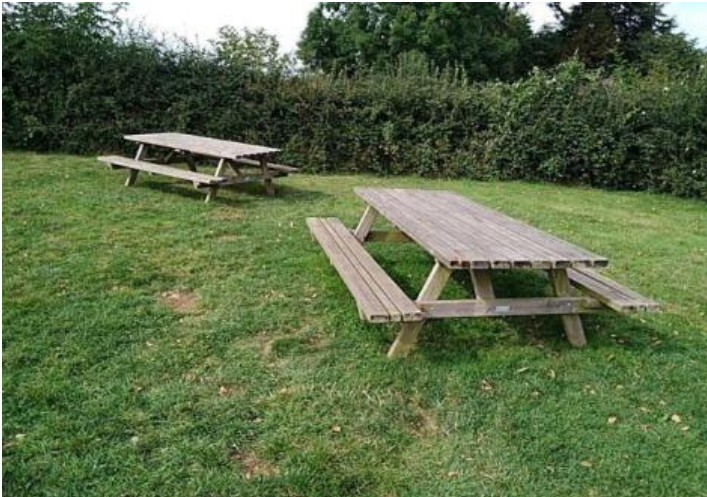
Finding: There is some evidence of rot in the timber

Action: Monitor for any further deterioration and replace as required

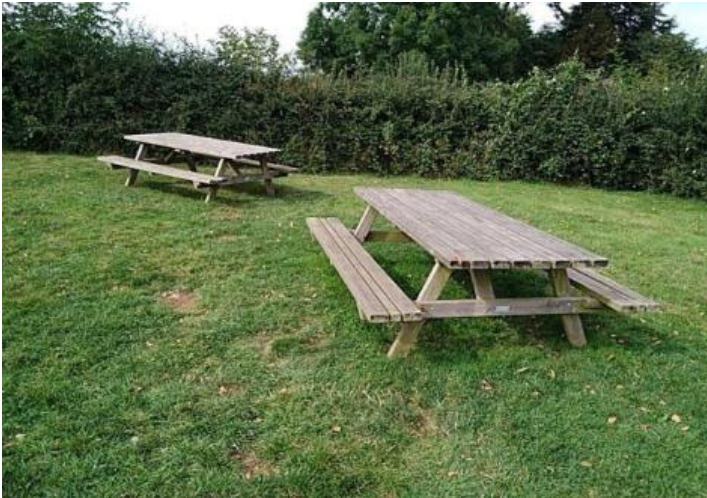
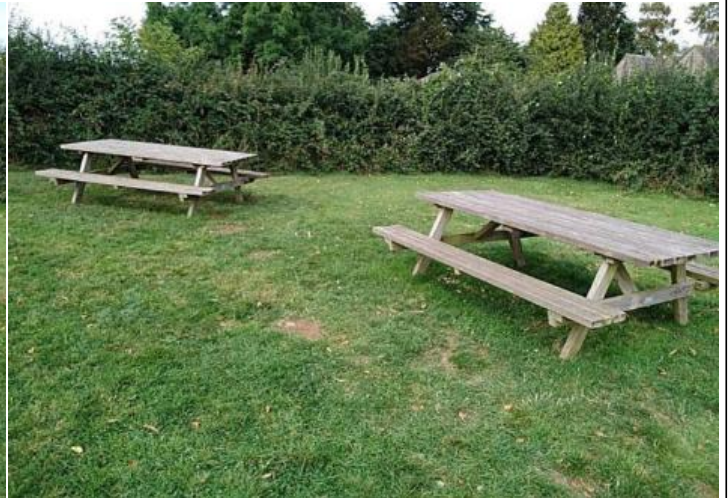
Finding: The table is not secured to the ground and there is some potential for the item to be moved within falling spaces of equipment
Action: Secure the item to the ground

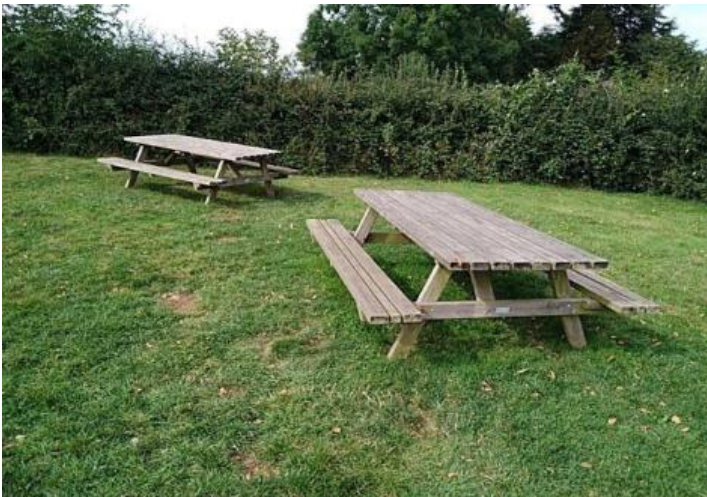
Finding: A number of fixing(s) have worked loose
Action: Secure all loose fixings

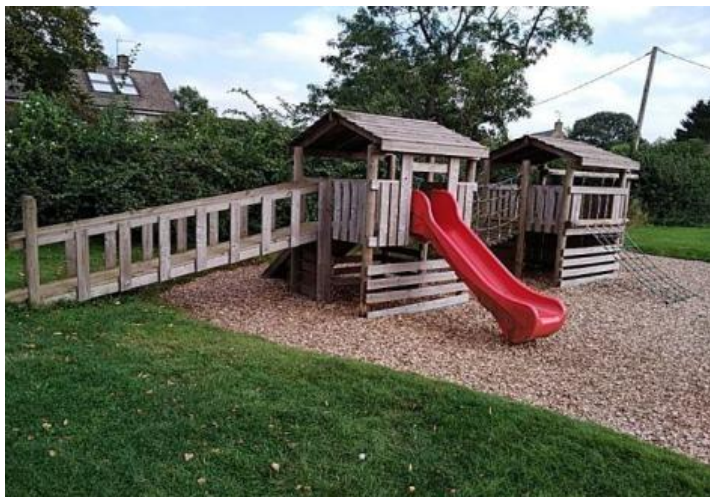
Finding: The depth of the loose fill surfacing is lower than the recommended depth specified in BS EN 1176; the free height of fall of the equipment is less than 2.0m and a minimum of 300mm depth should be provided (including an extra 100mm to allow for compaction and displacement as per BS EN 1176 Part 1 - Table 4)

Action: Top up loose fill surfacing to recommended levels

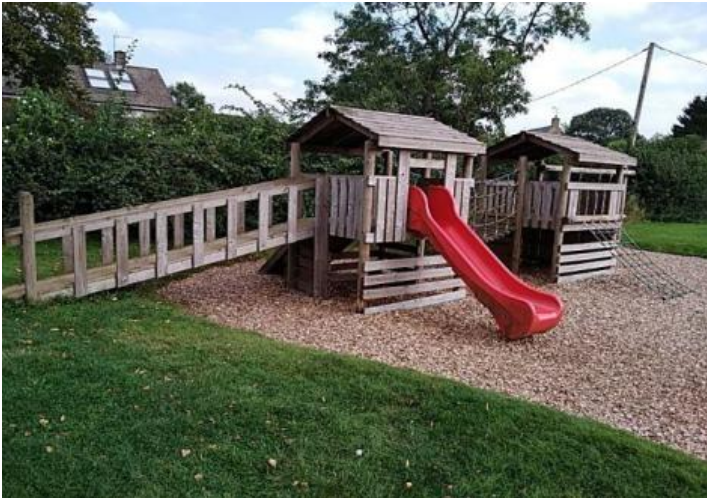
Finding: The unit is easily accessible and should have the appropriate barriers installed to meet the requirements of BS EN 1176 Part 1 as the height of the unit exceeds 600mm

Action: Monitor - No remedial work recommended

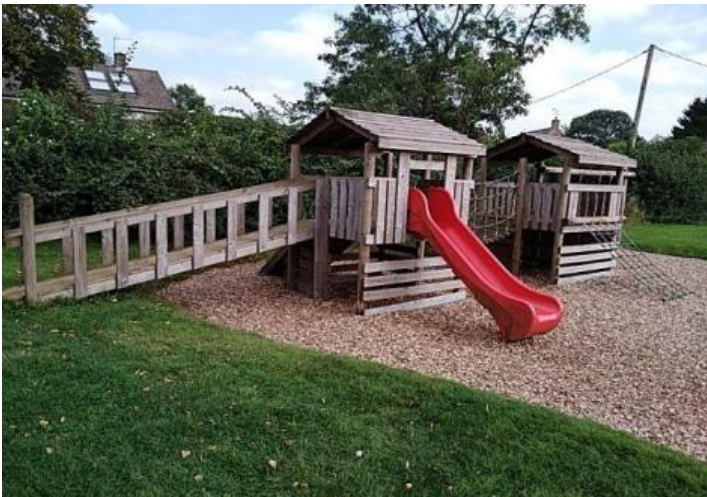
Finding: There is/are finger entrapment/s in the frame and the item fails to meet the requirements of BS EN 1176 Part 1 4.2.7.6 Entrapment of fingers

Action: Monitor - No remedial work recommended

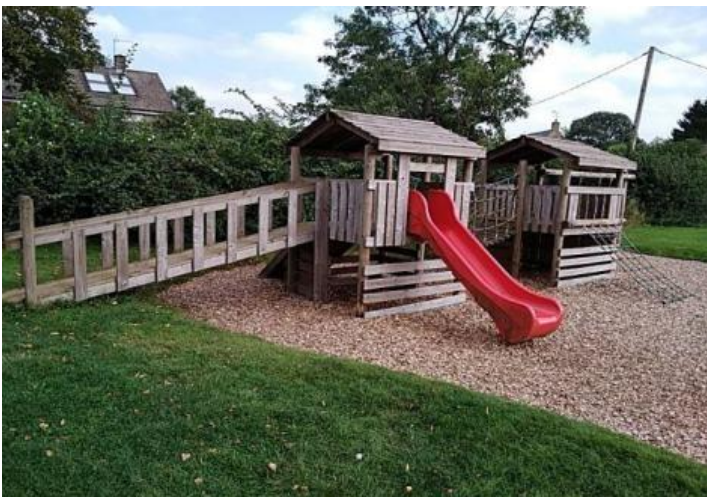
Finding: A number of fixing(s) have worked loose

Action: Secure all loose fixings

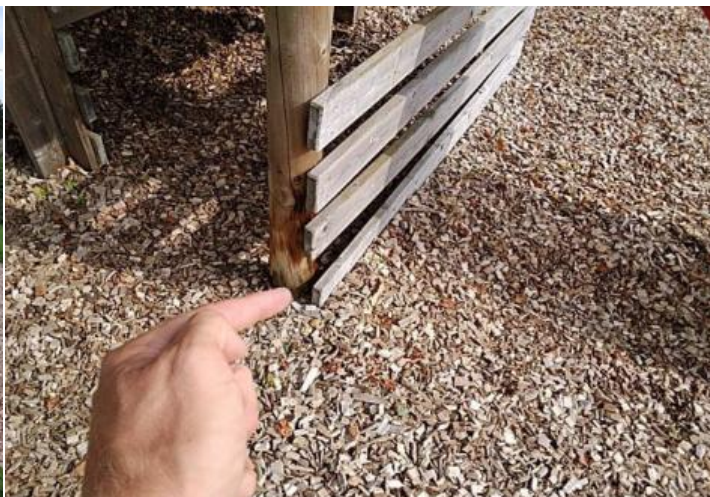
Finding: There is or are fixings missing on the item

Action: Replace all missing fixings

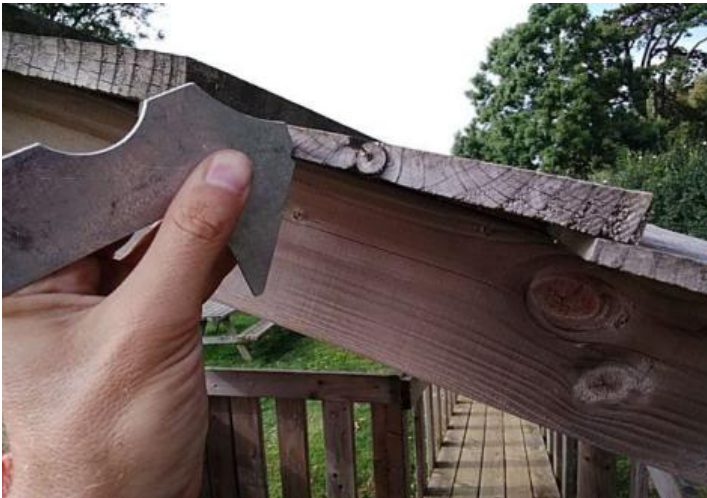
Finding: The item has exposed edges and corners with a radius of less than 3mm and fails the requirements of BS EN 1176
Action: Provide a 3mm radius to all exposed edges and corners

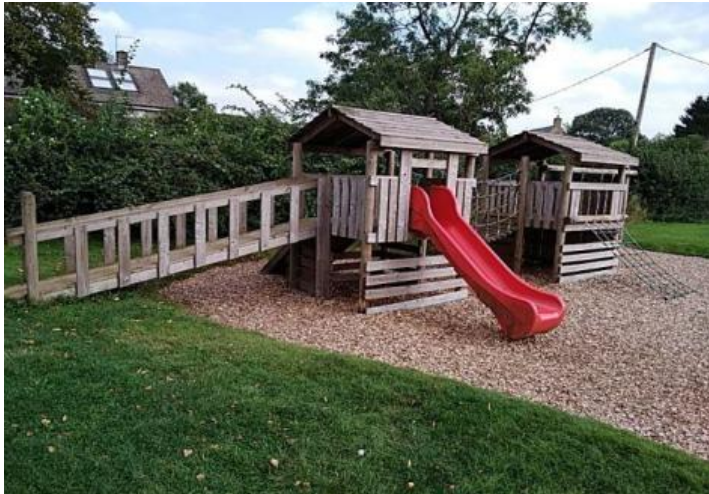
Finding: The surfacing dimensions are short and do not meet with the requirements of the current applicable standard

Action: Monitor - no remedial action recommended

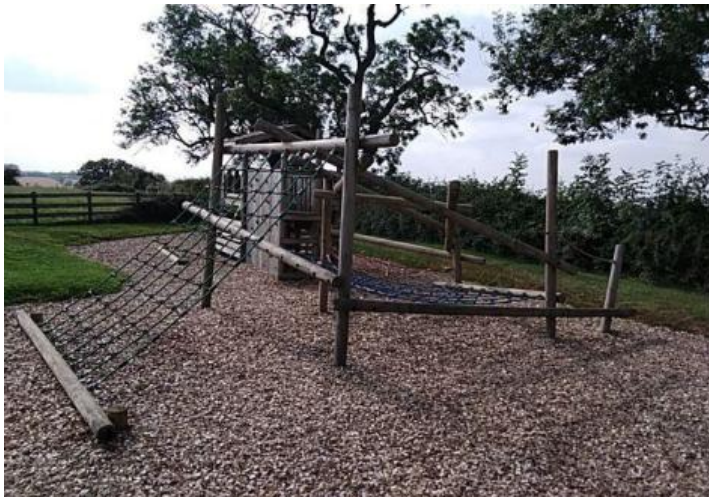
Finding: The item is slightly loose in its foundations

Action: Monitor for any further deterioration and repair as required

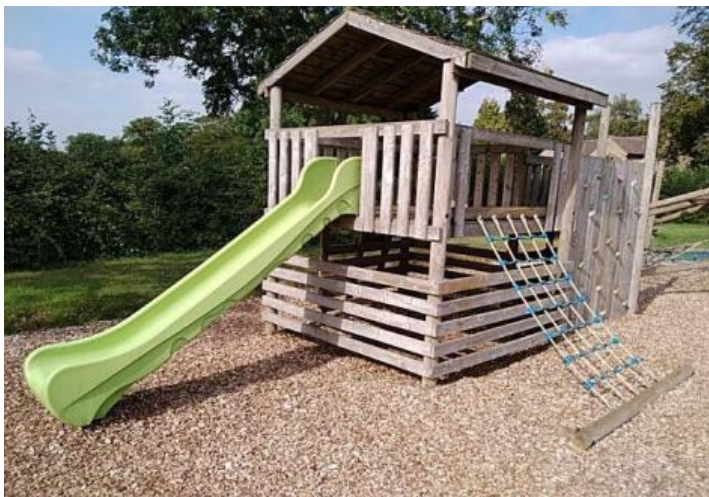
Finding: The depth of the loose fill surfacing is lower than the recommended depth specified in BS EN 1176; the free height of fall of the equipment is less than 2.0m and a minimum of 300mm depth should be provided (including an extra 100mm to allow for compaction and displacement as per BS EN 1176 Part 1 - Table 4)

Action: Top up loose fill surfacing to recommended levels

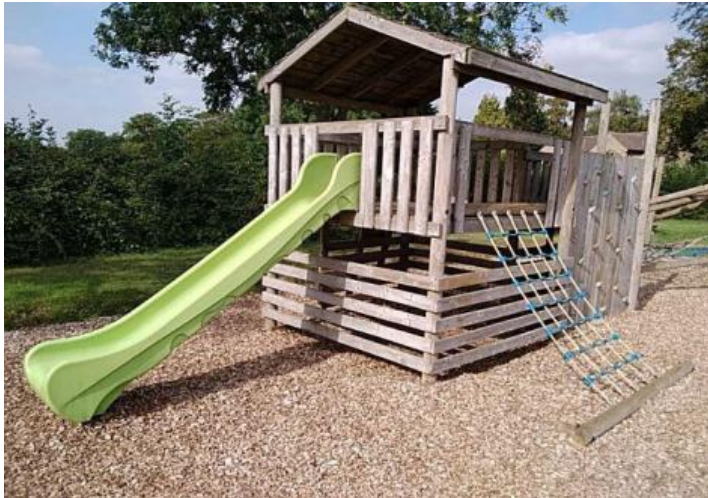
Finding: The net anchor forms a hard object within the impact area of the equipment in contravention of the requirements of BS EN 1176 Part 1

Action: Monitor - No remedial work recommended

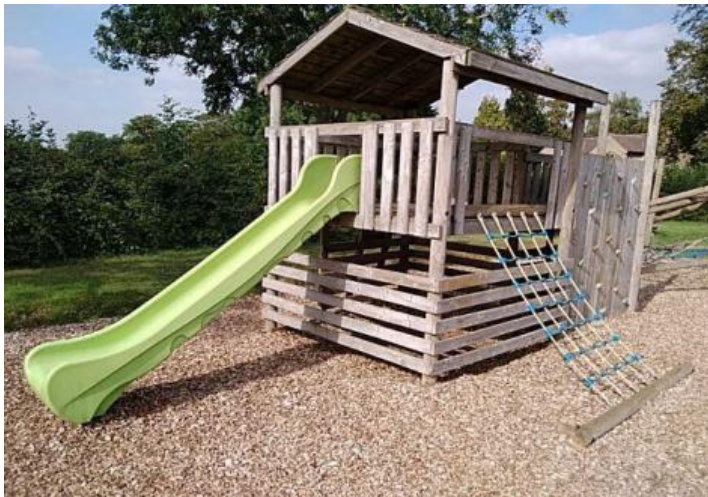
Finding: The platform provides access to a steep play element via a barrier with a width exceeding 1200mm and this fails to meet the requirements of BS EN1176 Part 1.

Action: Monitor - No remedial work recommended

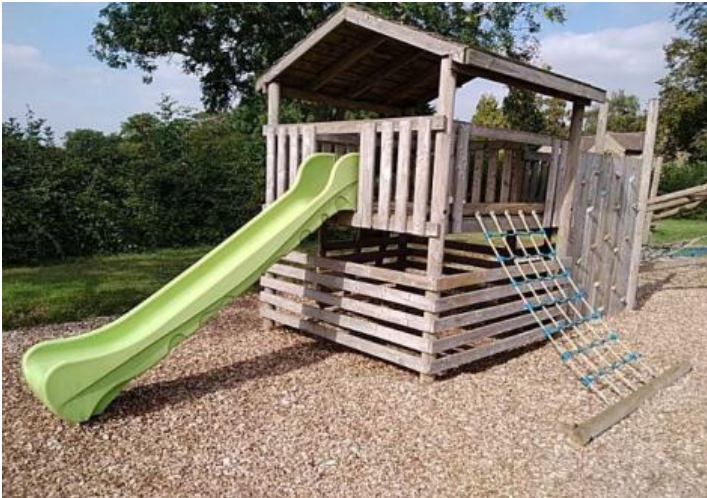
Finding: The height of the slide runout is in excess of 350mm and fails the requirements of BS EN 1176: Part 3

Action: Top up surfacing to comply

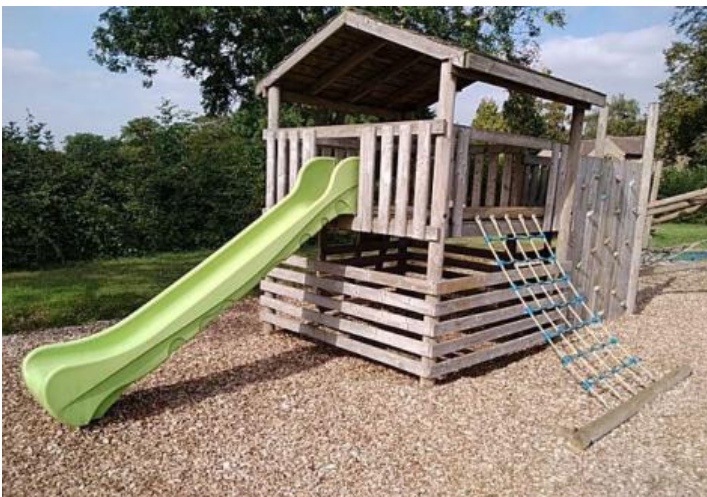
Finding: There is/are finger entrapment/s in the platform and the item fails to meet the requirements of BS EN 1176 Part 1 4.2.7.6 Entrapment of fingers

Action: Monitor - No remedial work recommended

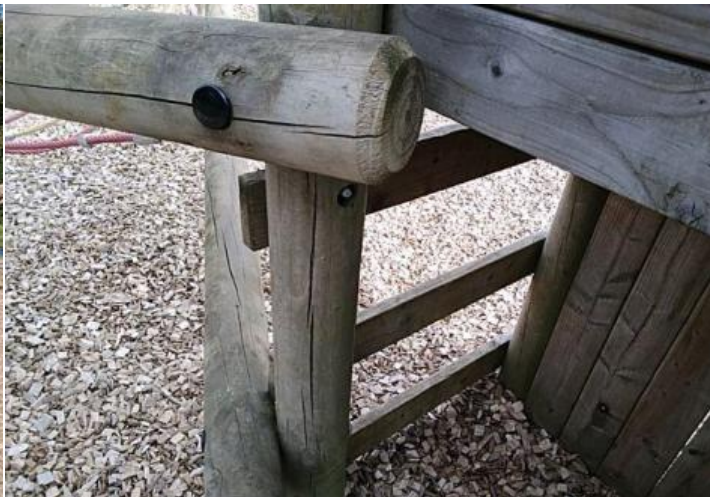
Item: Activity Equipment - Multi Play (Junior)
Manufacturer: Not Identified

Finding: There is/are bolt cap covers missing or damaged on the item

Action: Replace missing or damaged bolt cap covers

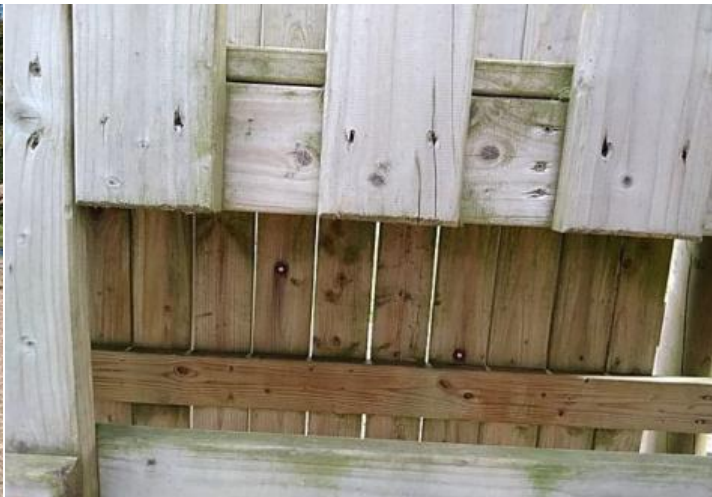
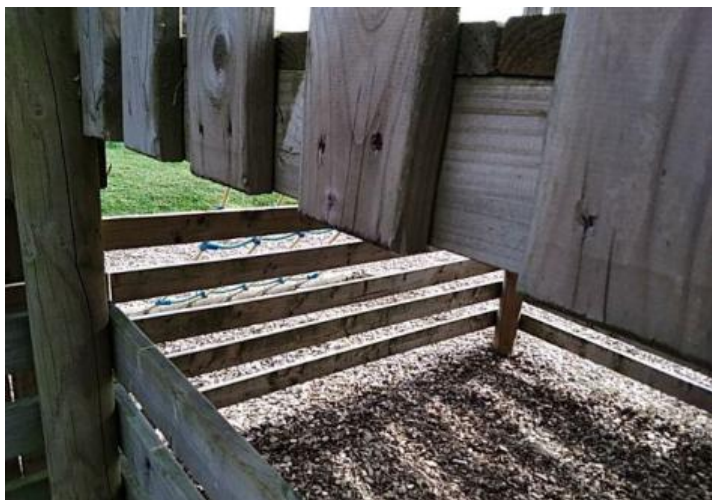
Item: Activity Equipment - Multi Play (Junior)
Manufacturer: Not Identified

Finding: Parts of the timber are rough or splintered

Action: Remove all rough or sharp edges

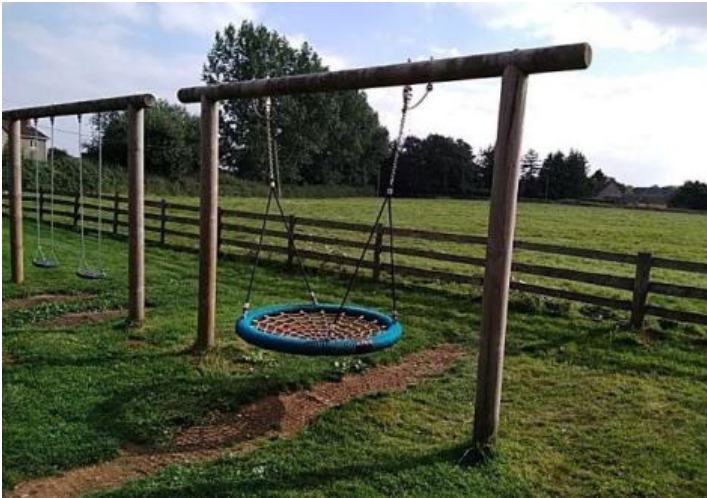
Item: Swings - Basket Swing - Type 1
Manufacturer: Not Identified

Finding: The surfacing dimensions are short and do not meet with the requirements of the current applicable standard

Action: Monitor - no remedial action recommended

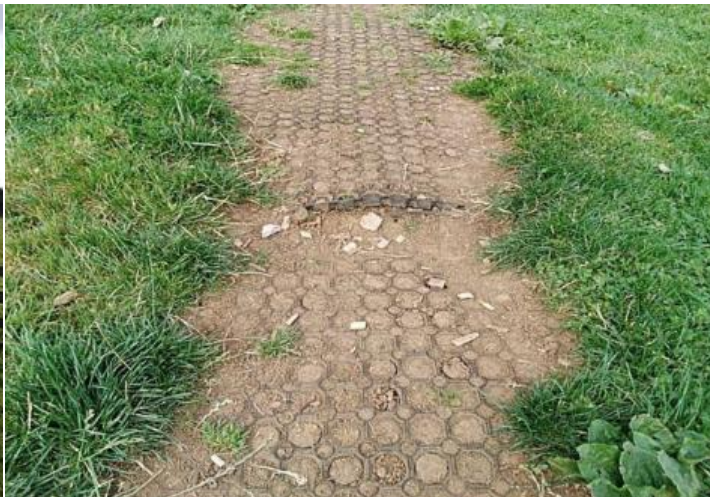
Item: Swings - Basket Swing - Type 1
Manufacturer: Not Identified

Finding: The edges of the grass mat surface have not been installed in accordance with the API Code of Practice
Action: Tuck in edges of grass mat to remove trip hazards

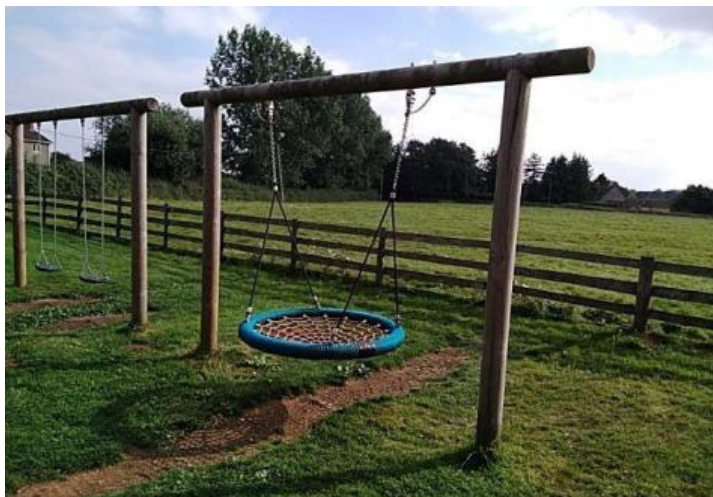
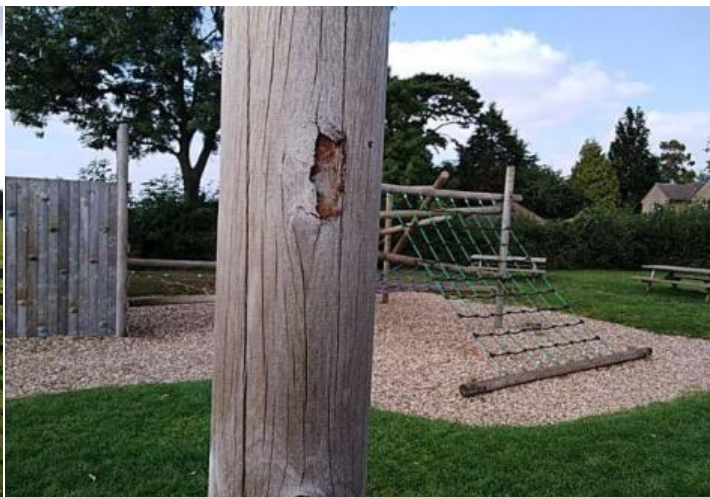
Item: Swings - Basket Swing - Type 1
Manufacturer: Not Identified

Finding: Parts of the timber are rough or splintered
Action: Remove all rough or sharp edges

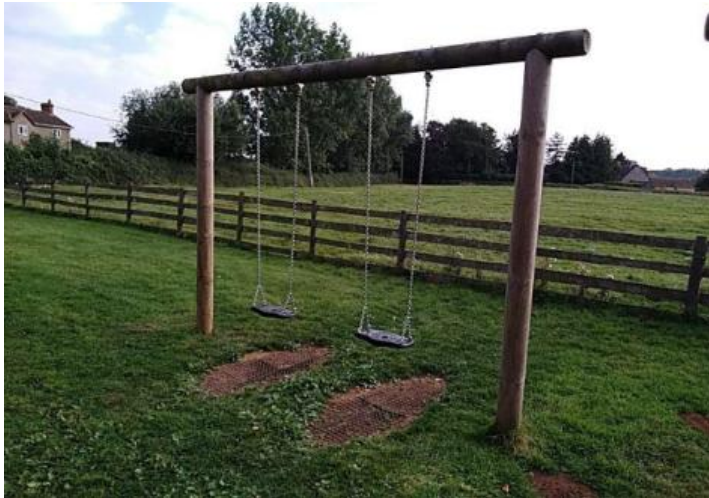
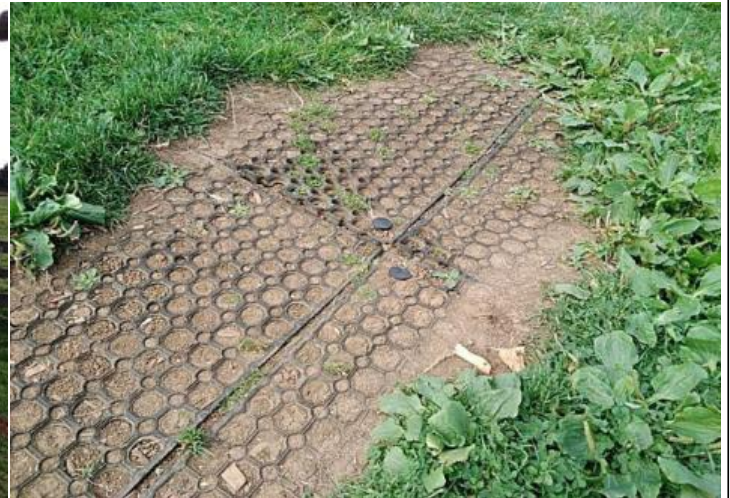
Item: Swings - 1 Bay 2 Seat (Flat)
Manufacturer: Not Identified

Finding: Fixing Pins have been installed in the impact areas of the grass mats **Action:** Remove pins from impact areas

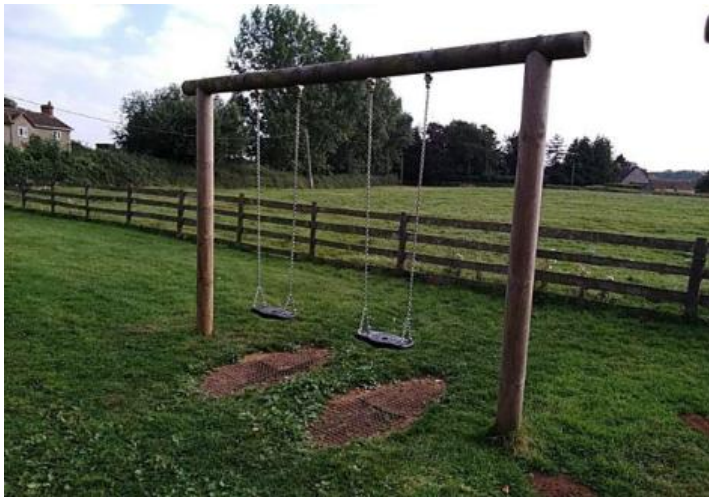
Item: Swings - 1 Bay 2 Seat (Flat)
Manufacturer: Not Identified

Finding: The swing seat connectors are loose

Action: Tighten to secure
