# the **play inspection** company

## Annual Inspection

Farthinghoe Parish Council

Farthinghoe Play Park

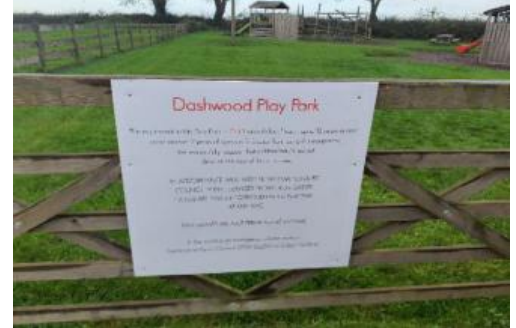
**Item:** Sign  
**Manufacturer:** Owner/Operator  
**Surface Type:** N/A  
**Item Quantity:** 1  
**Equipment Compliance:** N/A  
**Surface Area Compliance:** N/A

This item is satisfactory - no work required -

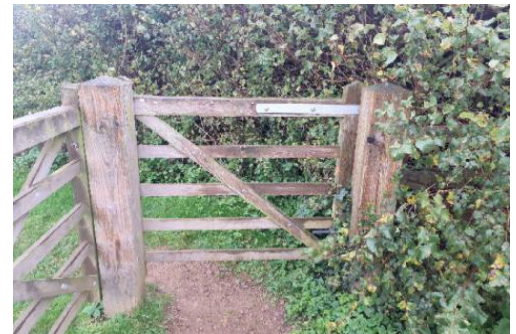
**Item:** Gate - Pedestrian  
**Manufacturer:** Owner/Operator  
**Surface Type:** Gravel  
**Item Quantity:** 1  
**Equipment Compliance:** N/A  
**Surface Area Compliance:** N/A

There are projecting nail ends and staples present - Remove and provide more appropriate fixings if required

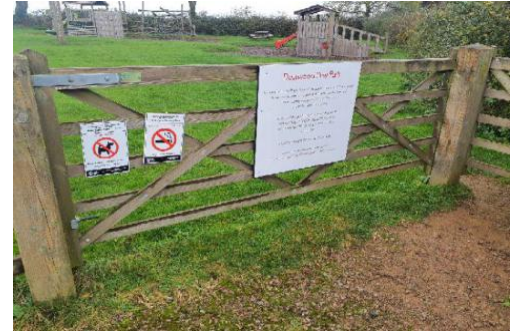
**Item:** Gate - Maintenance  
**Manufacturer:** Owner/Operator  
**Surface Type:** Gravel  
**Item Quantity:** 1  
**Equipment Compliance:** N/A  
**Surface Area Compliance:** N/A

Cable ties have been used on the item and there are sharp projecting ends - Remove if not required or replace with a more appropriate alternative fixing method if used as a fixing

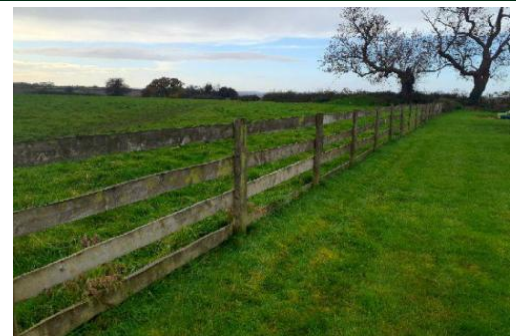
**Item:** Fencing - Timber  
**Manufacturer:** Owner/Operator  
**Surface Type:** Grass  
**Item Quantity:** 1  
**Equipment Compliance:** N/A  
**Surface Area Compliance:** N/A

There are a number of loose posts around the fence - Monitor for any further deterioration and reset as required

There is some evidence of rot in the timber - Monitor for any further deterioration and replace as required

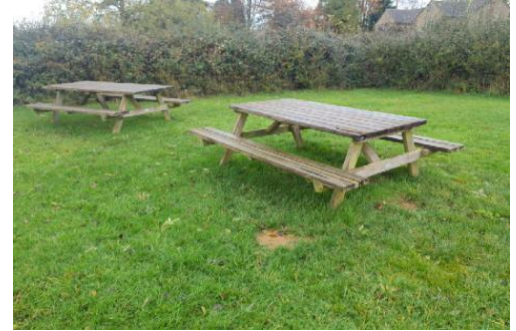
**Item:** Picnic Table  
**Manufacturer:** Owner/Operator  
**Surface Type:** Grass  
**Item Quantity:** 2  
**Equipment Compliance:** N/A  
**Surface Area Compliance:** N/A

The table/s is/are not secured to the ground and there is some potential for the item/s to be moved within falling spaces of equipment - Secure to the ground

There are areas or parts of the timber on the structure that have rotted - Replace all affected timbers

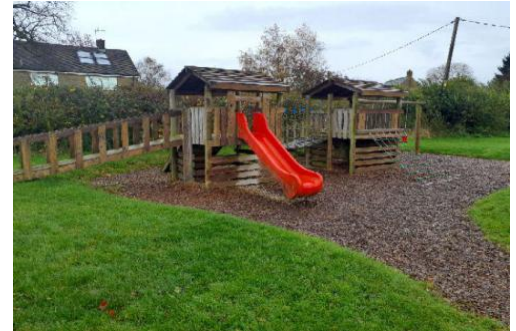
**Item:** Multi Play (Junior)  
**Manufacturer:** Not Identified  
**Surface Type:** Woodchip  
**Item Quantity:** 1  
**Equipment Compliance:** No  
**Surface Area Compliance:** No

The depth of the loose fill surfacing is lower than the recommended depth specified in BS EN 1176; the free height of fall of the equipment is less than 2.0m and a minimum of 300mm depth should be provided (including an extra 100mm to allow for compaction and displacement as per BS EN 1176 Part 1 - Table 4) - Top up loose fill surfacing to recommended levels

The surfacing dimensions are short and do not meet with the requirements of the current applicable standard - Monitor - no remedial action recommended

Swing frames or their top bar should only be attached to other equipment where specific measures are undertaken to segregate them from other activities, eg. additional 1.50m circulation area, barrier, or enclosures - BS EN 1176 Part 2 - 4.9 - Monitor - No remedial work recommended

This design of swing joint has been known to fail on the weld connecting the joint to the threaded stud - We would recommend that the joint be dismantled and checked on a regular basis or consulting with manufacturer on whether a Secondary Safety Device can be fitted

The unit is easily accessible and should have the appropriate barriers installed to meet the requirements of BS EN 1176 Part 1 as the height of the unit exceeds 600mm - Monitor - No remedial work recommended

The height of the slide runout is in excess of 200mm and does not meet the requirements of BS EN 1176 Part 3 - Top up loose fill surfacing to recommended levels

The height of the barrier(s) is insufficient and fails to meet the requirements of BS EN 1176 Part 1 - Monitor - No remedial work recommended

The unit is easily accessible and has an opening in the barrier to steep play elements in excess of 500mm in contravention of BS EN 1176 Part 1 - Monitor - No remedial work recommended

There are areas or parts of the timber barriers on the structure that have rotted - Replace all affected timbers

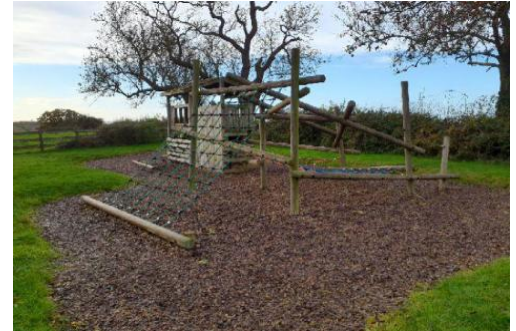
**Item:** Log Climber  
**Manufacturer:** Not Identified  
**Surface Type:** Woodchip  
**Item Quantity:** 1  
**Equipment Compliance:** No  
**Surface Area Compliance:** No

The depth of the loose fill surfacing is lower than the recommended depth specified in BS EN 1176 for a fall height over 2.0m. A minimum depth of 400mm is recommended (including an extra 100mm to allow for compaction and displacement as per BS EN 1176 Part 1 - Table 4) - Top up loosefill to recommended levels

The surfacing dimensions are short and do not meet with the requirements of the current applicable standard - Monitor - no remedial action recommended

There are falls in excess of 600mm between adjacent components on the structure, in contravention of the recommendations set out in BS EN 1176 Part 1; 4.2.8.4 - Monitor use and review risk assessment regularly

The connecting links are in excess of 8.6mm and less than 12mm and fail the requirements of BS EN 1176 Part 1; clause 4.2.13, Chains - Monitor - No remedial work recommended

The item is slightly loose in its foundations - Monitor for any further deterioration and repair as required

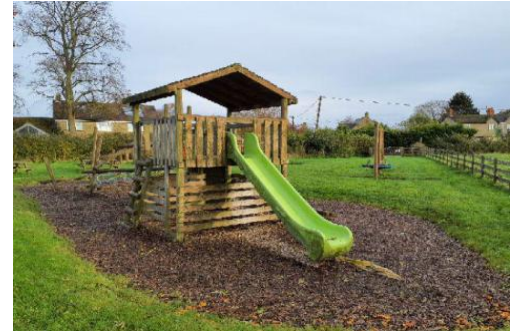
**Item:** Multi Play (Junior)  
**Manufacturer:** Not Identified  
**Surface Type:** Woodchip  
**Item Quantity:** 1  
**Equipment Compliance:** No  
**Surface Area Compliance:** Yes

The depth of the loose fill surfacing is lower than the recommended depth specified in BS EN 1176 for a fall height over 2.0m. A minimum depth of 400mm is recommended (including an extra 100mm to allow for compaction and displacement as per BS EN 1176 Part 1 - Table 4) - Top up loosefill to recommended levels

The height of the slide runout is in excess of 350mm and does not meet the requirements of BS EN 1176: Part 3 - Top up loose fill surfacing to reduce height below 350mm

The item fails to meet the requirements of BS EN 1176 Part 1 4.2.7.2 for head and neck entrapment in the framework - Monitor - No remedial work recommended

There are openings leading from platforms in excess of 1.0m in height to steep play elements and no hand supports complying with grip or grasp are provided, in contravention of BS EN 1176 Part 1: 4.2.9.4 - Monitor - No remedial work recommended

The item fails to meet the requirements of BS EN 1176 Part 1 4.2.7.2 for head and neck entrapment in between the rope net and framework - Monitor - No remedial work recommended

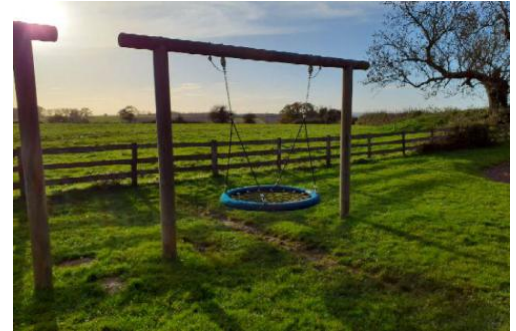
**Item:** Basket Swing - Type 1  
**Manufacturer:** Not Identified  
**Surface Type:** Grass Matrix Tiles  
**Item Quantity:** 1  
**Equipment Compliance:** No  
**Surface Area Compliance:** No

The grass mats are silted up and the soil is compacted; this may have an effect on the impact absorbing properties of the surface. Consideration should be given to HIC testing the surface to verify impact attenuating properties ( <https://playinspections.co.uk/inspection-services/safety-surface-testing/> ) - Contact our office for a quotation for this service

There is some notable evidence of chain wear - Monitor for any further deterioration and replace when 40% worn

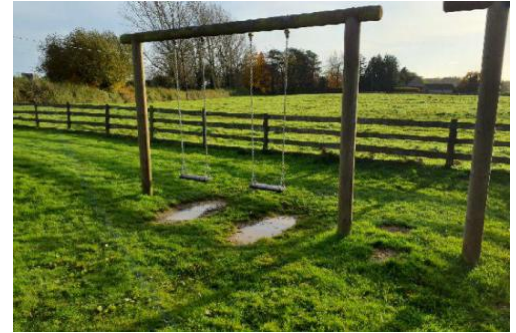
**Item:** 1 Bay 2 Seat (Flat)  
**Manufacturer:** Not Identified  
**Surface Type:** Grass Matrix Tiles  
**Item Quantity:** 1  
**Equipment Compliance:** No  
**Surface Area Compliance:** No

The grass mats are silted up and the soil is compacted; this may have an effect on the impact absorbing properties of the surface. Consideration should be given to HIC testing the surface to verify impact attenuating properties ( <https://playinspections.co.uk/inspection-services/safety-surface-testing/> ) - Contact our office for a quotation for this service

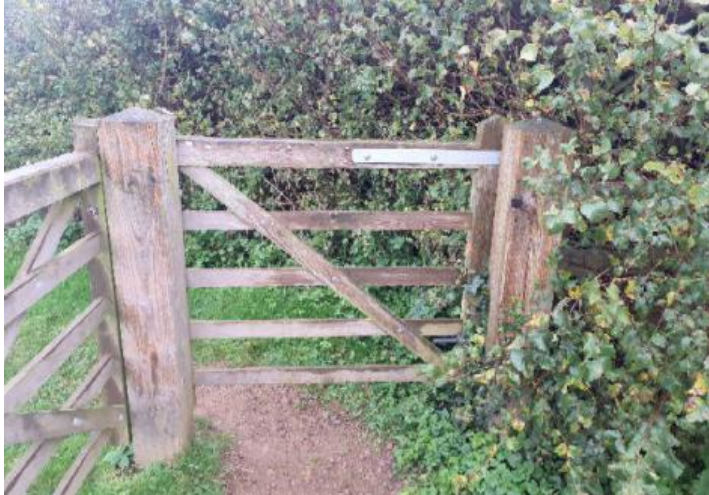
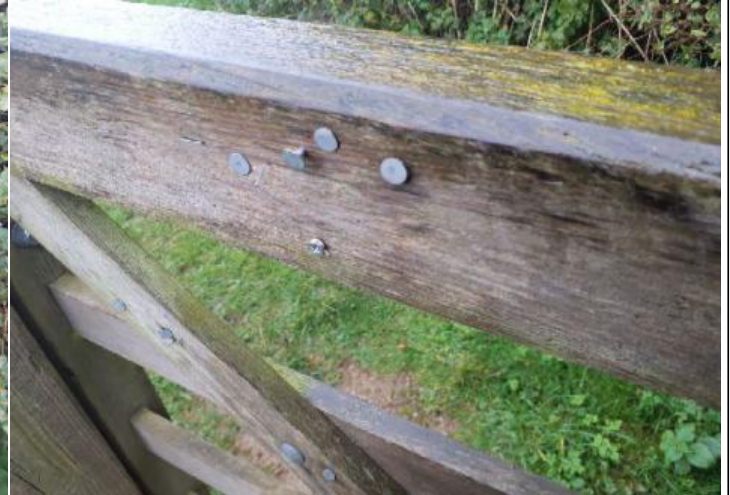
**Item:** Gates - Gate - Pedestrian  
**Manufacturer:** Owner/Operator

**Finding:** There are projecting nail ends and staples present **Action:** Remove and provide more appropriate fixings if required

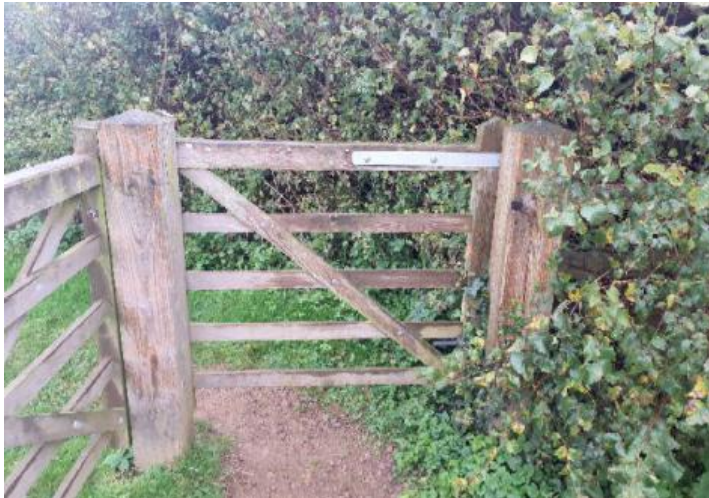
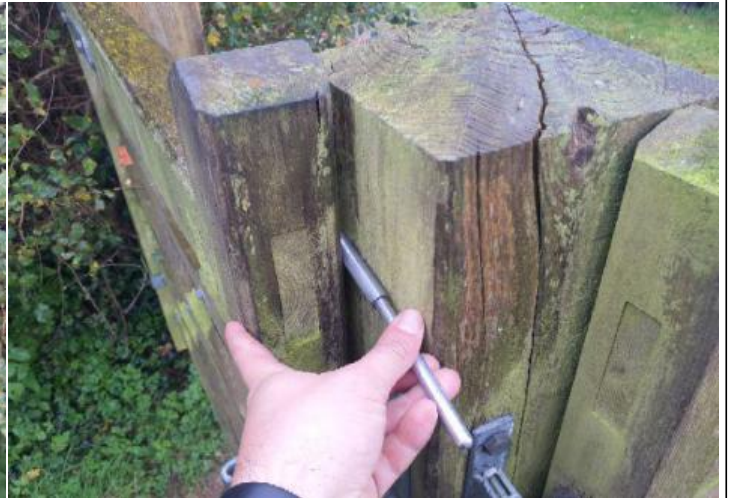
**Item:** Gates - Gate - Pedestrian  
**Manufacturer:** Owner/Operator

**Finding:** There are openings that are less than 12mm that could trap or crush fingers

**Action:** Provide a 12mm gap throughout full range of motion at both sides of gate

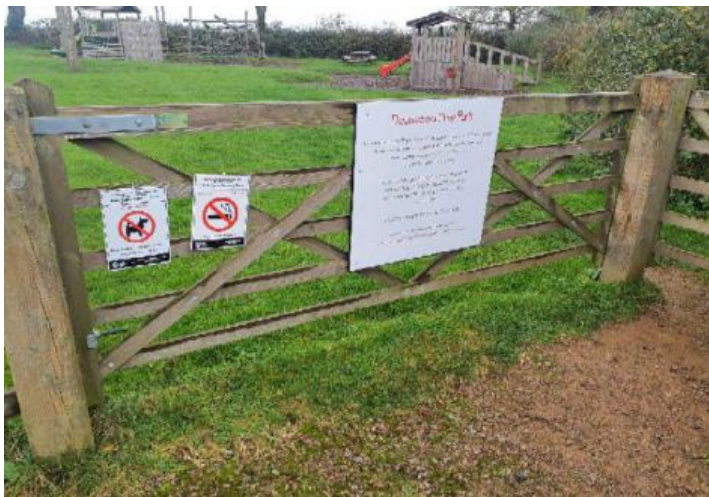
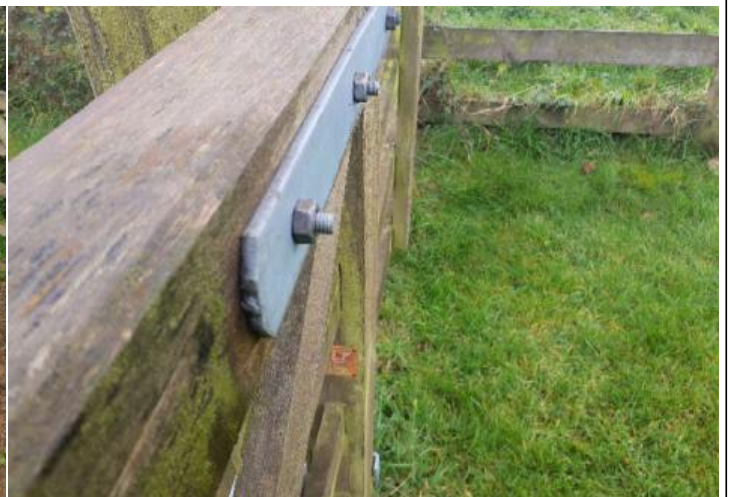
**Item:** Gates - Gate - Maintenance  
**Manufacturer:** Owner/Operator

**Finding:** There are projecting bolt thread(s) present

**Action:** Remove excess thread length and deburr or provide cap

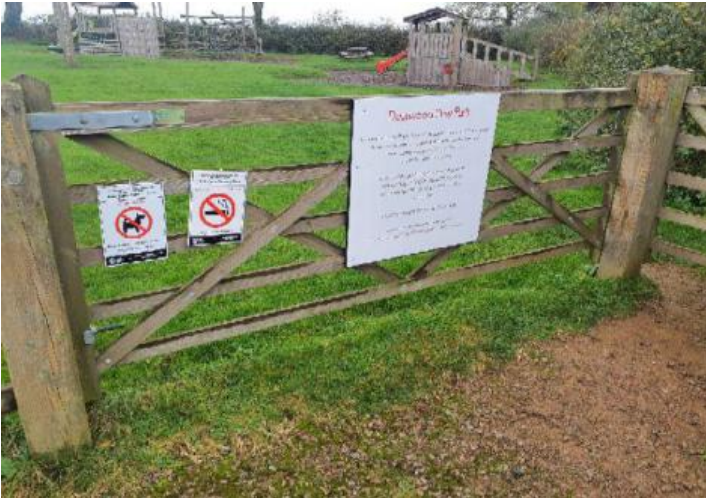
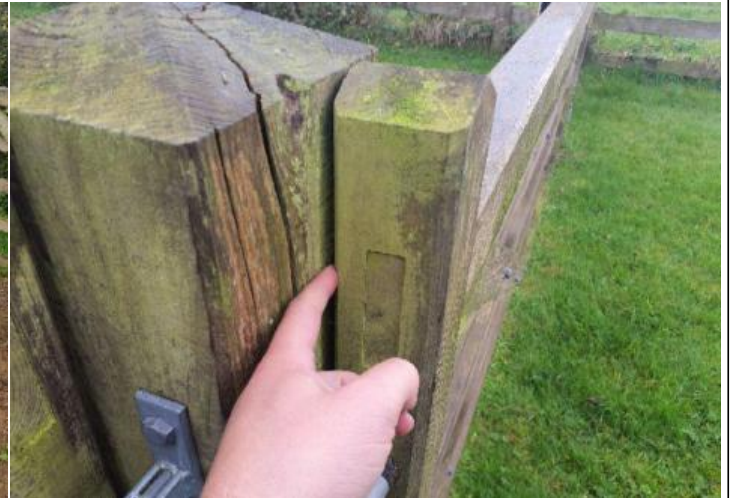
**Item:** Gates - Gate - Maintenance  
**Manufacturer:** Owner/Operator

**Finding:** There are openings that are less than 12mm that could trap or crush fingers

**Action:** Provide a 12mm gap throughout full range of motion at both sides of gate

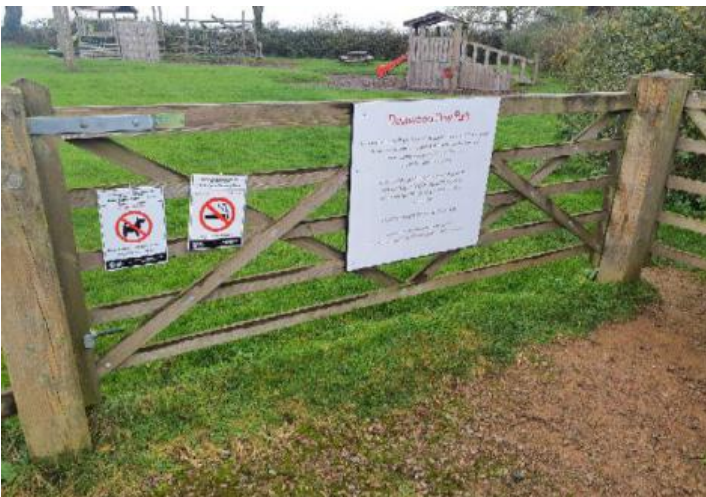
**Item:** Gates - Gate - Maintenance  
**Manufacturer:** Owner/Operator

**Finding:** Cable ties have been used on the item and there are sharp projecting ends

**Action:** Remove if not required or replace with a more appropriate alternative fixing method if used as a fixing

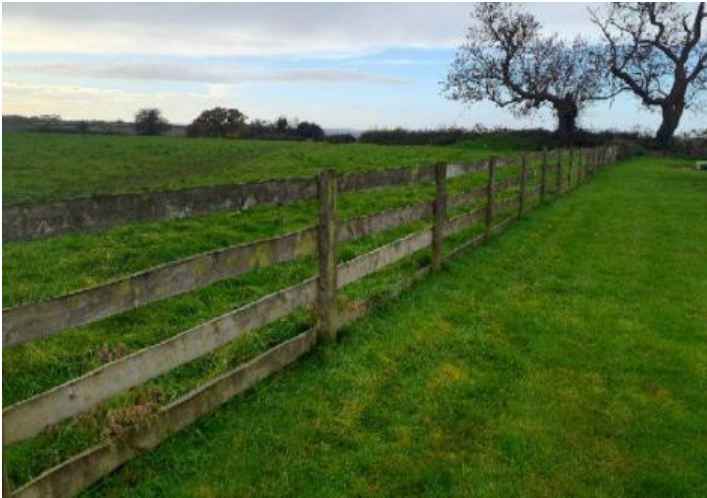
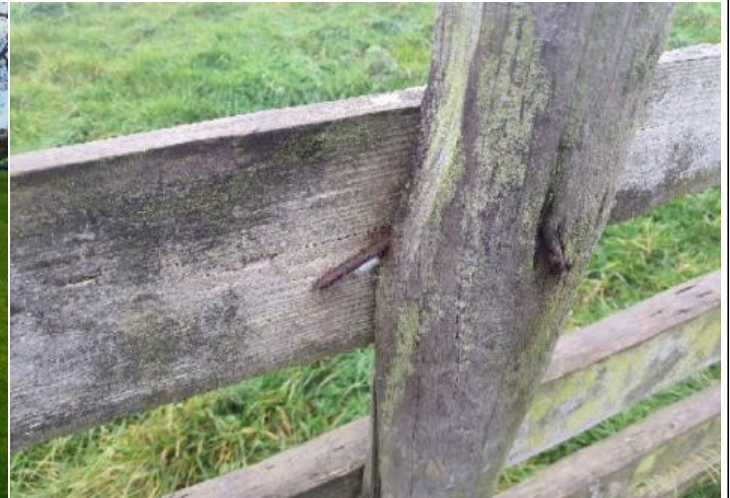
**Item:** Fences - Fencing - Timber  
**Manufacturer:** Owner/Operator

**Finding:** There are projecting nail ends present

**Action:** Remove and provide more appropriate fixings if required

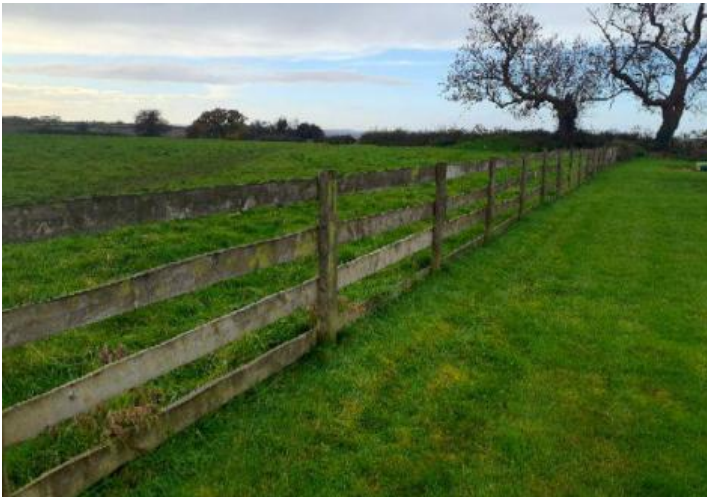
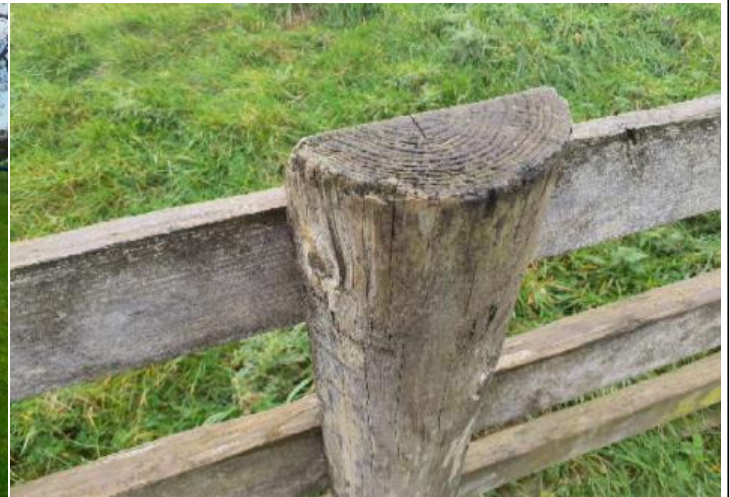
**Item:** Fences - Fencing - Timber  
**Manufacturer:** Owner/Operator

**Finding:** Parts of the timber are rough or splintered

**Action:** Remove all rough or sharp edges

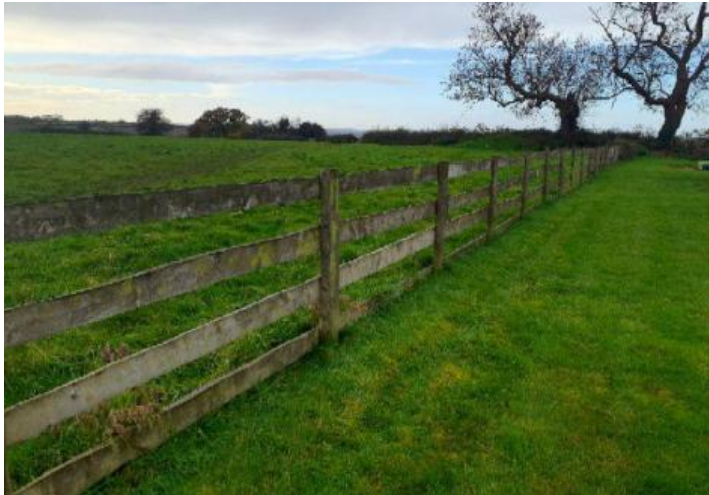
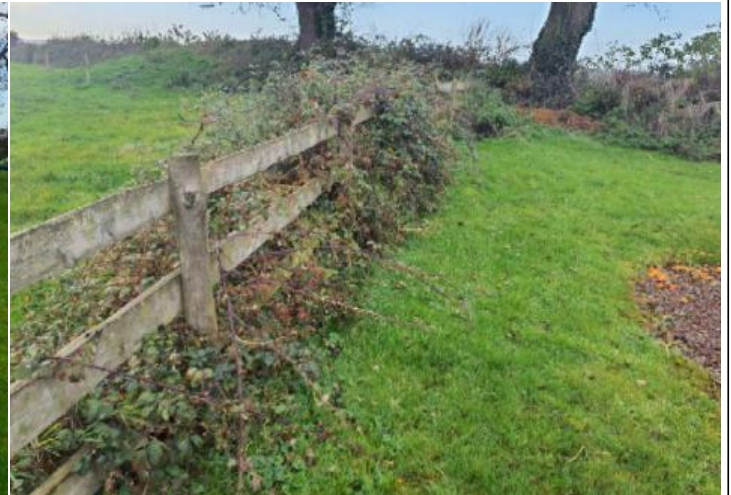
**Item:** Fences - Fencing - Timber  
**Manufacturer:** Owner/Operator

**Finding:** The adjacent foliage is overhanging

**Action:** Cut back and maintain

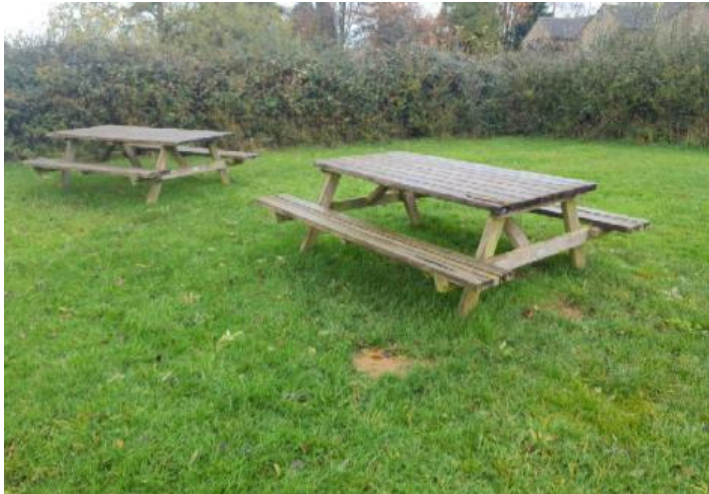
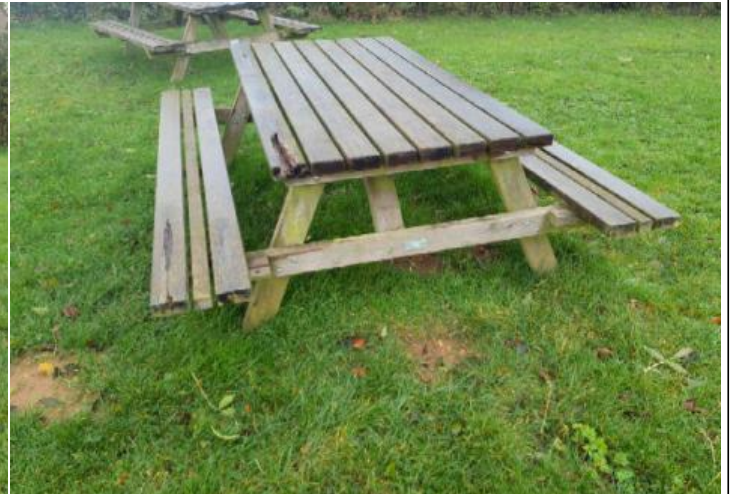
**Item:** Ancillary Items - Picnic Table  
**Manufacturer:** Owner/Operator

**Finding:** The table/s is/are not secured to the ground and there is some potential for the item/s to be moved within falling spaces of equipment

**Action:** Secure to the ground

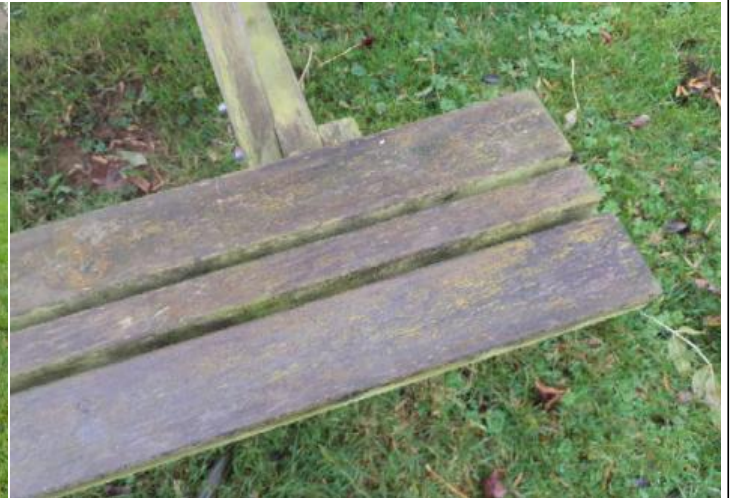
**Item:** Ancillary Items - Picnic Table  
**Manufacturer:** Owner/Operator  
**Risk Level:** L - Low Risk  
**Surface:** Grass

**Finding:** There is algae or moss on the surface of the item  
**Action:** Clean and treat appropriately

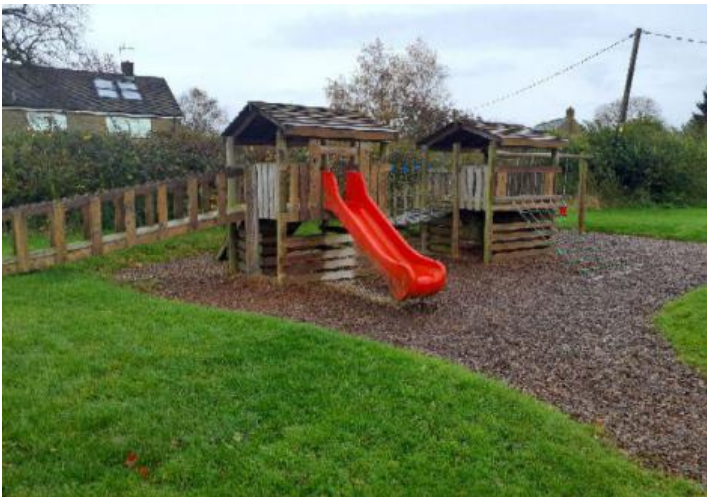
**Item:** Activity Equipment - Multi Play (Junior)  
**Manufacturer:** Not Identified

**Finding:** Swing frames or their top bar should only be attached to other equipment where specific measures are undertaken to segregate them from other activities, eg. additional 1.50m circulation area, barrier, or enclosures - BS EN 1176 Part 2 - 4.9

**Action:** Monitor - No remedial work recommended

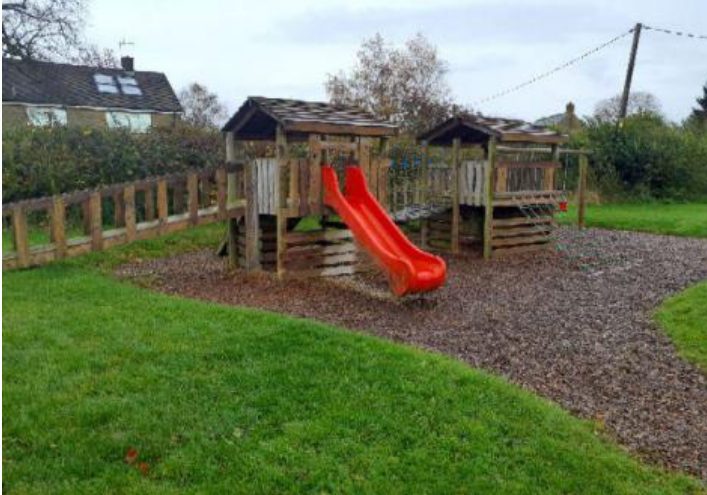
**Item:** Activity Equipment - Multi Play (Junior)  
**Manufacturer:** Not Identified

**Finding:** This design of swing joint has been known to fail on the weld connecting the joint to the threaded stud

**Action:** We would recommend that the joint be dismantled and checked on a regular basis or consulting with manufacturer on whether a Secondary Safety Device can be fitted

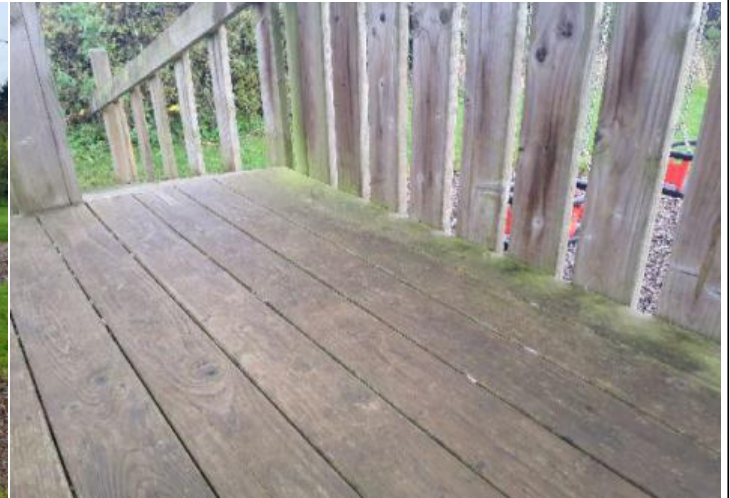
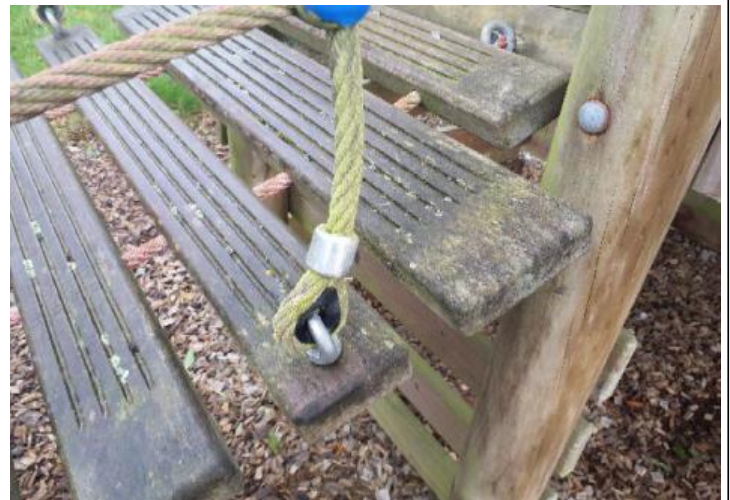
**Item:** Activity Equipment - Multi Play (Junior)  
**Manufacturer:** Not Identified

**Finding:** There is algae or moss on the surface of the equipment

**Action:** Clean and treat appropriately

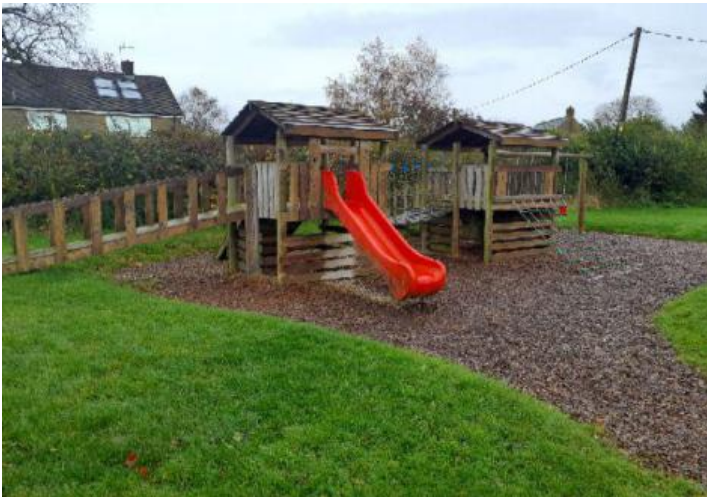
**Item:** Activity Equipment - Multi Play (Junior)  
**Manufacturer:** Not Identified

**Finding:** The unit is easily accessible and has an opening in the barrier to steep play elements in excess of 500mm in contravention of BS EN 1176 Part 1  
**Action:** Monitor - No remedial work recommended

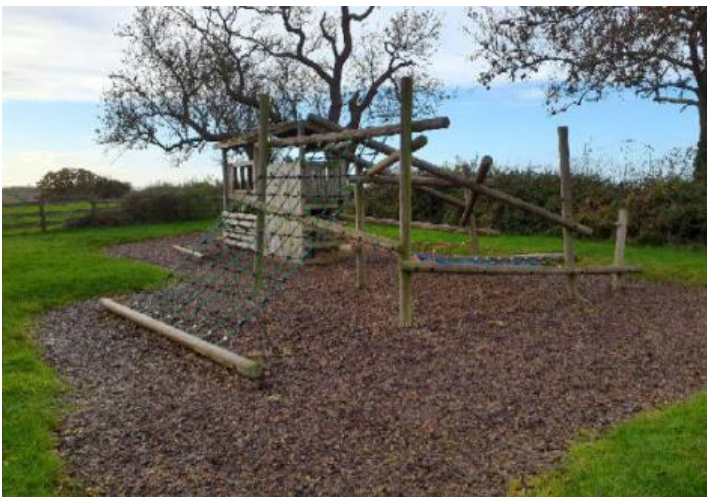
**Item:** Activity Equipment - Log Climber  
**Manufacturer:** Not Identified

**Finding:** The depth of the loose fill surfacing is lower than the recommended depth specified in BS EN 1176 for a fall height over 2.0m. A minimum depth of 400mm is recommended (including an extra 100mm to allow for compaction and displacement as per BS EN 1176 Part 1 - Table 4)

**Action:** Top up loosefill to recommended levels

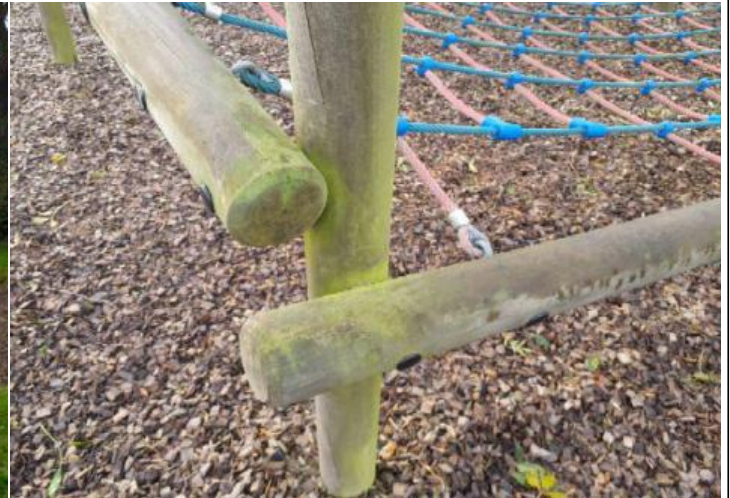
**Item:** Activity Equipment - Log Climber  
**Manufacturer:** Not Identified

**Finding:** There is algae or moss on the surface of the equipment

**Action:** Clean and treat appropriately

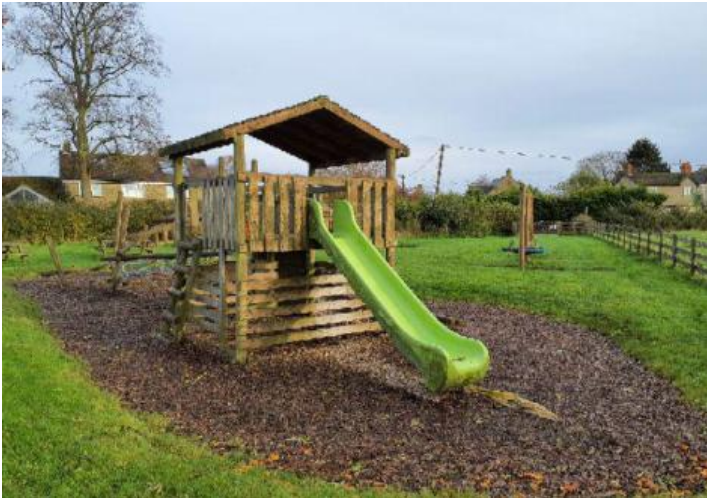
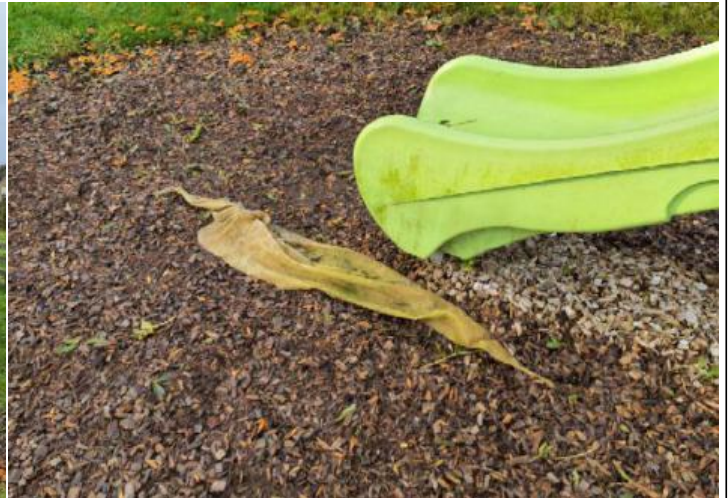
**Item:** Activity Equipment - Multi Play (Junior)  
**Manufacturer:** Not Identified

**Finding:** The safety surface is low and the membrane is exposed creating trip points

**Action:** Remove or resecure the exposed membrane and top up the surface to the correct level

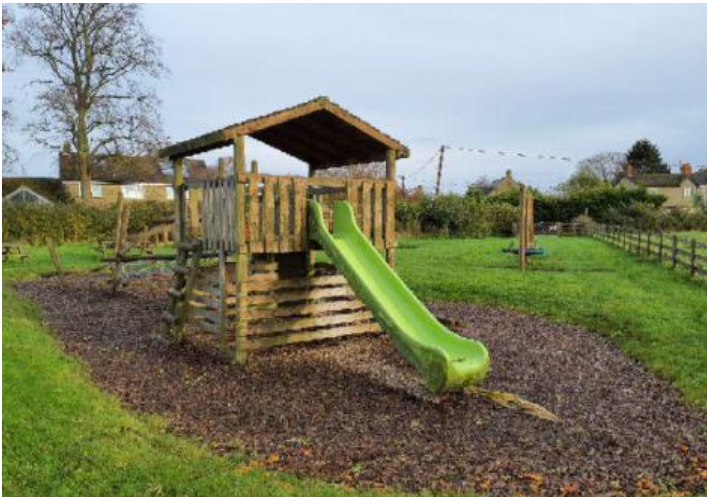
**Item:** Activity Equipment - Multi Play (Junior)  
**Manufacturer:** Not Identified

**Finding:** The height of the slide runout is in excess of 350mm and does not meet the requirements of BS EN 1176: 350mm Part 3

**Action:** Top up loose fill surfacing to reduce height below 350mm

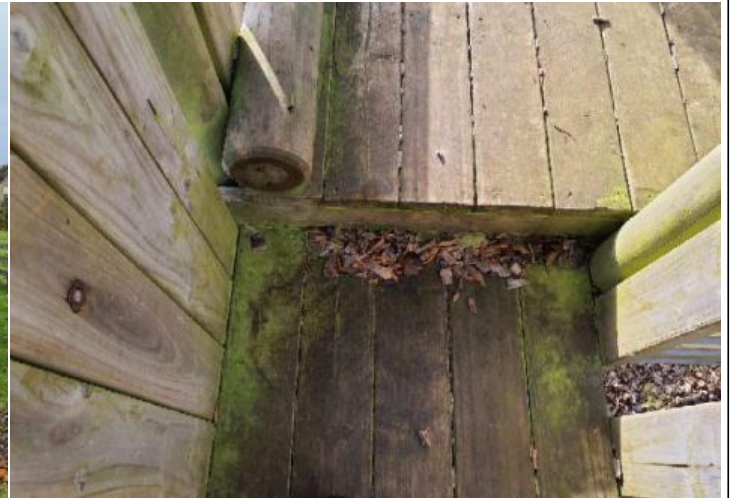
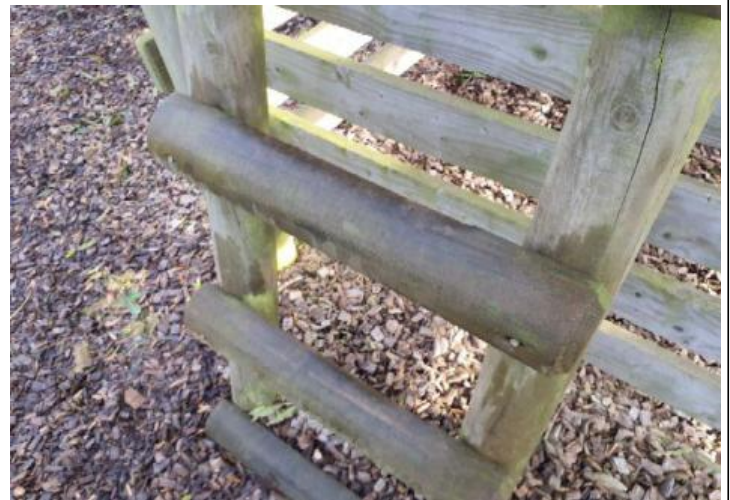
**Item:** Activity Equipment - Multi Play (Junior)  
**Manufacturer:** Not Identified

**Finding:** There is algae or moss on the surface of the equipment

**Action:** Clean and treat appropriately

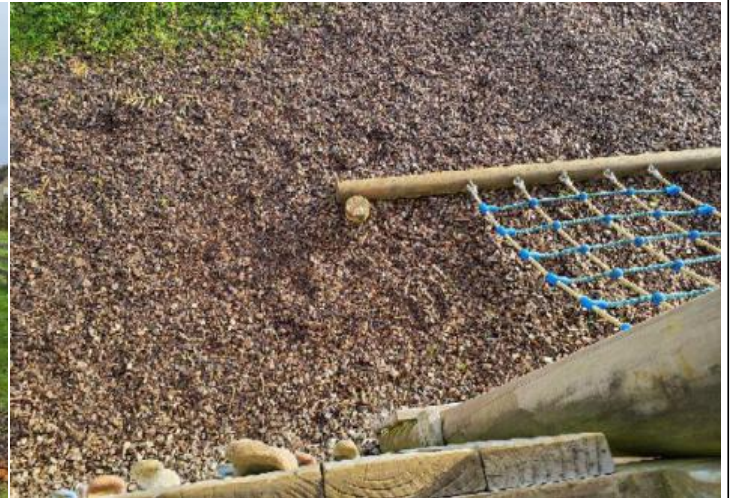
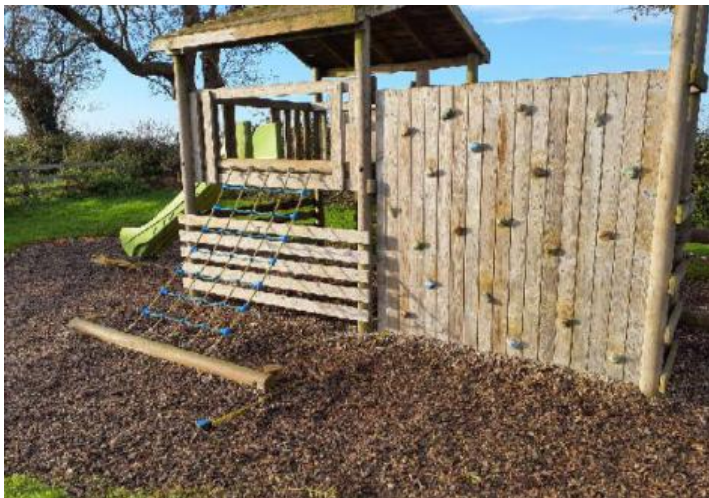
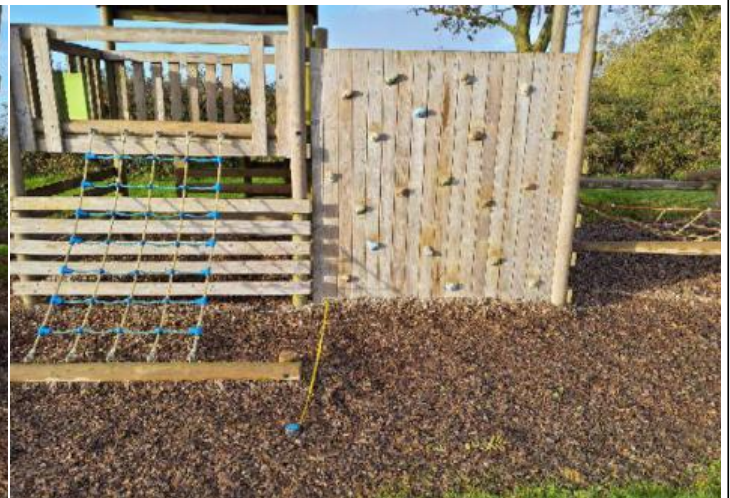
**Item:** Activity Equipment - Multi Play (Junior)  
**Manufacturer:** Not Identified

**Finding:** The rope net anchor beam forms a hard object within the falling space of the equipment in contravention of the requirements of BS EN 1176 Part 1

**Action:** Consider reducing the length of the beam to the base of the net

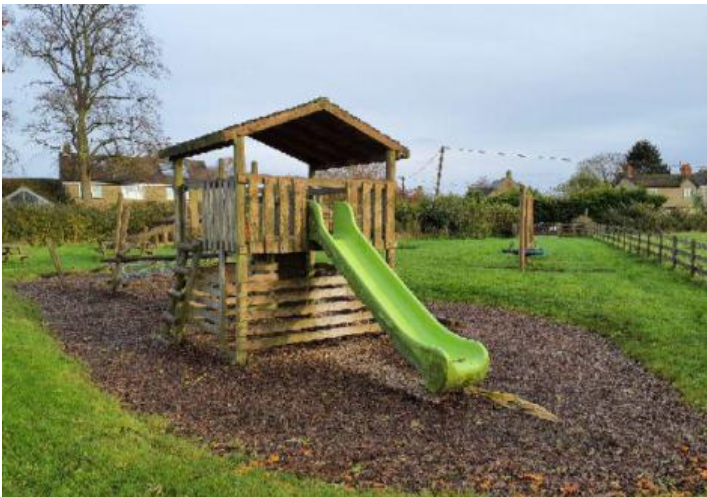
**Item:** Activity Equipment - Multi Play (Junior)  
**Manufacturer:** Not Identified

**Finding:** There is/are finger entrapment/s in the guardrail and the item fails to meet the requirements of BS EN 1176 Part 1 4.2.7.6 Entrapment of fingers  
**Action:** Remove entrapments

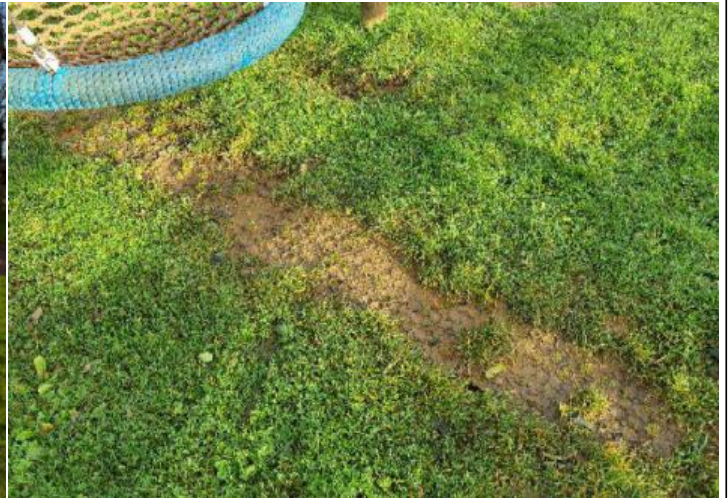
**Item:** Swings - Basket Swing - Type 1  
**Manufacturer:** Not Identified

**Finding:** The grass mats are silted up and the soil is compacted; this may have an effect on the impact absorbing properties of the surface. Consideration should be given to HIC testing the surface to verify impact attenuating properties ( <https://playinspections.co.uk/inspection-services/safety-surface-testing/> )

**Action:** Contact our office for a quotation for this service

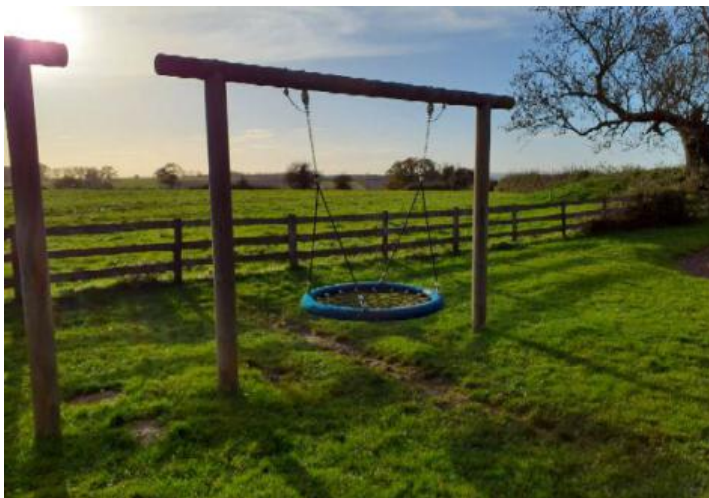
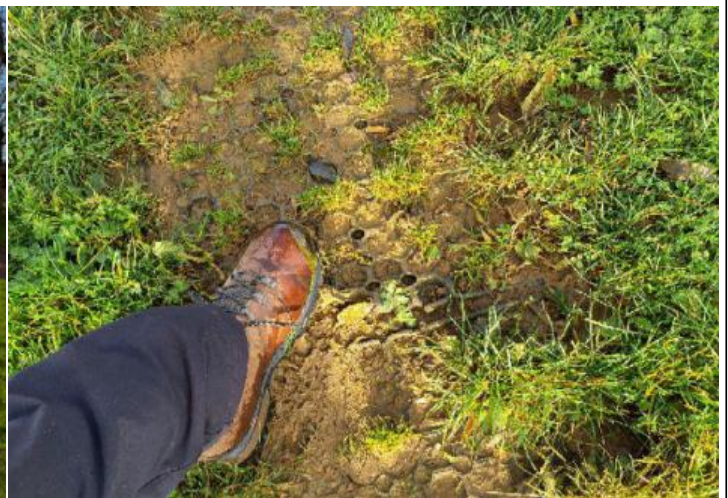
**Item:** Swings - Basket Swing - Type 1  
**Manufacturer:** Not Identified

**Finding:** There are gaps opening between the grass mat tiles

**Action:** Provide additional ties or secure / reinstate surface tiles

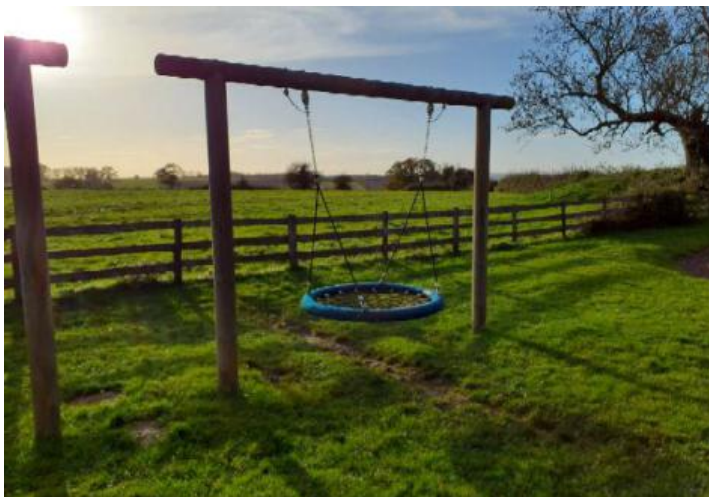
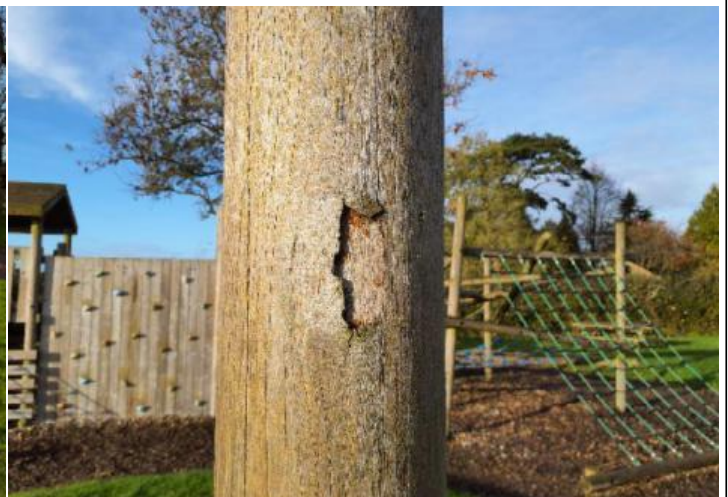
**Item:** Swings - Basket Swing - Type 1  
**Manufacturer:** Not Identified

**Finding:** Parts of the timber are rough or splintered

**Action:** Remove all rough or sharp edges

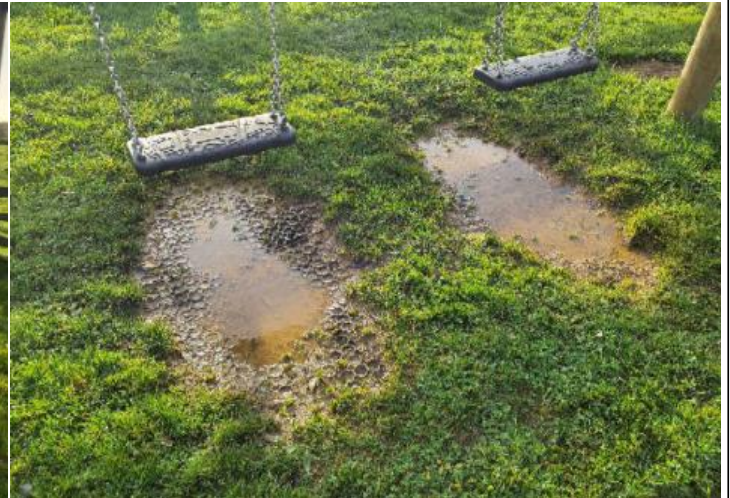
**Item:** Swings - 1 Bay 2 Seat (Flat)  
**Manufacturer:** Not Identified

**Finding:** The grass mats are silted up and the soil is compacted; this may have an effect on the impact absorbing properties of the surface. Consideration should be given to HIC testing the surface to verify impact attenuating properties ( <https://playinspections.co.uk/inspection-services/safety-surface-testing/> )

**Action:** Contact our office for a quotation for this service

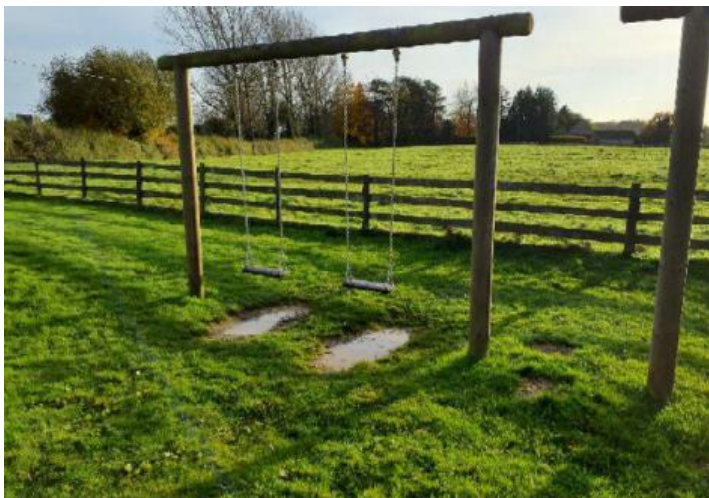
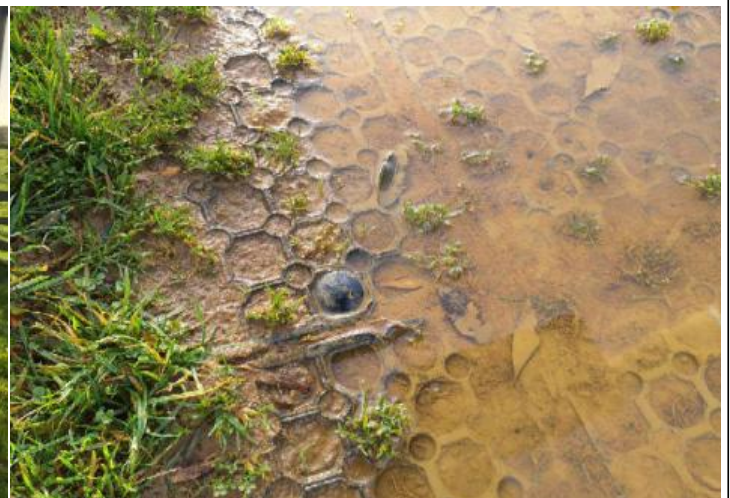
**Item:** Swings - 1 Bay 2 Seat (Flat)  
**Manufacturer:** Not Identified

**Finding:** Fixing Pins have been installed in the impact areas of the grass mats

**Action:** Remove pins from impact areas

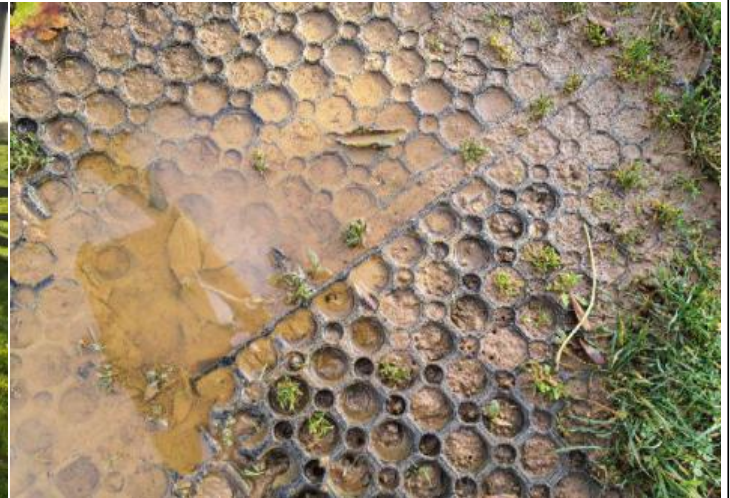
**Item:** Swings - 1 Bay 2 Seat (Flat)  
**Manufacturer:** Not Identified

**Finding:** There are gaps opening between the grass mat tiles

**Action:** Provide additional ties or secure / reinstate surface
