1061 Farthinghoe Bridge

The structure carries the A422 over Farthinghoe stream and consists of 2 types of construction; the original brick arch bridge with a steel corrugated arch extension.

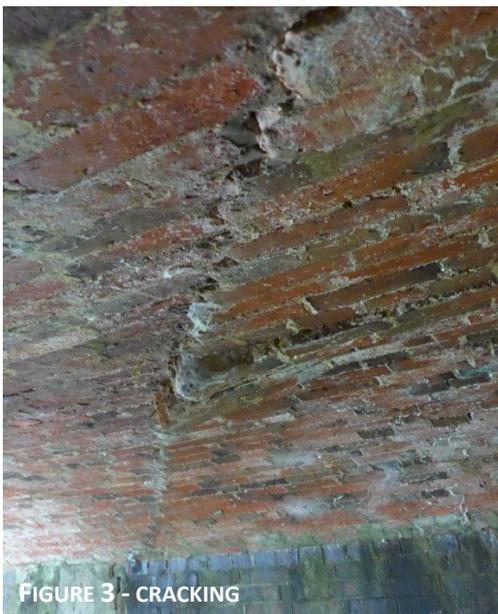
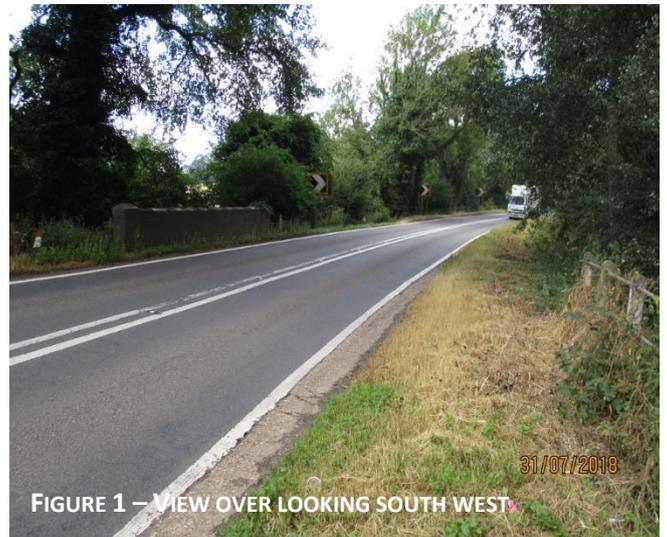
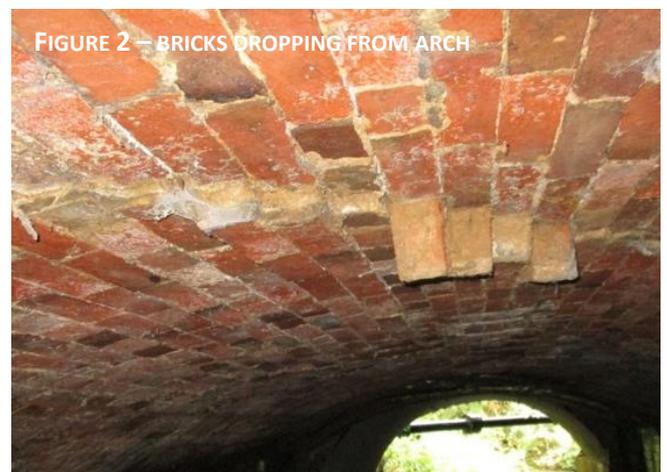
The last inspection in October 2016 identified defects in the brick arch that were of concern, including cracks and bricks dropping from the crown of the arch barrel. These defects had deteriorated gradually over years, but had worsened considerably in recent years.

At the last monitoring inspection in August 2018, there was a noticeable increase in the measurement of the drop of the bricks in the arch crown. If these bricks do drop out, then the structural integrity of the arch is compromised, with the potential for it to collapse without warning.

Due to the volume of traffic and number of heavy vehicles using the route, Northamptonshire Highways took the operational decision to close the A422, to allow temporary propping to be installed before the arch collapses, and allow the road to be reopened, probably under signal control. This will be carried out as quickly as possible, once the temporary props are designed.
